# *Poultry Engineering, Economics & Management*

## Newsletter of the National Poultry Technology Center, Auburn University

Produced in cooperation with the U.S. Poultry & Egg and Alabama Poultry & Egg Associations  
Issue No 73, September 2011

## Can Your Trusses Be Trusted?

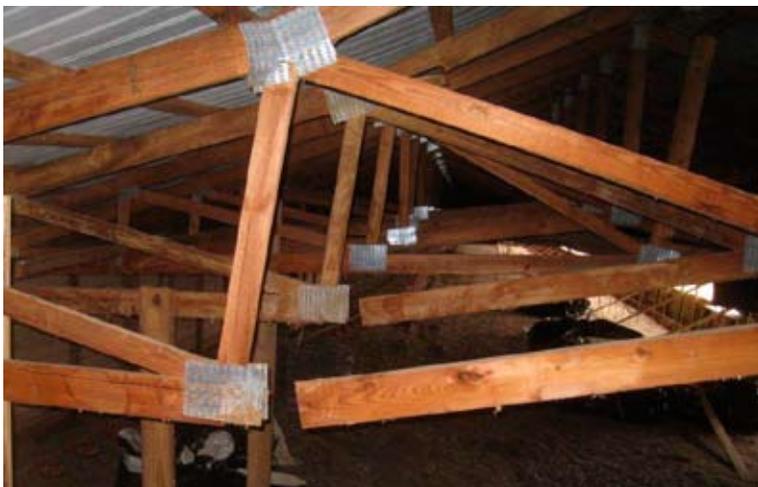
**The poultry house attic is a critically important part of the house and is the most often overlooked. In a worst case scenario, a single failure of a single truss member could eventually cause the total collapse of the house.**

**Growers should thoroughly inspect truss systems on a regular basis to spot weaknesses on their way to becoming disasters.**

**If repairs are needed or have recently been done, growers should make sure they are done properly, closely inspecting houses following repairs.**

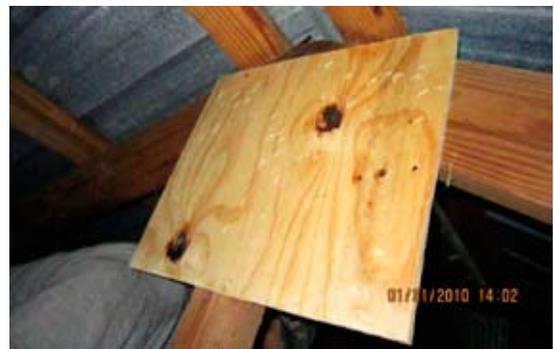
Photo above shows an acceptable truss repair in progress. The plate is 3/8-inch plywood of significant size being applied with numerous fasteners on each truss member. This repair will be complete when a matching plate is similarly applied to the other side.

Applying plywood plating is a key repair strategy: use at least 3/8-inch plywood (not OSB) cut to at least two times the size of the metal nailing plate being repaired. A plate needs to be fastened on both sides of the truss with not less than six 1-1/4 inch 12d nails in each lumber member under it.

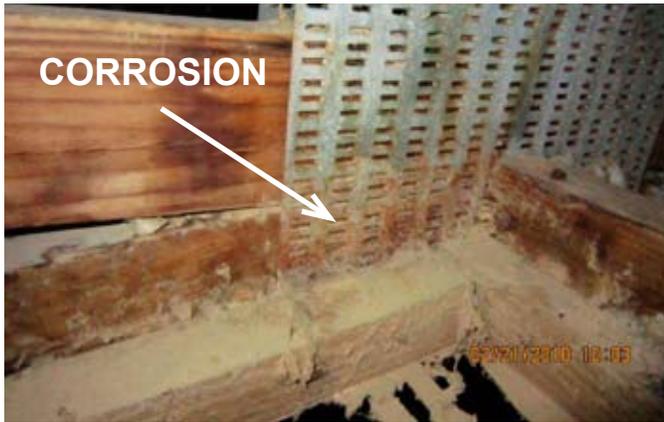
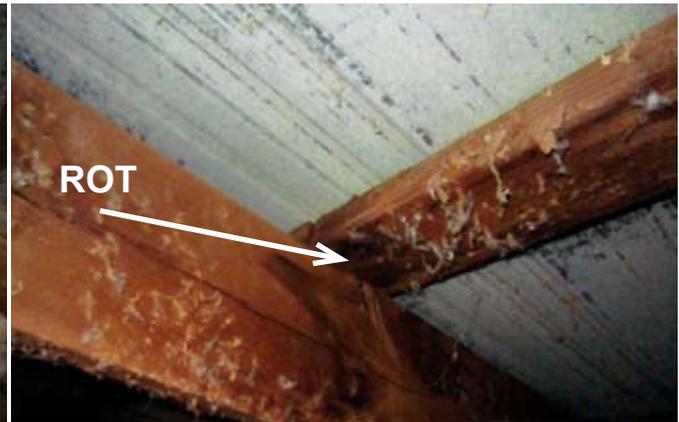
Moisture is the enemy in a poultry house attic. Humid “bird air” like that leaking around the attic access panel in the left photo causes the metal nailing plates to corrode and wooden members to show early signs of rot. Roof leaks seen in the right hand photo can also cause truss members and purlins to rot.

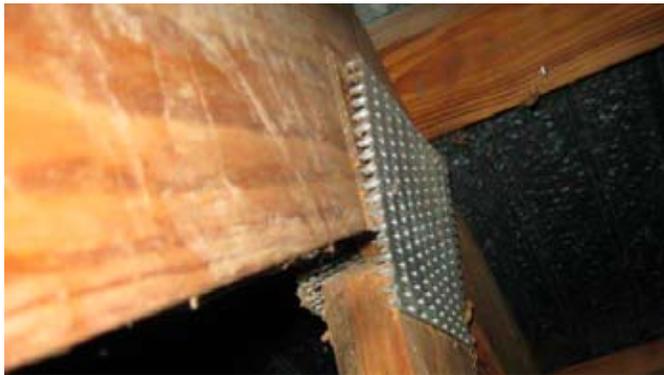
The truss plates on these trusses are in the first stage of failure, beginning to pull out and allow the trusses to deform. Neither of these trusses showed any sign of a problem from the outside of the house. Only through close attic inspection can this be found. This may be the result of a storm event or normal aging.

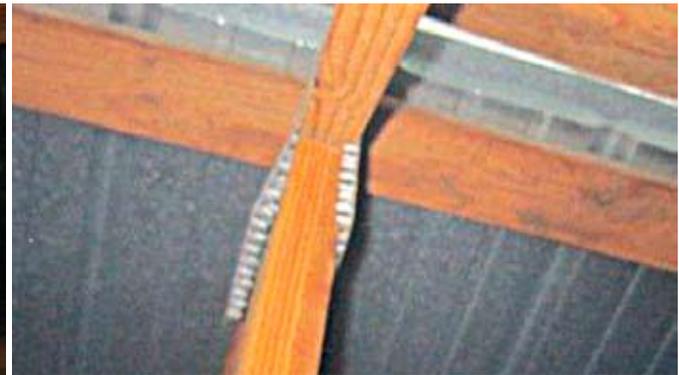
Photo at right illustrates an inferior repair attempt. Notice the bottom chord of the truss on the left hand side down in the insulation. The 1/4-inch finish plywood plate, on one side, with a few nails, did not hold this truss together as the grower intended. This repair might have been successful if the plates had been 3/8-inch thick plywood, installed on both sides of the truss, and a sufficient number of fasteners installed.

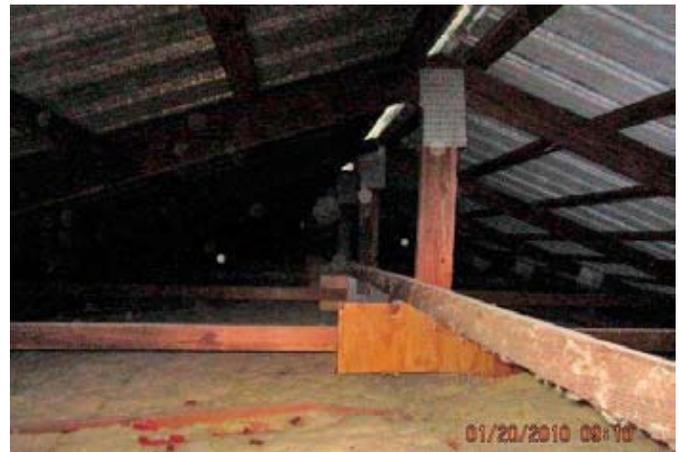
Photo at left shows an acceptable plating repair of a truss whose center metal truss plates had come loose. Numerous screws were used instead of nails in the plywood plates. A matching plate on the other side makes this truss as strong or stronger than it was prior to the damage. However, these large plates do restrict attic access for future inspection.
