Poultry Engineering, Economics & Management

Produced in cooperation with the U.S. Poultry & Egg and Alabama Poultry & Egg Associations
Issue No 85, October 2014

Repairing Corroded Sidewall Metal

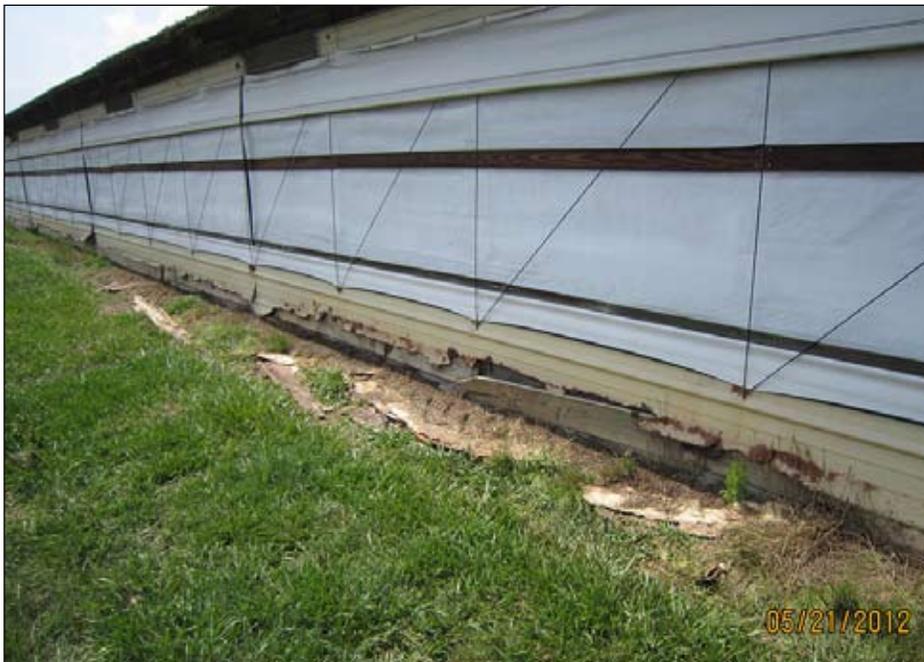
Metal along the lower sidewall of poultry houses is exposed to many corrosive forces. If not addressed, this corrosion can become severe, causing multiple problems. Air leakage is the most common detrimental effect. Vermin entry and compromised structural integrity can occur in the worst cases.

A new siding product NPTC began testing in 2011 is showing good performance in field trials, as explained in this newsletter.

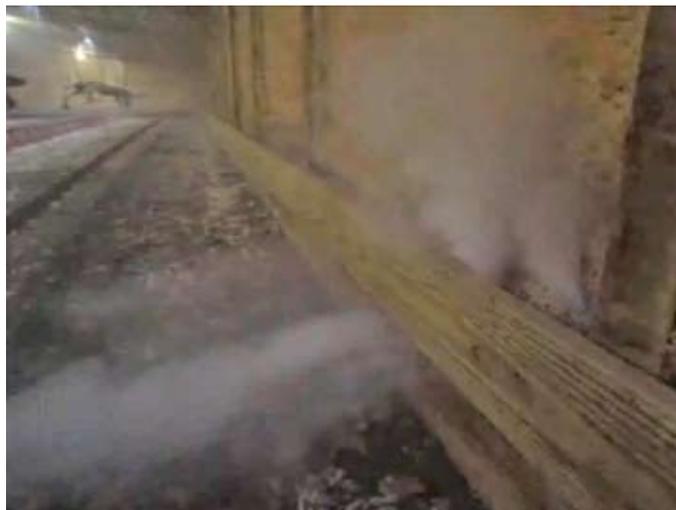
As shown in this smoke test photo, when using negative pressure to ventilate in the winter, damaged sidewalls allow streams of cold, damp air to flow directly onto the litter at chick level. This causes a multitude of problems. Wet litter, chilled chicks and increased fuel usage to combat these are the obvious. Increased difficulties ventilating such houses will impact overall flock performance, as well.

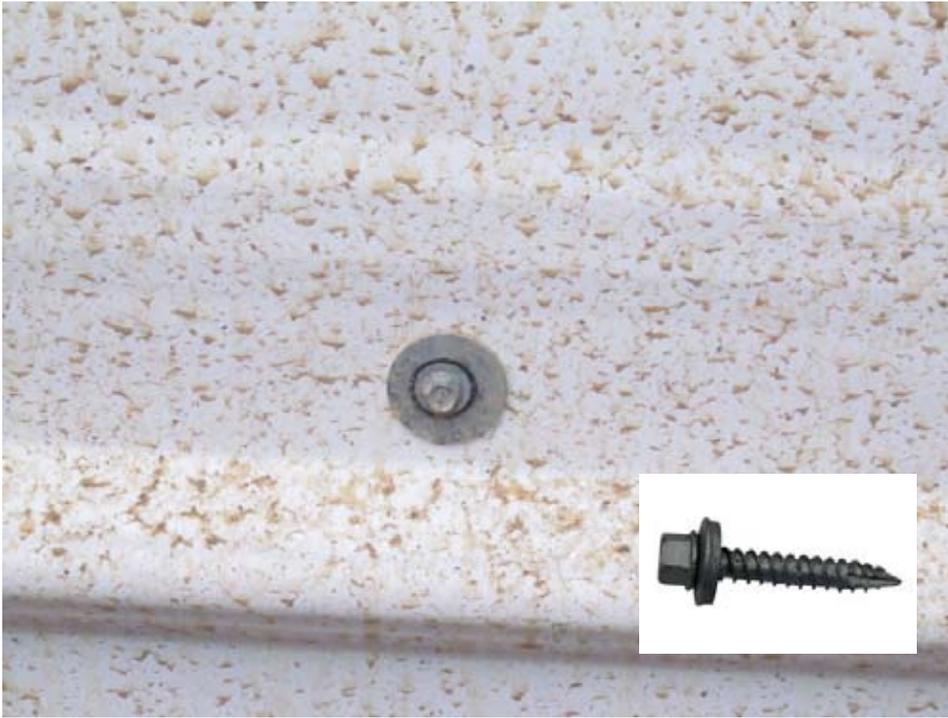
Adding a common quarter-inch flat washer, larger than the neoprene washers that come with a typical 1-inch roofing screw, provides an additional backer that helps hold the PVC panel in place while reducing chance of potential problems with expansion/contraction down the road.

success, following trials added common quarter-inch flat washers installed as additional backers to the screws, care being taken not to over-torque the screws into the plastic. Just a gentle snug up is all that is needed so the neoprene washers that come with the screws are only slightly compressed. Screws should be installed in the flats as with normal metal siding at similar spacing of no more than 2 feet on center. After installation, the dirt backfill is replaced against the new siding.

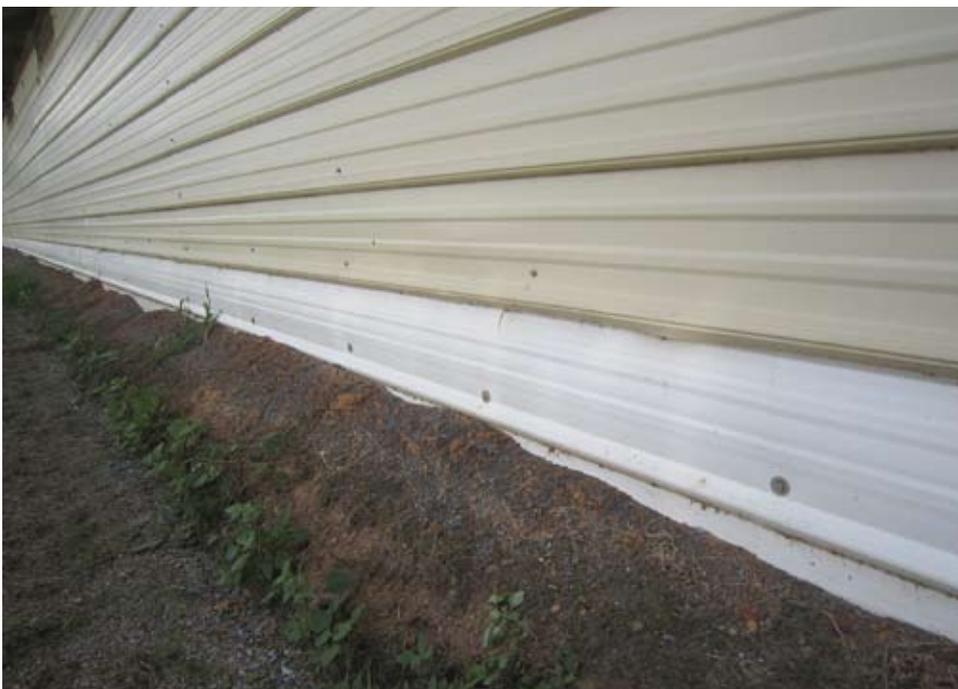
After three years of field trials, the PVC panel repaired houses still look good and have maintained their tightness with no additional maintenance. The panels remain tightly installed to the lumber beneath with no signs of cracking or fasteners loosening. This house is ready for several more years of service.

Using this method, the PVC panels have proven to hold up over time with minimal contraction and expansion in all weather conditions. Air leakage along the lower sidewalls of the repaired houses has been virtually eliminated, yielding noticeably drier litter along the sidewalls and lowering the amount of fuel required for litter management. Brooding conditions immediately improved as well.
