Parkerson Mill Creek Watershed Management Plan

Chapter 1: Executive Summary and Introduction

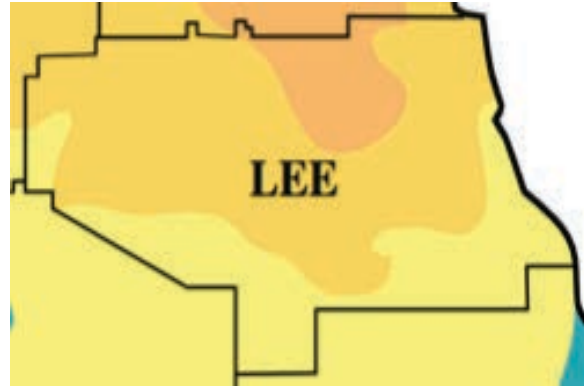
Figure 6. Elevation in Lee County, (Alabama Maps)

lay at the southern most tip of the Appalachian Mountain chain, with some of the final foothills being present in Chewacla State Park, just southeast of the Parkerson Mill Creek Watershed. Most of this region is characterized by rolling plains. Elevation in this area changes from 117 m (386 feet) (Chewacla Creek) to 257.7 m (845 feet) above sea level near the Chambers county line. Variations in elevation for Lee County are shown in Figure 6.

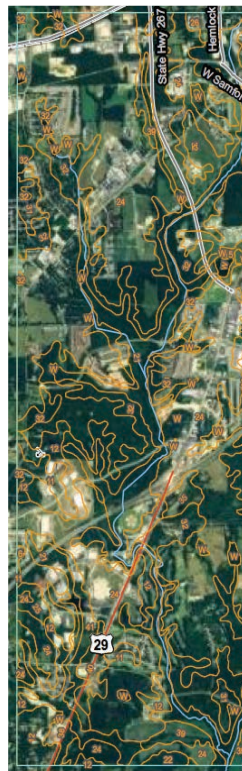
Figure 7. Soils within Parkerson Mill Watershed Vicinity (Web Soil Survey)

The predominant soils in this area are the Marvyn Loamy Sand (1-6% slopes) and the Pacolet Sandy Loam (6-10% slopes). The area in the vicinity of Parkerson Mill Creek is primarily made up of loamy sand and sandy loams (Pacolet, Gwinnett, and Hiawassee Soil Series). These soils have moderate infiltration rates, hydrologic soil groups B, and relatively low surface runoff. The majority of the soils have >200 cm (6.5ft)

Soil	Slope
Blanton Loamy Sand	0-5%
Blanton Loamy Sand	5-10%
Cartecay Silt Loam	0-1%
Cecil Cobbly Loam	10-25%
Cowarts Loamy Sand	2-6%
Cowarts Loamy Sand	6-10%
Kinston Silt Loam	0-1%
Louisburg Sandy Loam	10-25%
Marvyn Loamy Sand	1-6%
Marvyn Loamy Sand	6-10%
Marvyn-Urban Land Complex	1-8%
Pacolet Sandy Loam	1-6%
Pacolet Sandy Loam	6-10%
Pits	-
Sacul Silt Loam	1-4%
Toccoa Sandy Loam	0-1%
Uchee Loamy Sand	0-6%
Uchee Loamy Sand	6-10%
Urban Land	-
Water	-

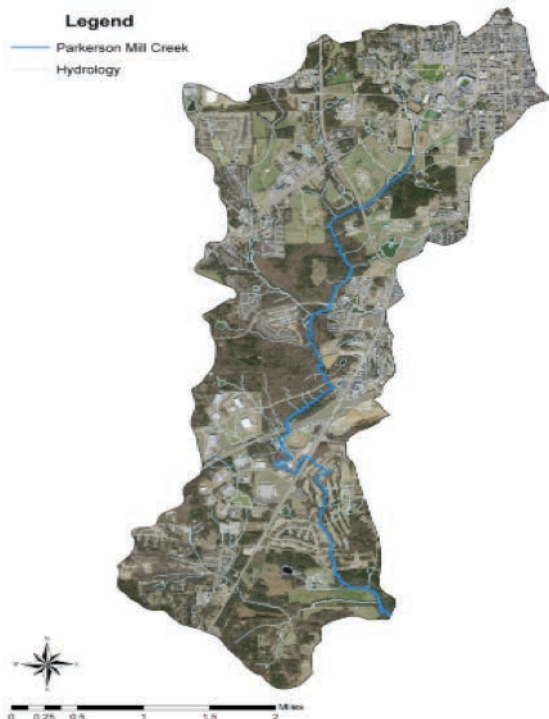
Figure 8. Hydrology of Parkerson Mill Creek Watershed (city of Auburn GIS)

Parkerson Mill Creek begins at an approximate 188 m (615 foot) elevation near Magnolia Avenue in downtown Auburn, with much of its headwaters located on the highly urbanized

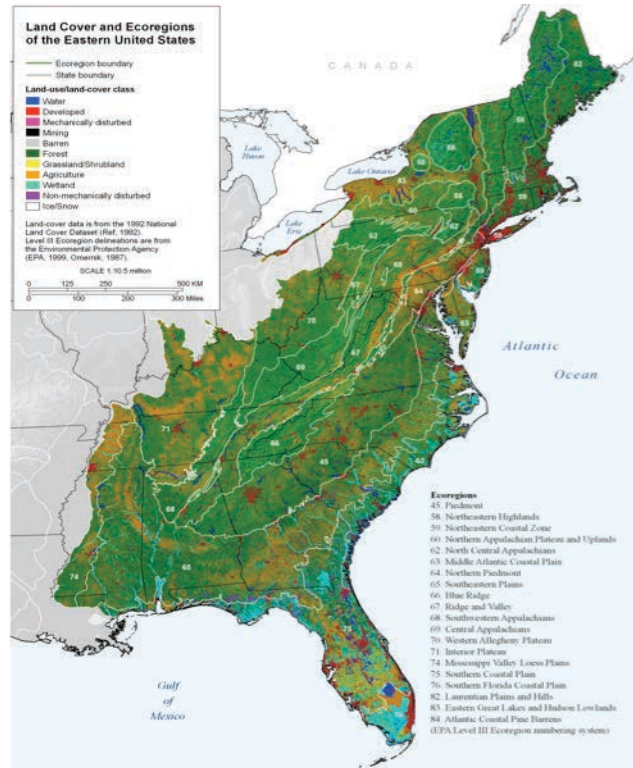
Figure 9. Ecoregions of the Eastern United States (Loveland and Acevedo, 2010)

Prior to settlement in the 1830's most of the Parkerson Mill Creek Watershed was comprised of old growth forests and rolling plains. Post settlement and up until the middle of the next century forests and farms made up much of the watershed and the ecoregion. The Parkerson Mill Creek Watershed is located on the cusp of the Piedmont and Southeastern Plains ecoregions (Piedmont, Southeastern, 2010). These ecoregions, as defined by the U.S. Geological Survey, are two of the largest ecoregions in the eastern United States (Figure 9). The Southeastern Plains region spans from the Gulf of Mexico up the east coast into southern Maryland, covering approximately 33,614,054 km² (12,978,459 mi²) (Southeastern, 2010). The Piedmont spans over 16, 545,986 km² (6,388,441 mi²), transitioning the Southeastern Plains up to the Appalachian Mountain chain and the Blue Ridge ecoregion (Piedmont, 2010). These regions are made up of cropland, pasture, forest, and wetlands. Because of their long growing season and abundant rainfall, they are rich in natural resources for farming and forests of pine, hickory and oak.

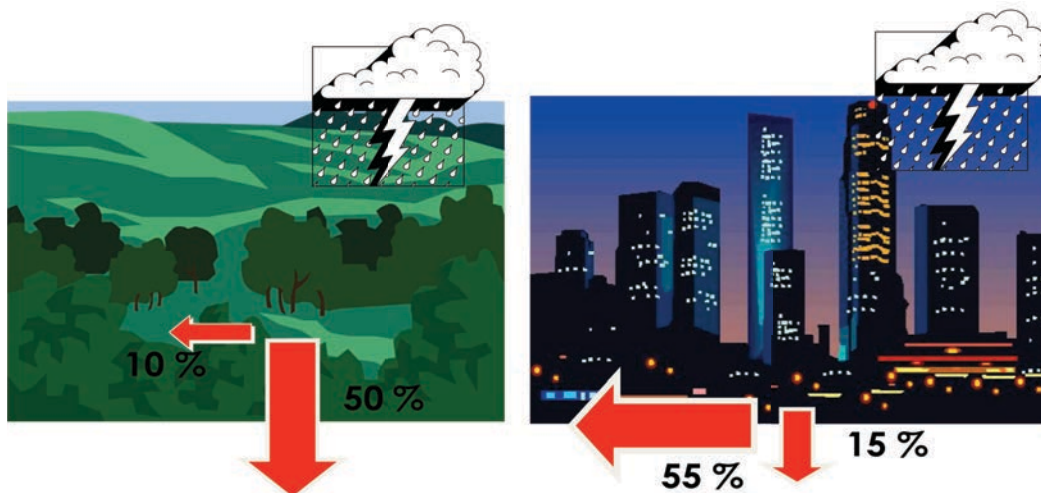
Figure 20. Runoff and Infiltration Percentages for Pre and Post Development Hydrology (NEMO)

As urban residential, commercial, and industrial land areas increase the result is an increase in impervious surfaces or imperviousness. These surfaces can often be directly connected to the regions that collect and drain runoff to surface waterbodies without the benefit of any water quality treatment. Figure 20 illustrates the changes in infiltration and runoff rates for predevelopment and post development hydrology.

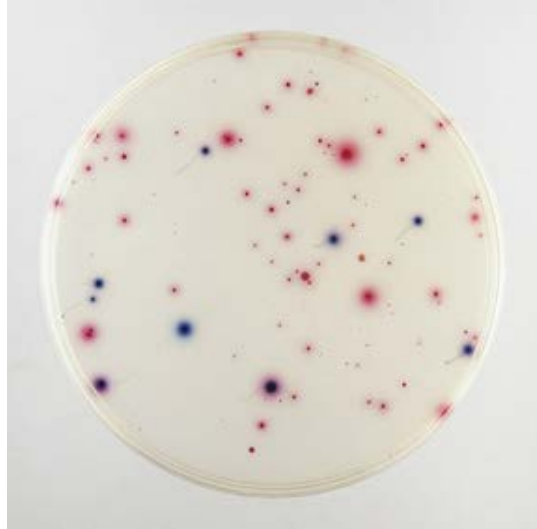
Figure 23. Coliscan™ Easy Gel, courtesy of Weber Scientific

The air and water temperature along with three replicates of 1 mL sample are collected at each site location. These samples are inserted in to Coliscan™ Easy Gel media and plated on Petri dishes. Once the media is gelled, the plates are incubated between 29-37°C for 30-48 hours. The results of each sample are determined by counting E. coli colonies after 48 hours. The blue to purple colonies are E. coli – an example is show in Figure 23.

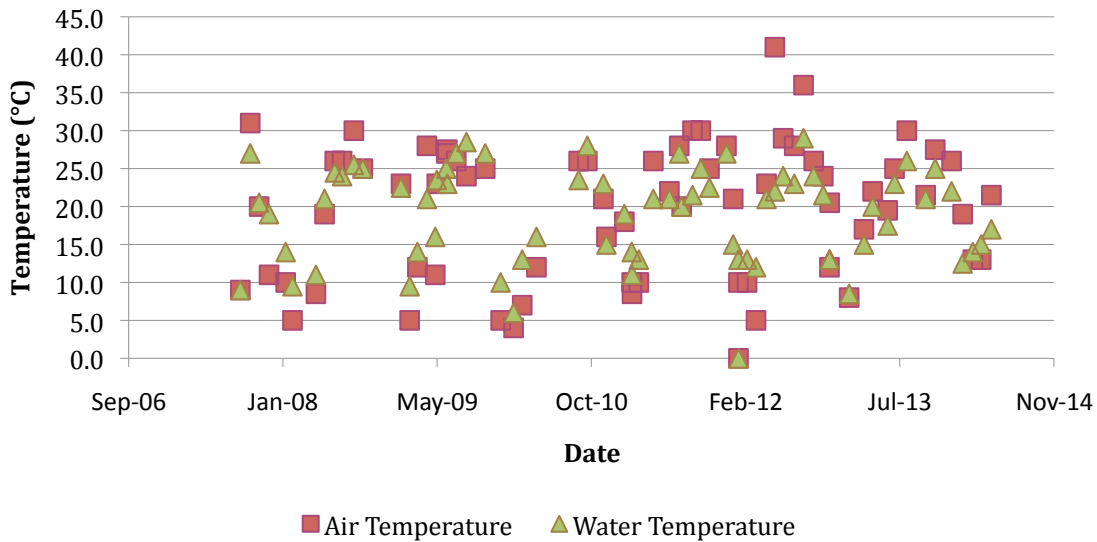
Figure 30. AWW Temperature Data for Reach 1

Water temperature ranges from 6°C to 29°C and air temperature from 4°C to 41°C. The temperatures recorded are shown in Figure 30. According to the Water Quality Standards (water temperature <32.2°C) Parkerson Mill Creek meets the water quality standard for Fish and Wildlife Use in terms of temperature within Reach 1.

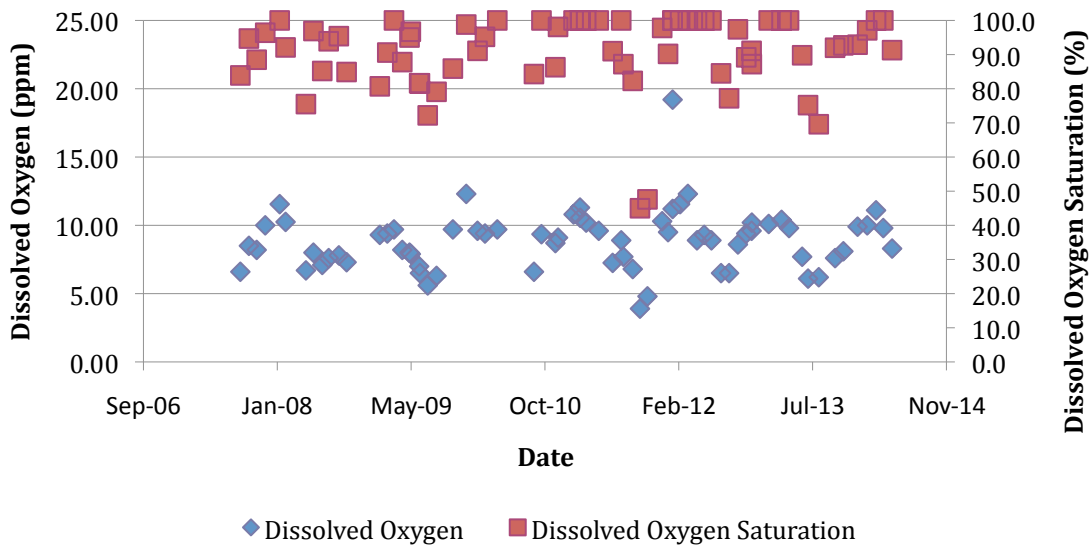
Figure 32. AWW Dissolved Oxygen Data for Reach 1

Dissolved Oxygen (DO) is important for the respiration of aquatic organisms. In Reach 1, DO ranges from 3.9 to 19.2 ppm with saturation percentages from 40%-100%. Only two samples are lower than the standard of 5 ppm. These samples (3.8 and 4.8) occur in September and October of 2007 and may have been affected by the reduced rainfall experienced that year. Figure 32 illustrates dissolved oxygen data for Reach 1.

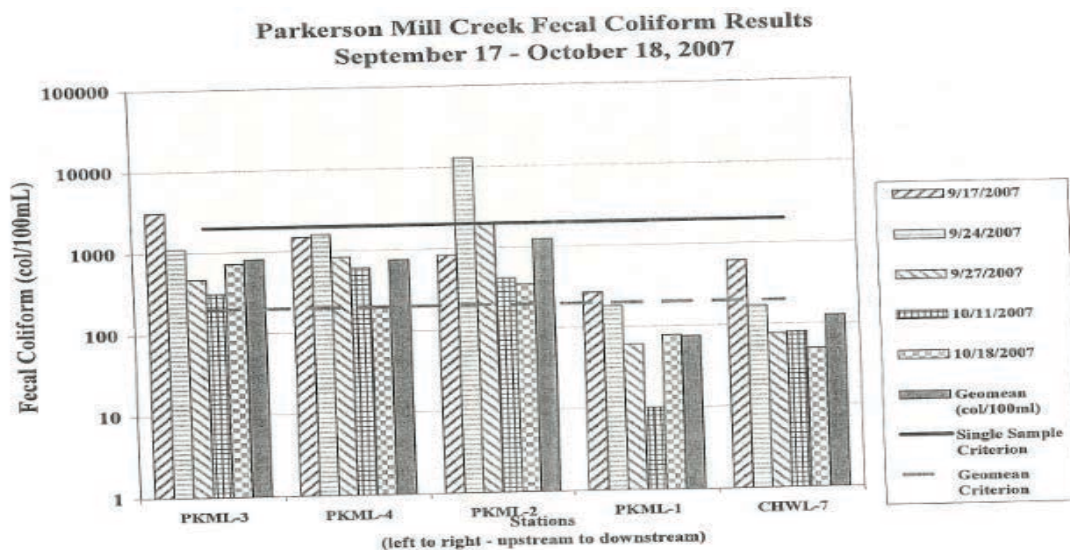
Figure 35. Copied from ADEM Auburn/Opelika Surface Water Bacteria Studies 2007-2008 (Figure 11).

In the follow up study conducted in October of 2003, an additional sampling location PKML-4, was included. PKML-4 is located downstream of the crossing of Lem Morrison Drive and Parkerson Mill Creek. For these locations, the sample on September 17, 2007 at PKML-3 exceeded the single sample limit for fecal coliform. In addition, the geometric mean exceeded the water quality criterion at both sites for all samples except the October 18, 2007 sample at PKML-4. The sampling results from this study are shown in Figure 35. Figure 35 is copied from the study report.

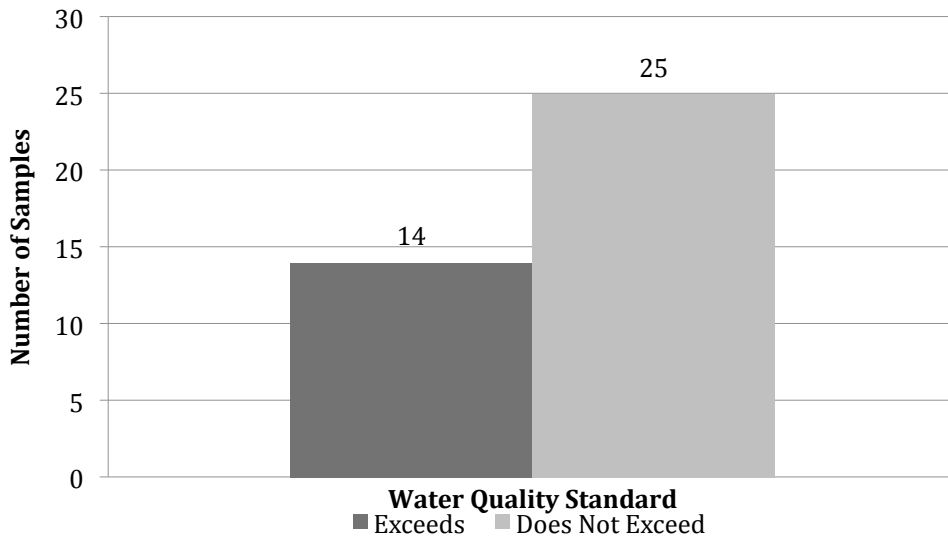
Figure 38. Exceedances in the Water Quality Standard for AWW Bacteriological Monitoring Sites in Reach 2

Of the 39 events, 14 of the events exceeded the water quality standard, while 25 samples met the water quality standard, as shown in Figure 38.
