Stream Restoration Implementation

Greg Jennings, PhD, PE
jenningsenv@gmail.com

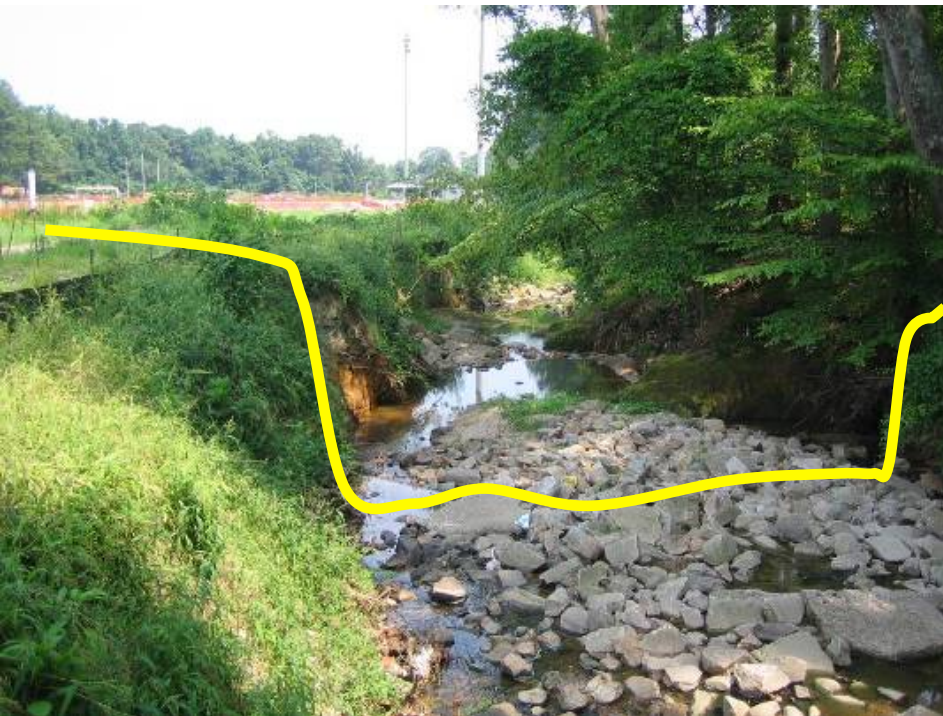
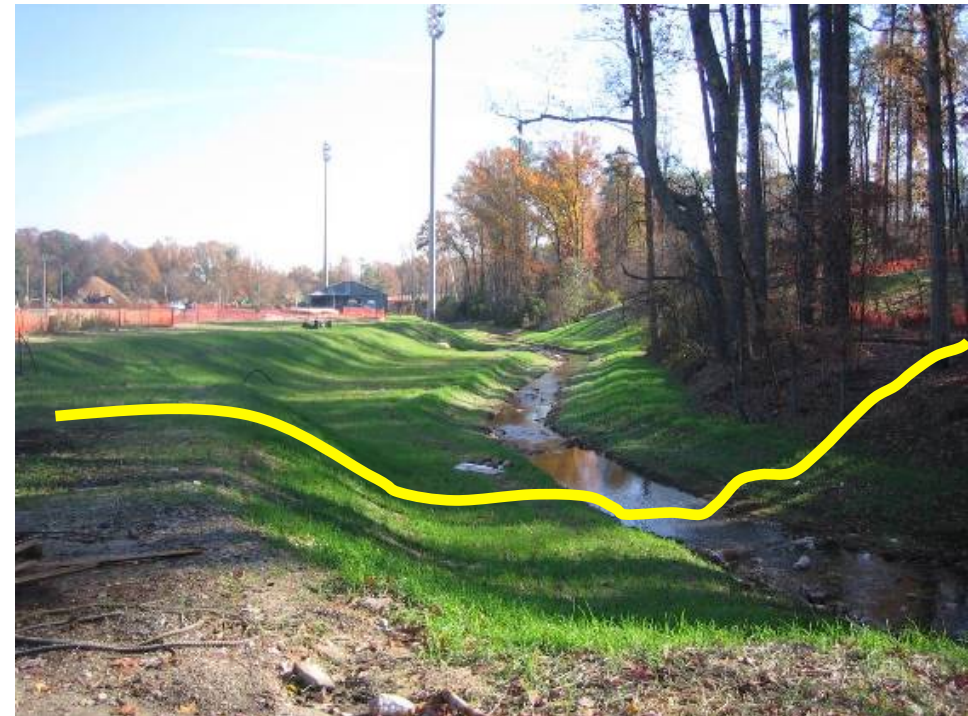
NCSU Rocky Branch

2005

2006

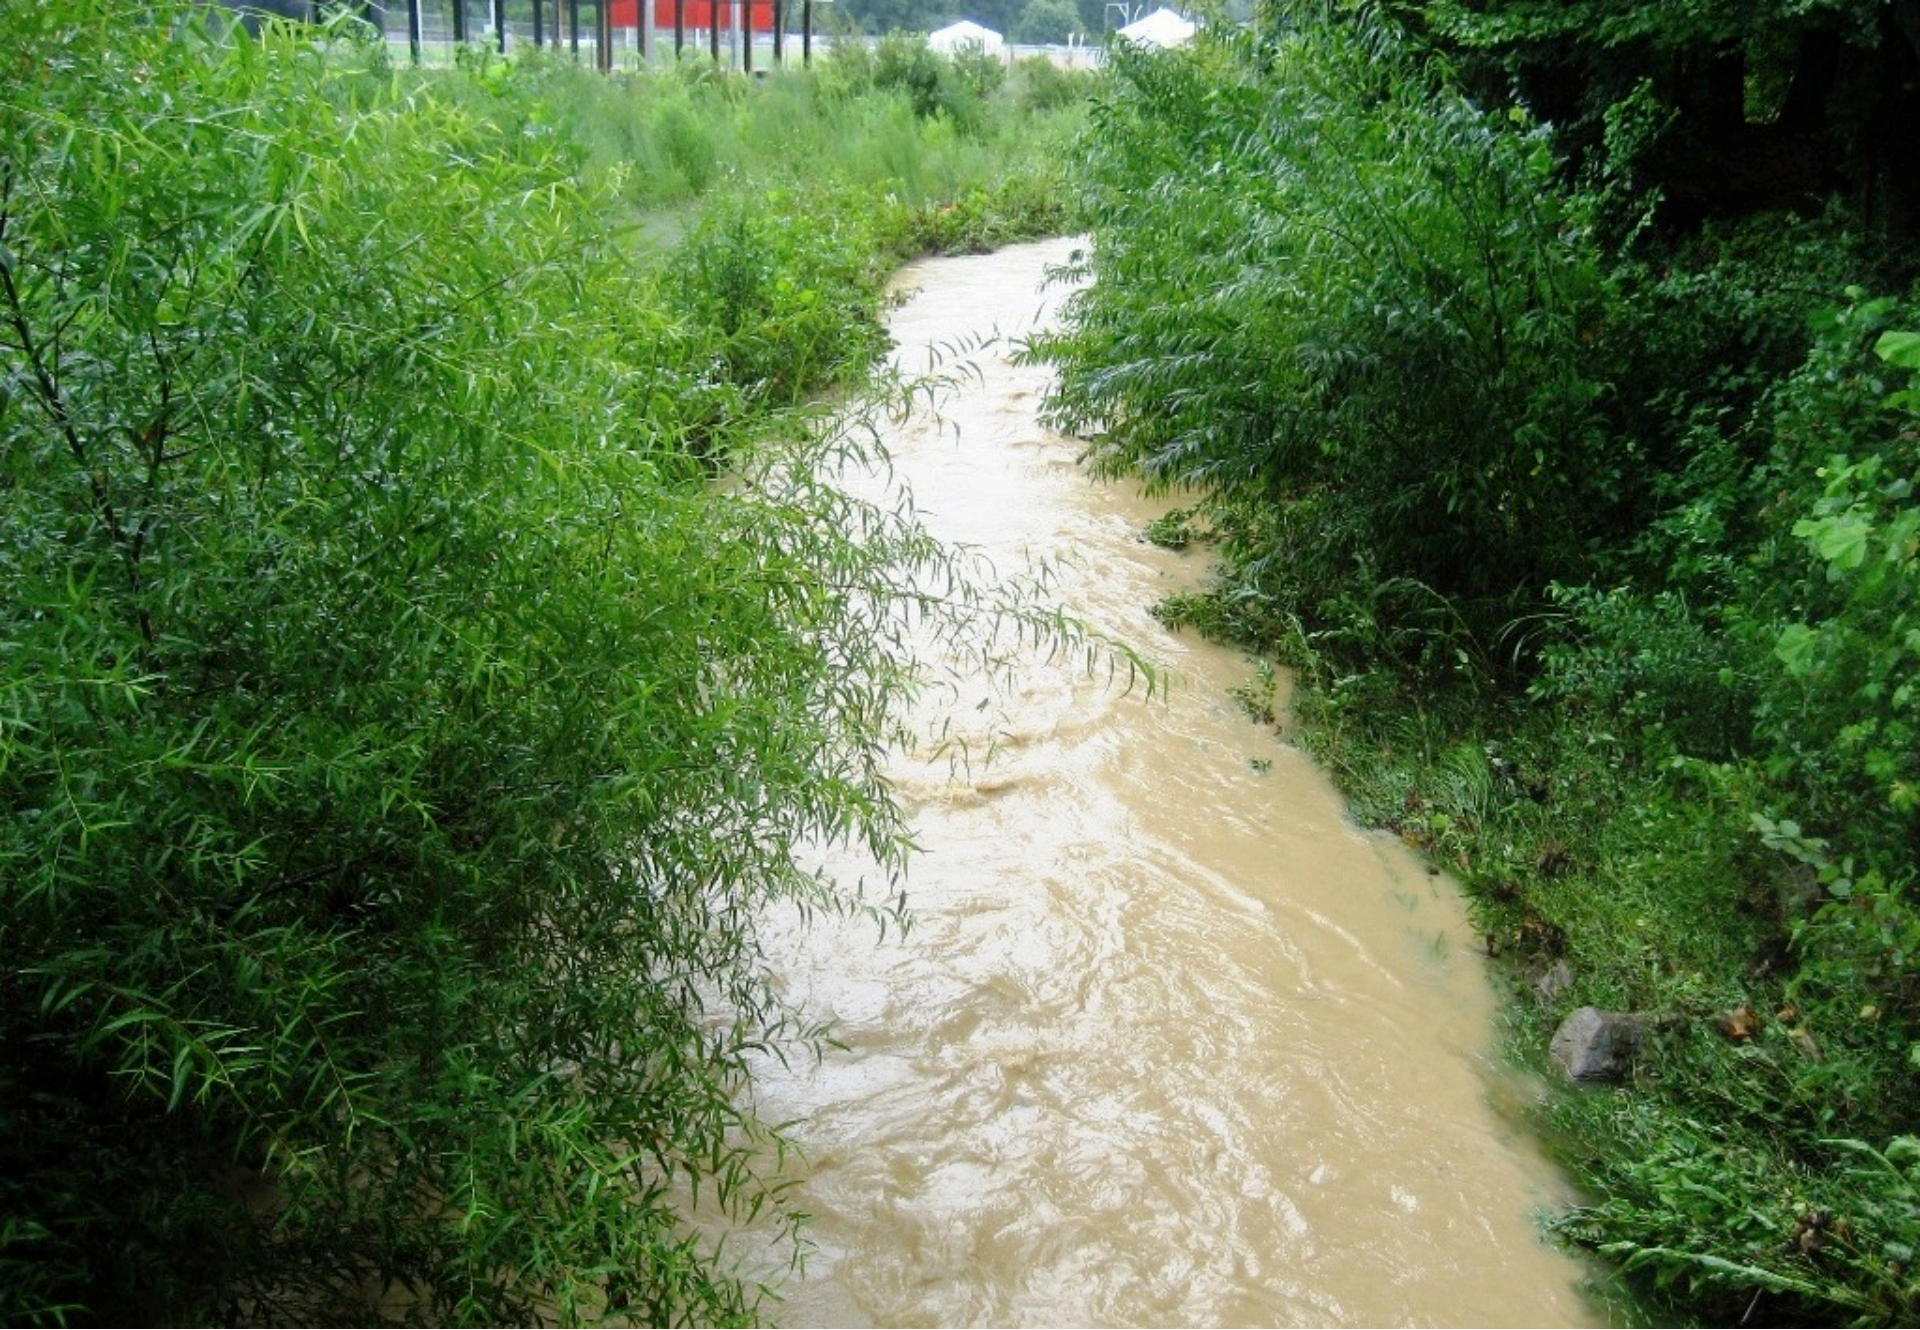
NCSU Rocky Branch

2008

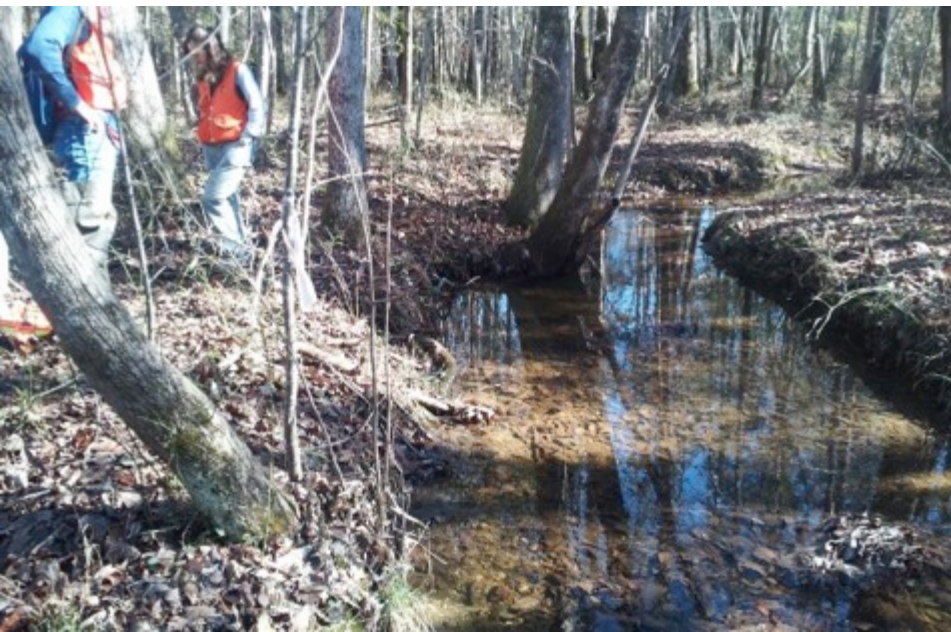
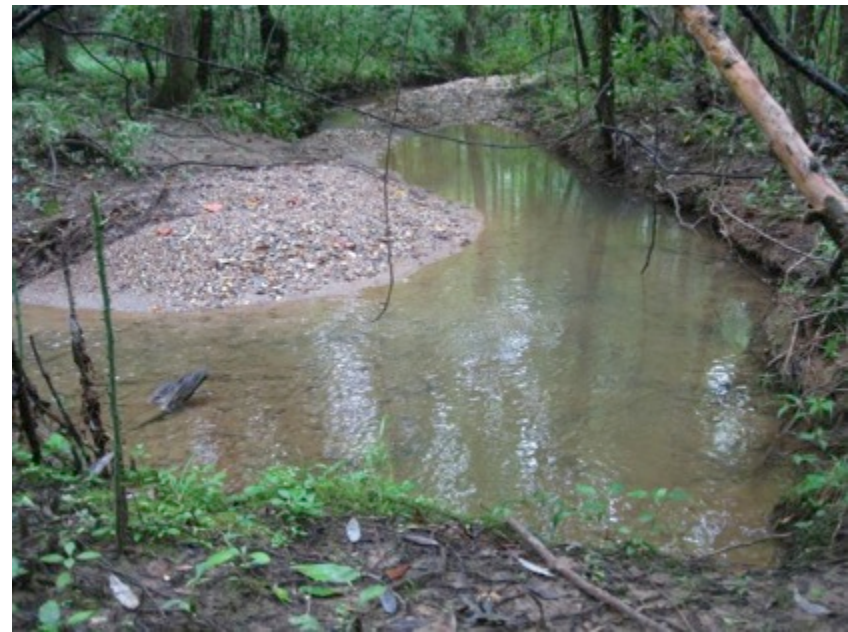
Low Bank Height and Natural Grade Control

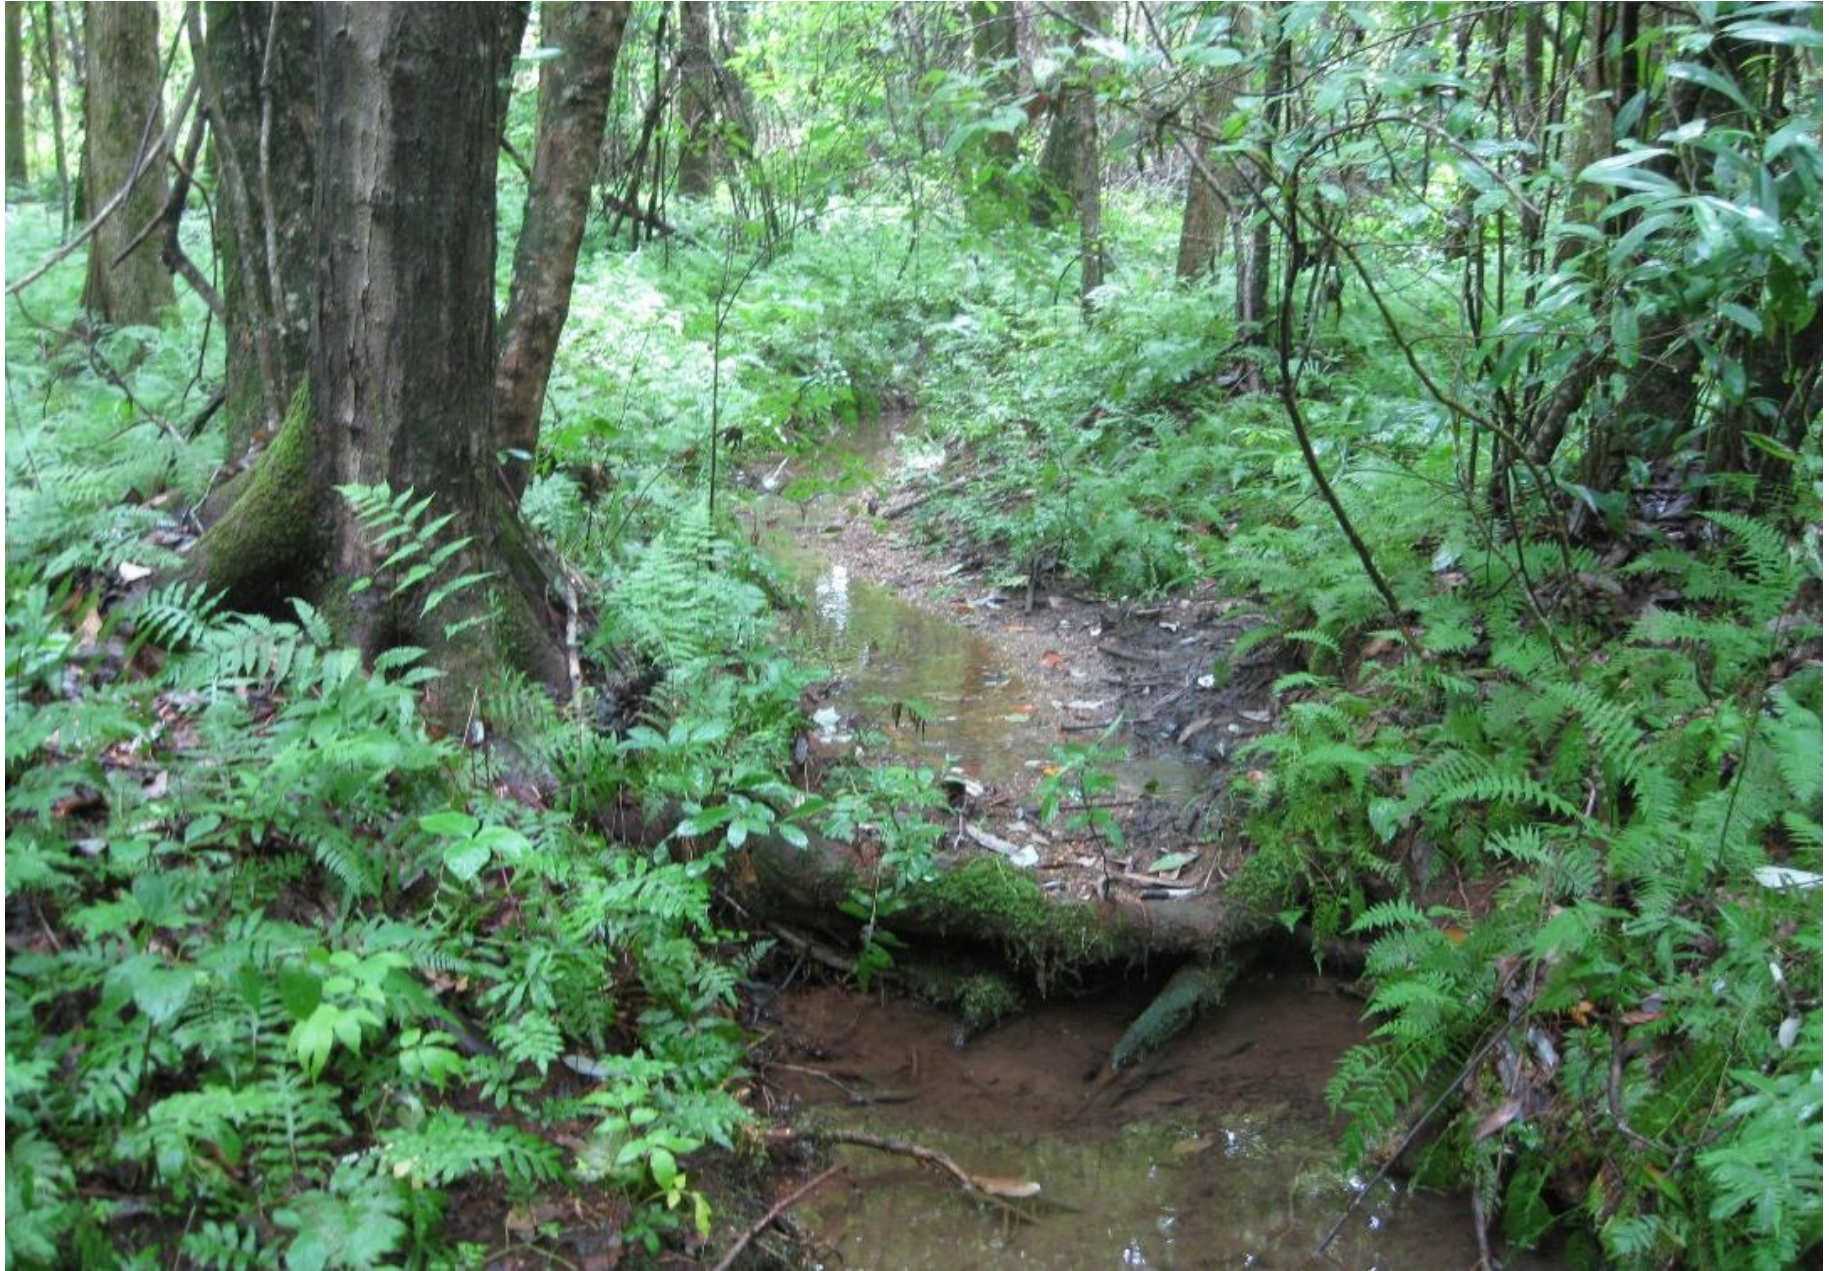
Bankfull Indicators:

Top of Bank, Point Bars, Lateral Benches

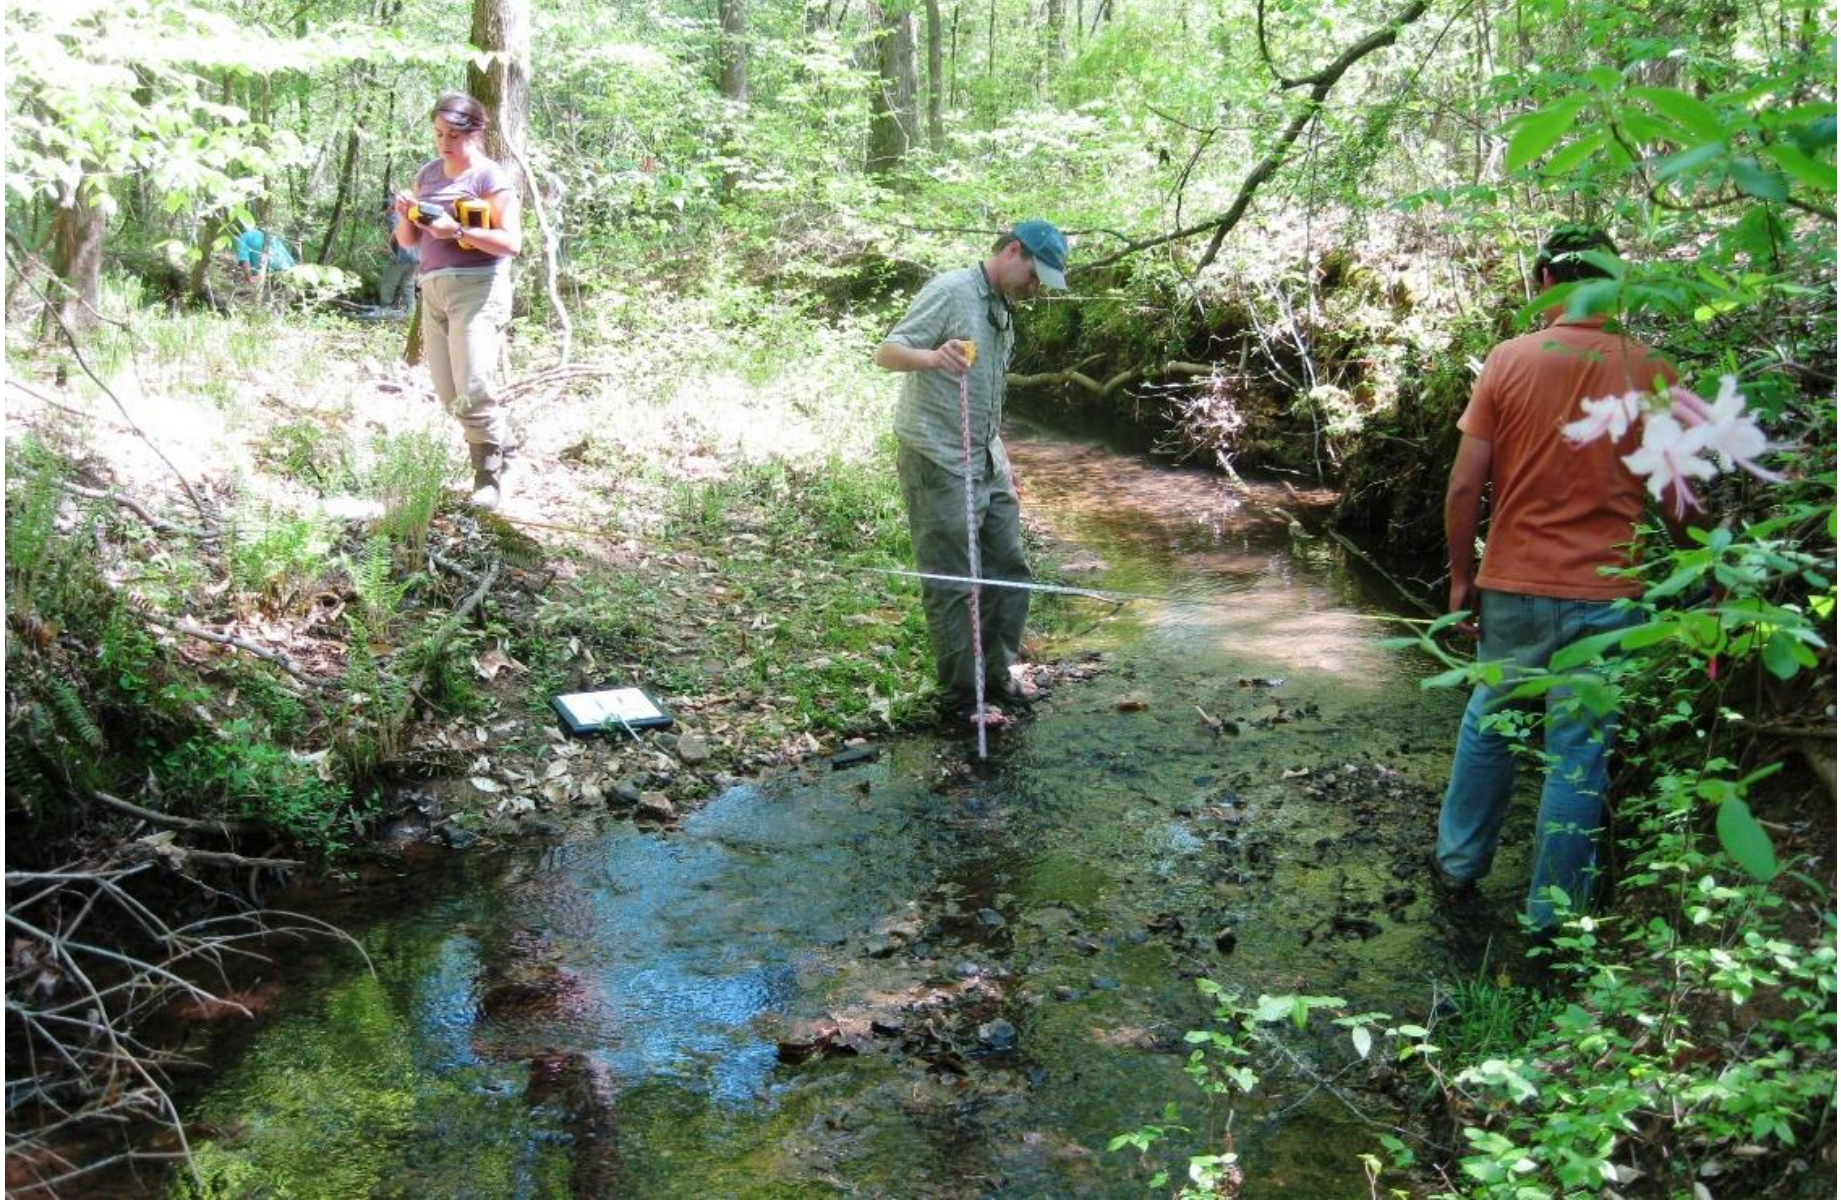
Regional curve development

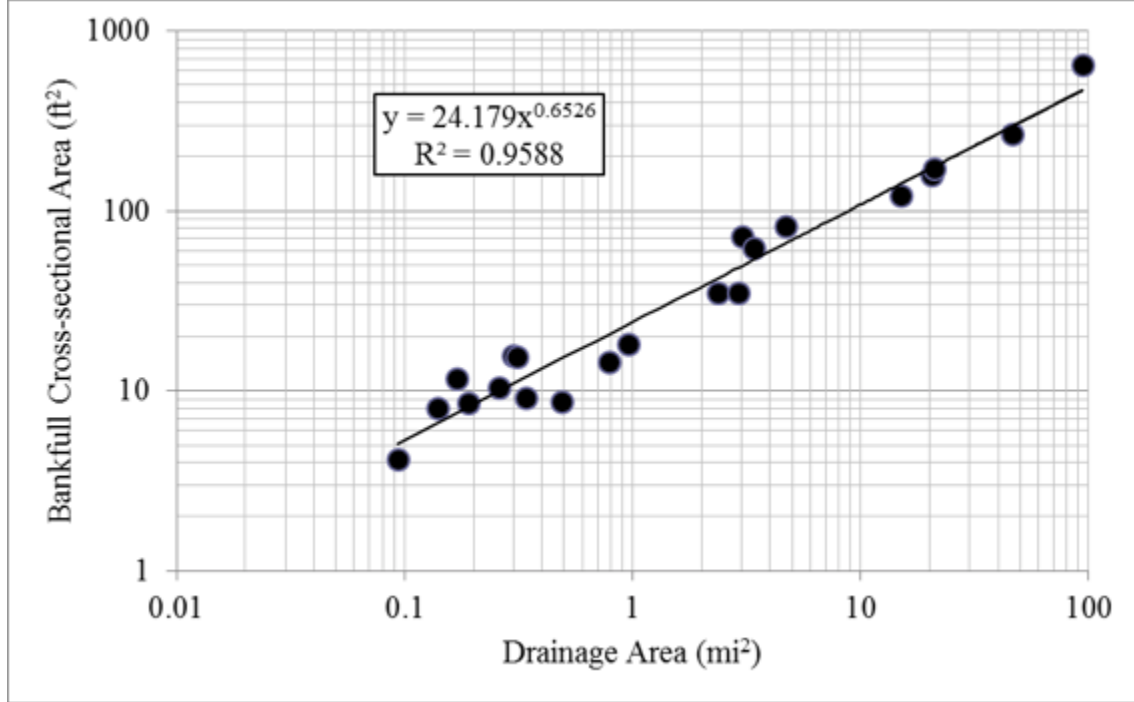
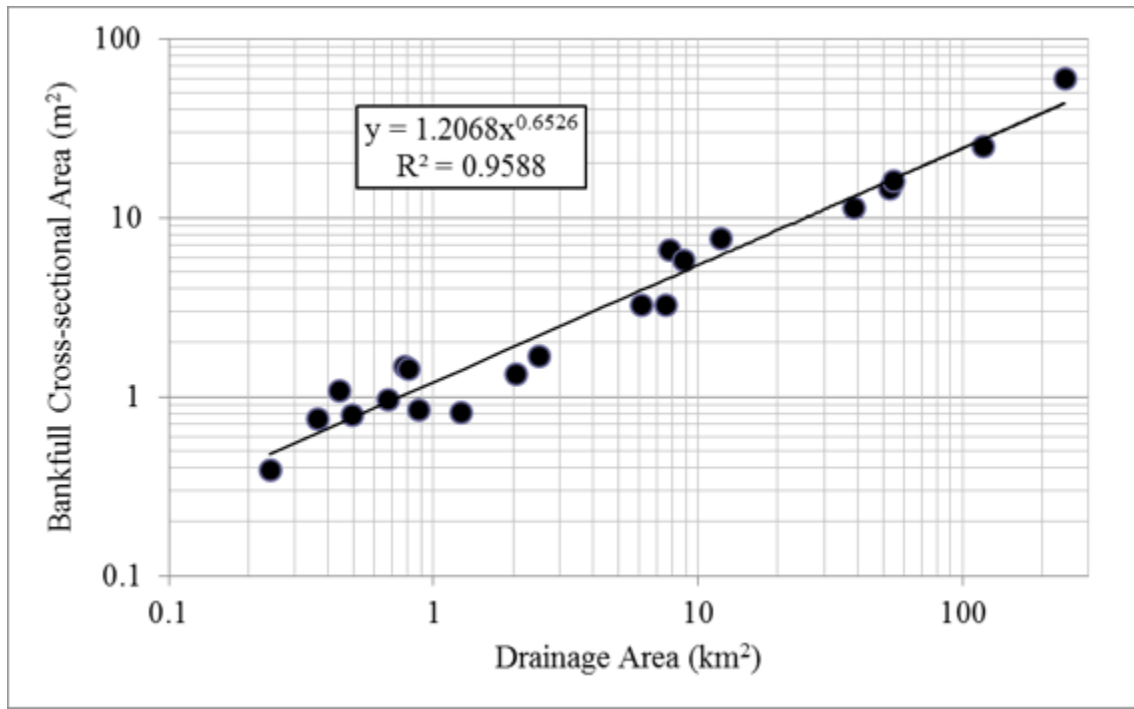
Alabama Piedmont Regional Curves (21 reference streams)

Bankfull Cross-sectional Area Related to Watershed Drainage Area

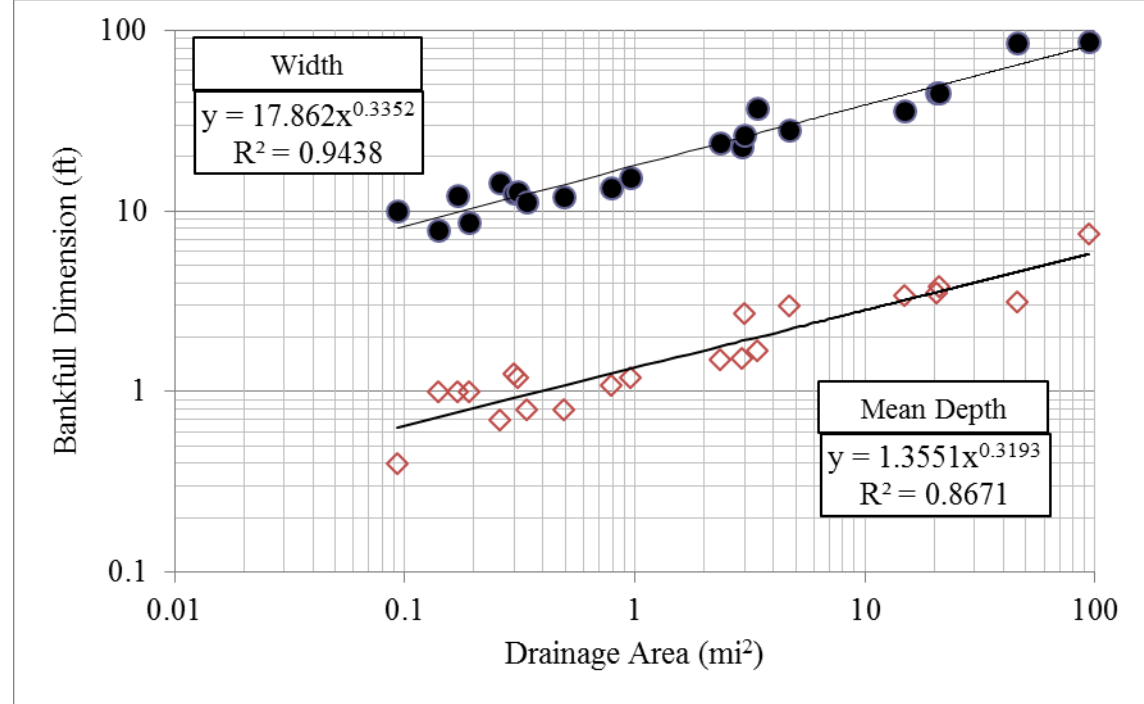
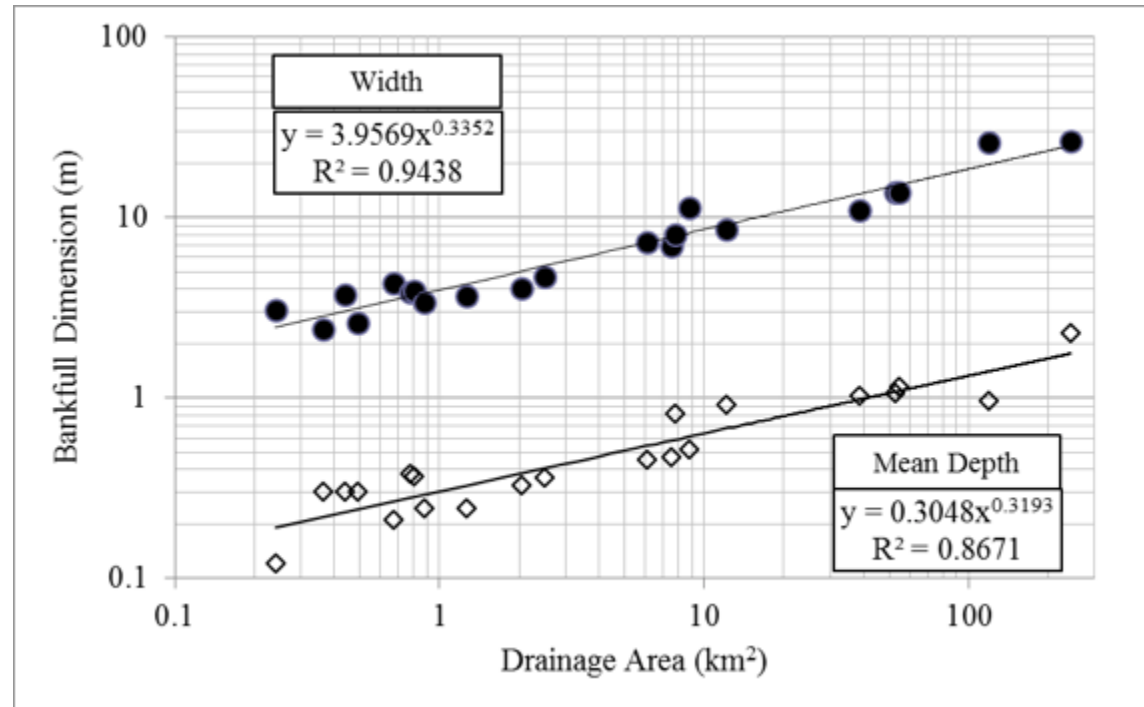
Alabama Piedmont Regional Curves (21 reference streams)

Bankfull Width and Mean Depth Related to Watershed Drainage Area

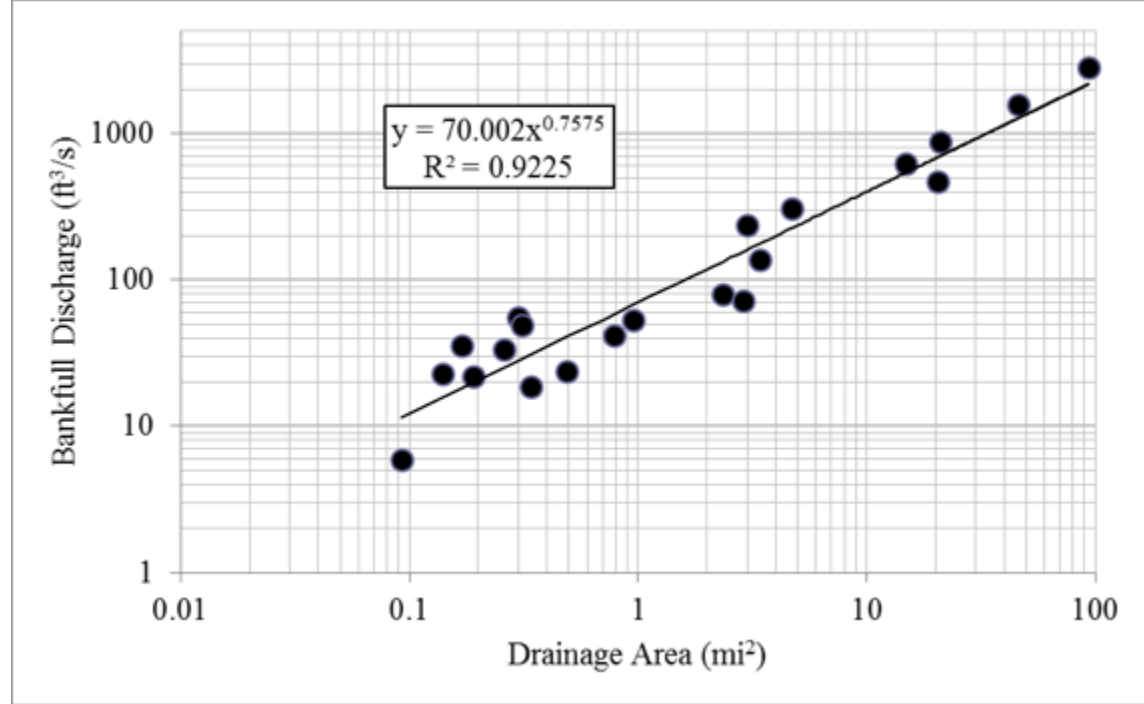
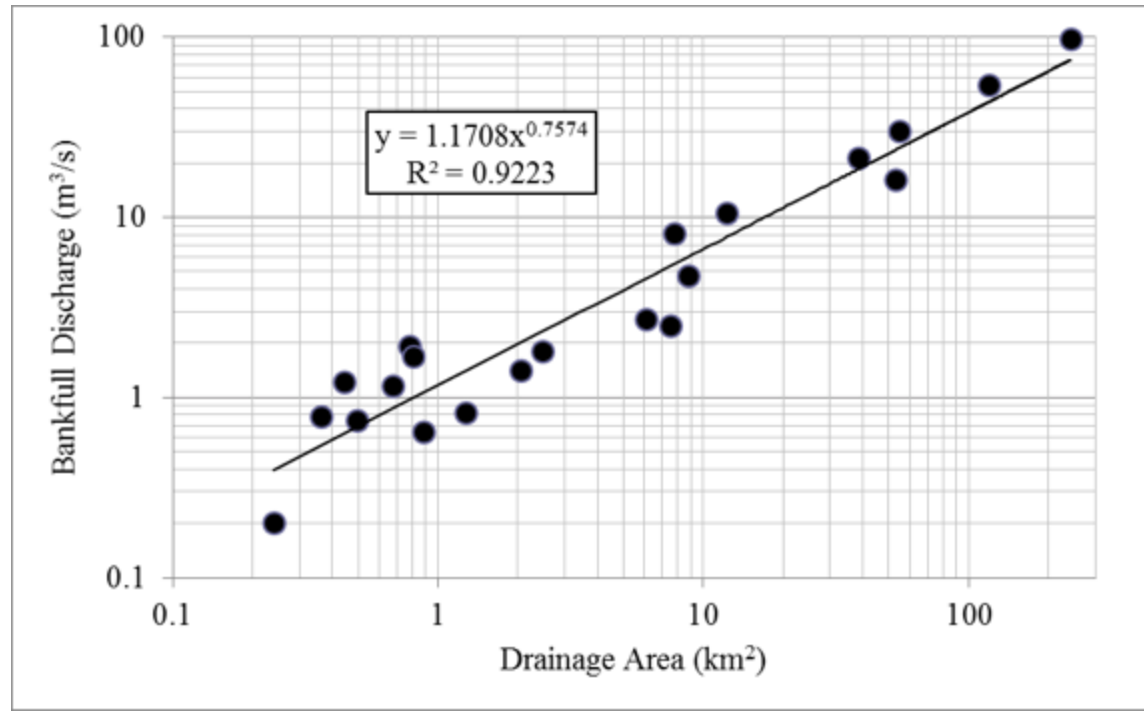
Alabama Piedmont Regional Curves (21 reference streams)

Bankfull Discharge
(estimated) Related
to Watershed
Drainage Area

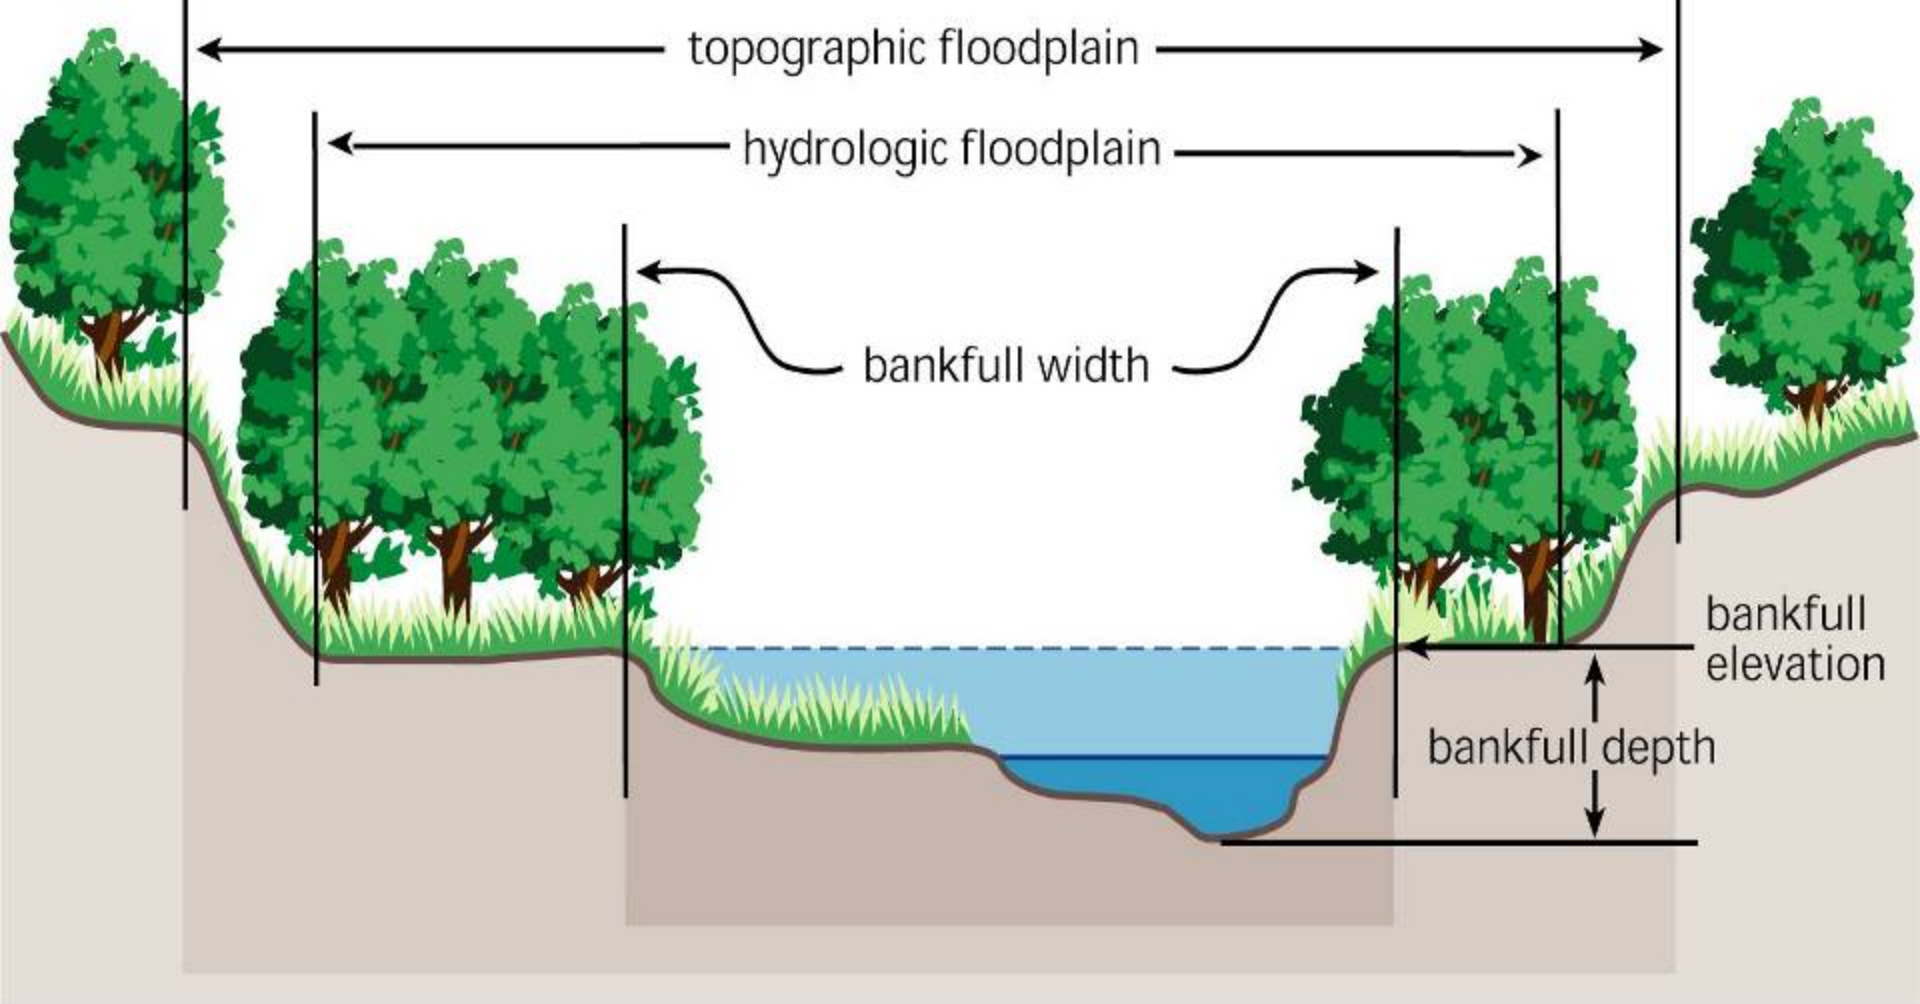
Bankfull Stage: Water fills the active channel and begins to spread onto the floodplain

Priority 1:
lift channel

Priority 2 & 3:
lower floodplain

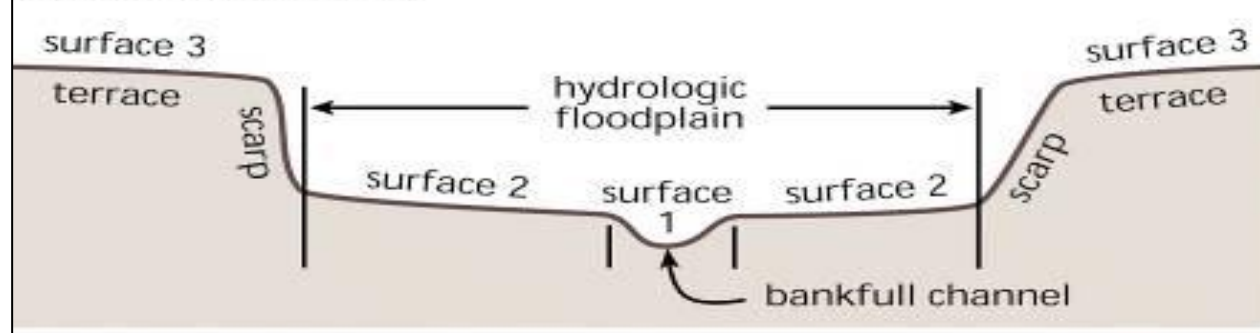
A. Nonincised Stream

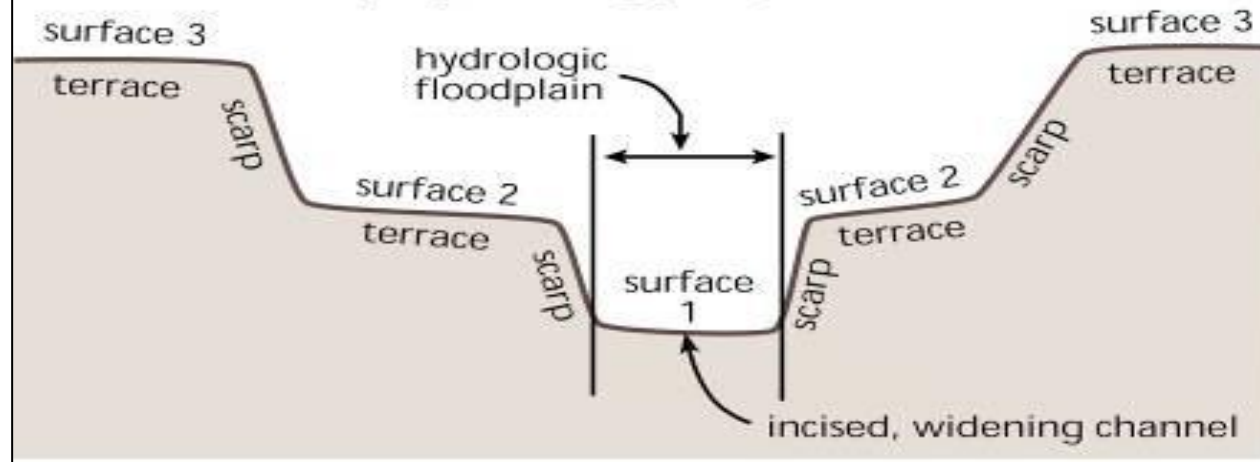
B. Incised Stream (early widening phase)

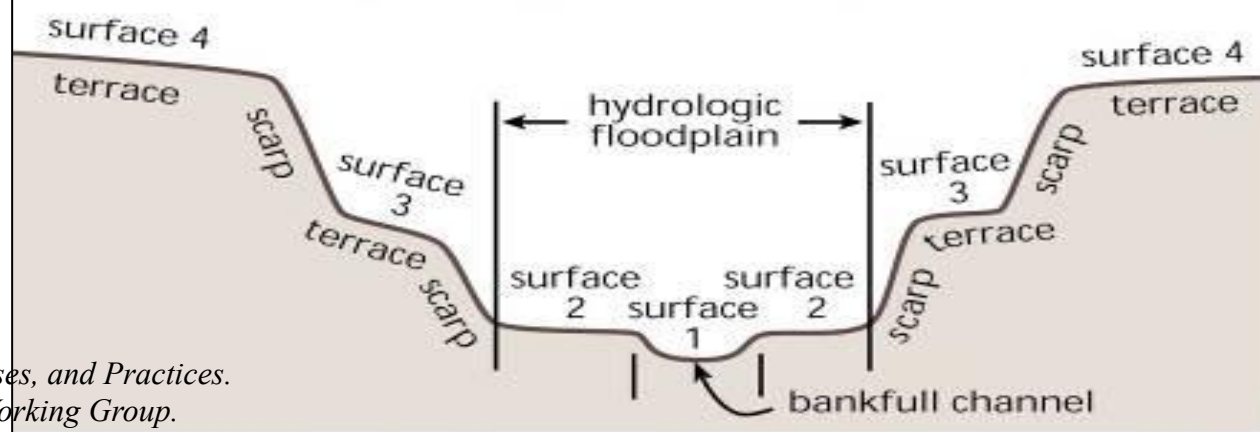
C. Incised Stream (widening phase complete)

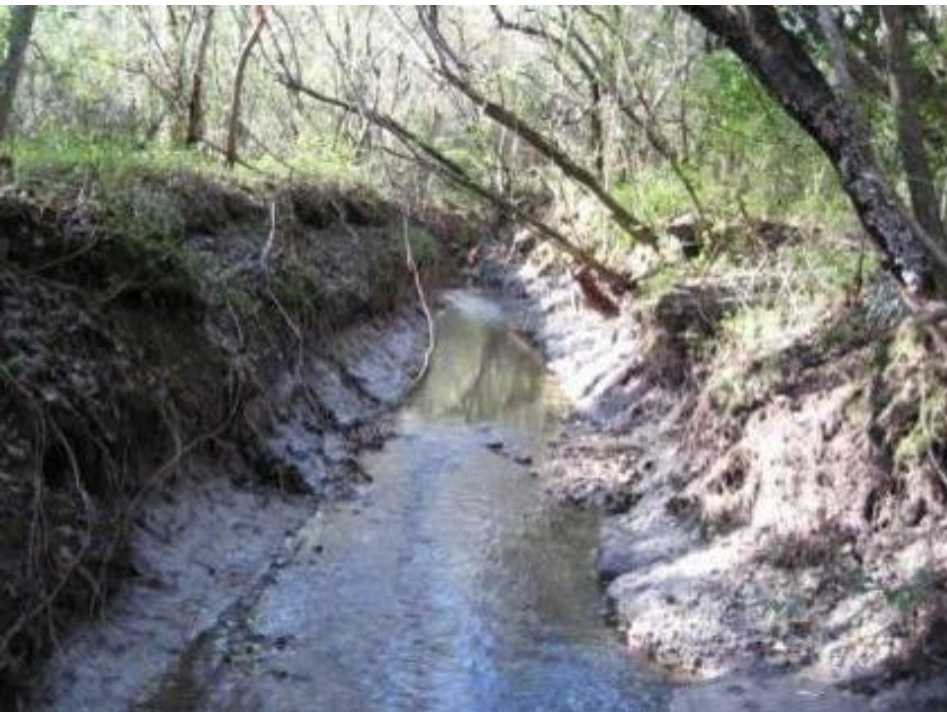
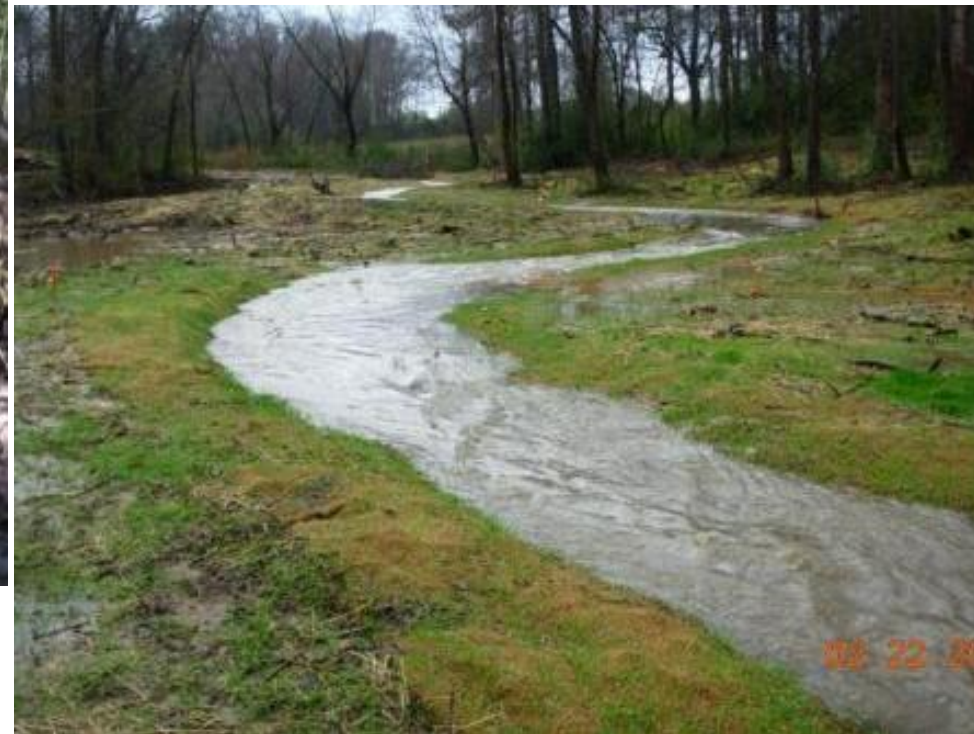
Town Creek Tributary

Priority 1: Reconnect Floodplain

Replace incised channel with shallow channel raised to existing floodplain elevation

2006

2007

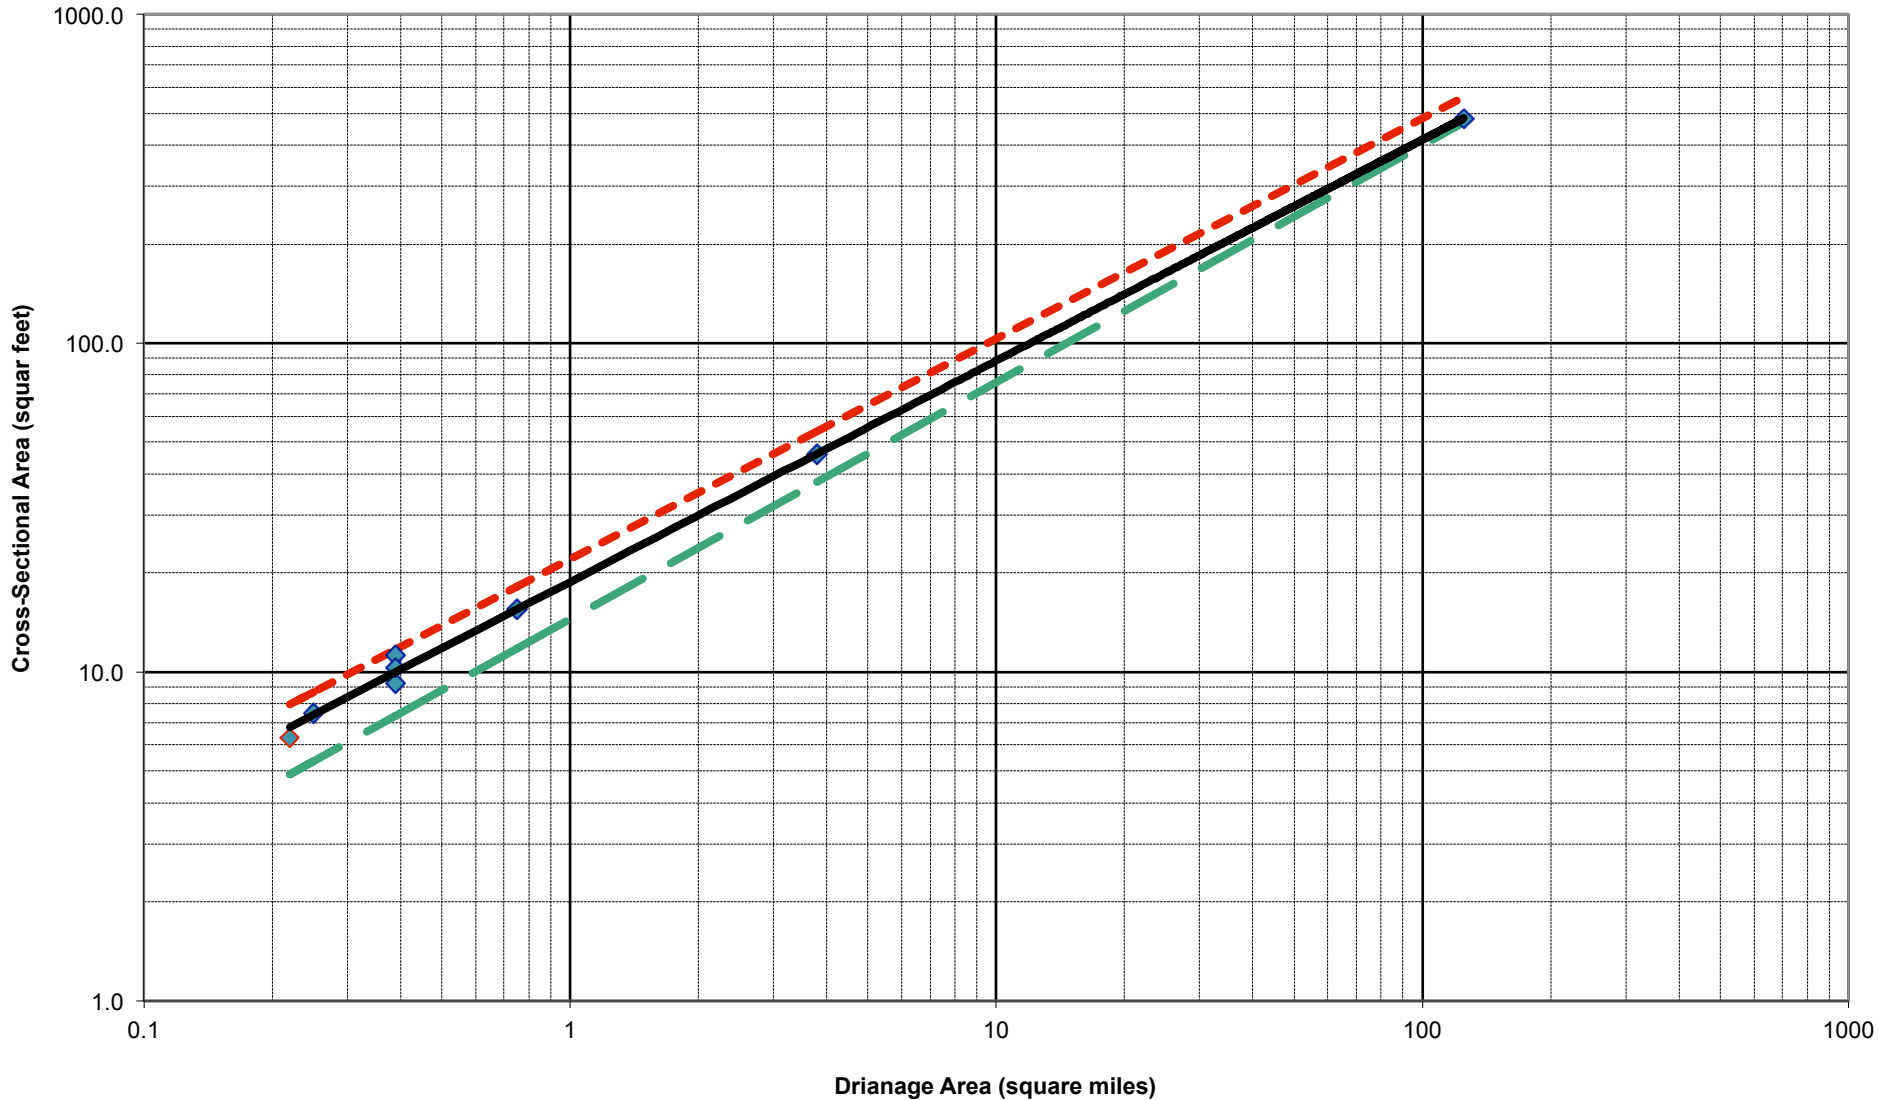
Concept NOT FOR DESIGN USE
Auburn Alabama and Tuskegee NF Mini-Regional Relationship
Prepared by DAB 11-29-07

$y = 18.786x^{0.6724}$
 $R^2 = 0.99815$
