Stream Restoration Implementation

Greg Jennings, PhD, PE
jenningsenv@gmail.com

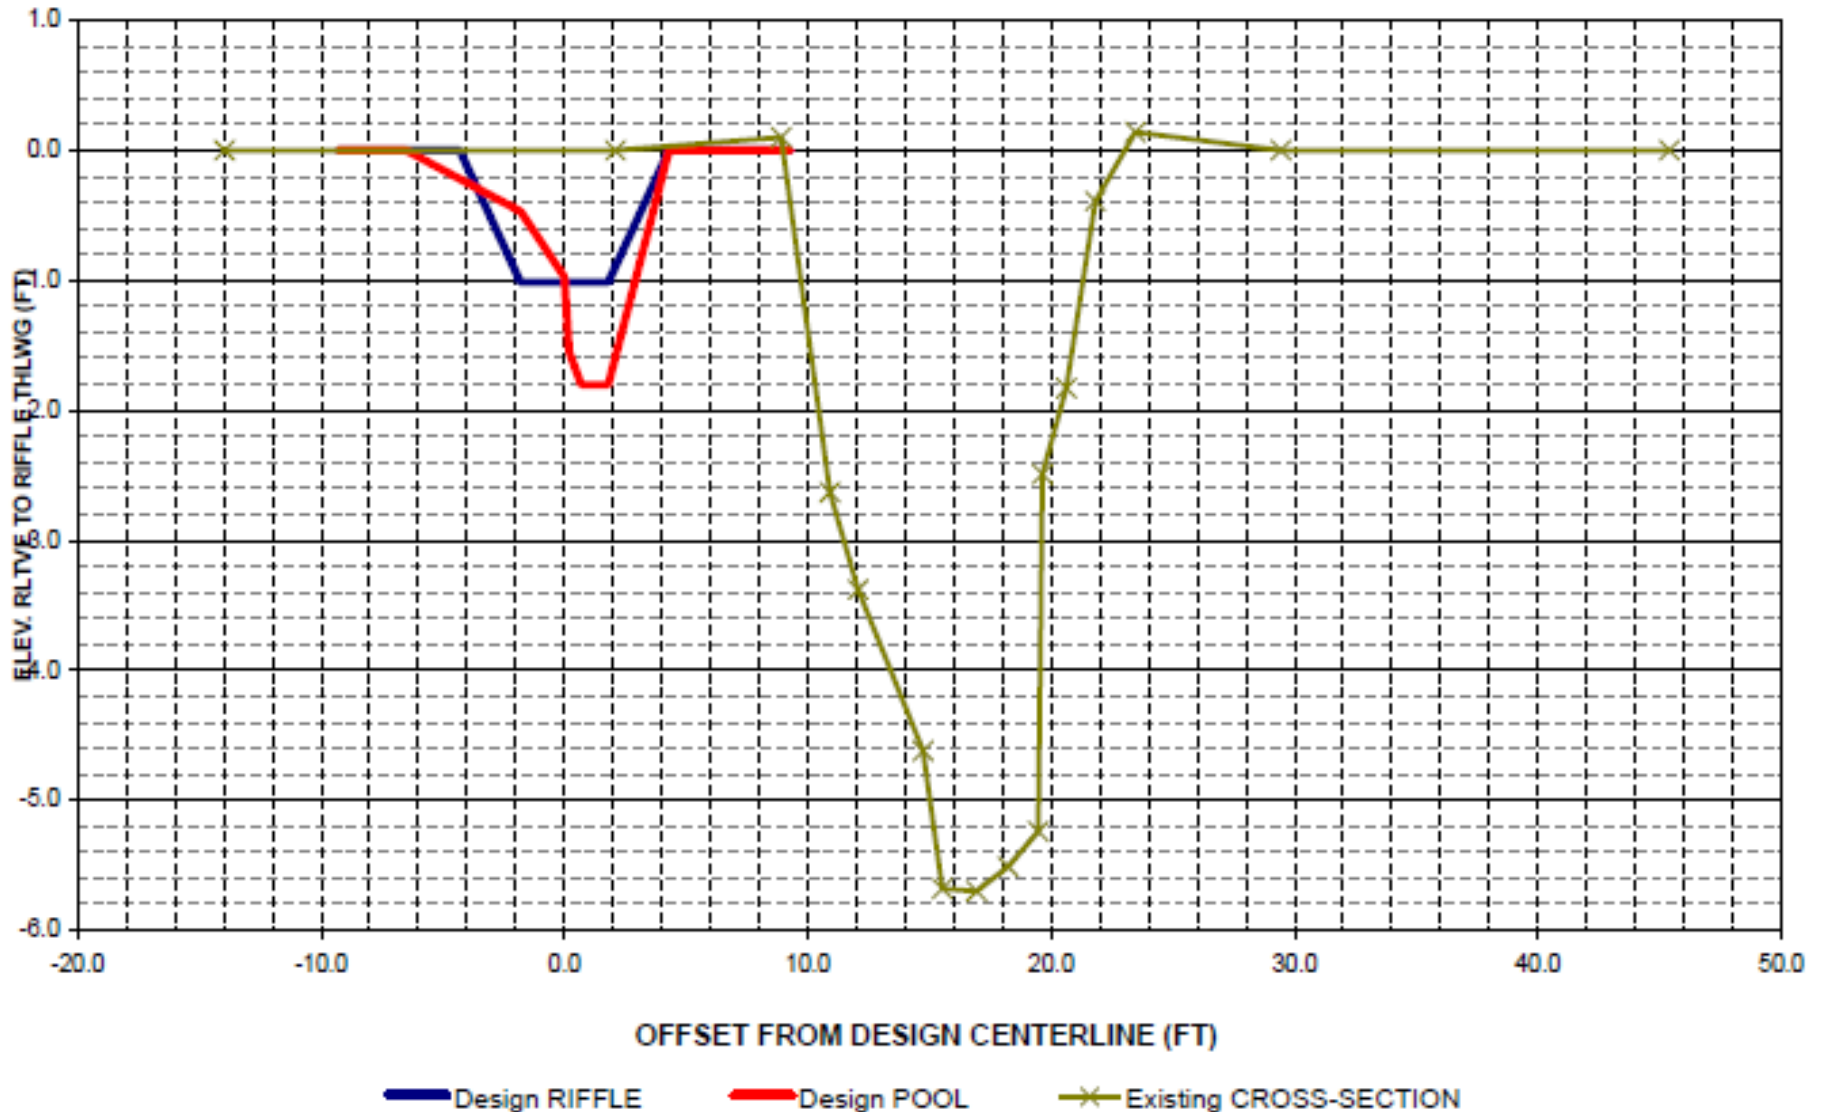
Design Cross-Sections UT Town Creek Stream Restoration 11-29-07

Engineering Design: David Bidelspach, PE, Stantec

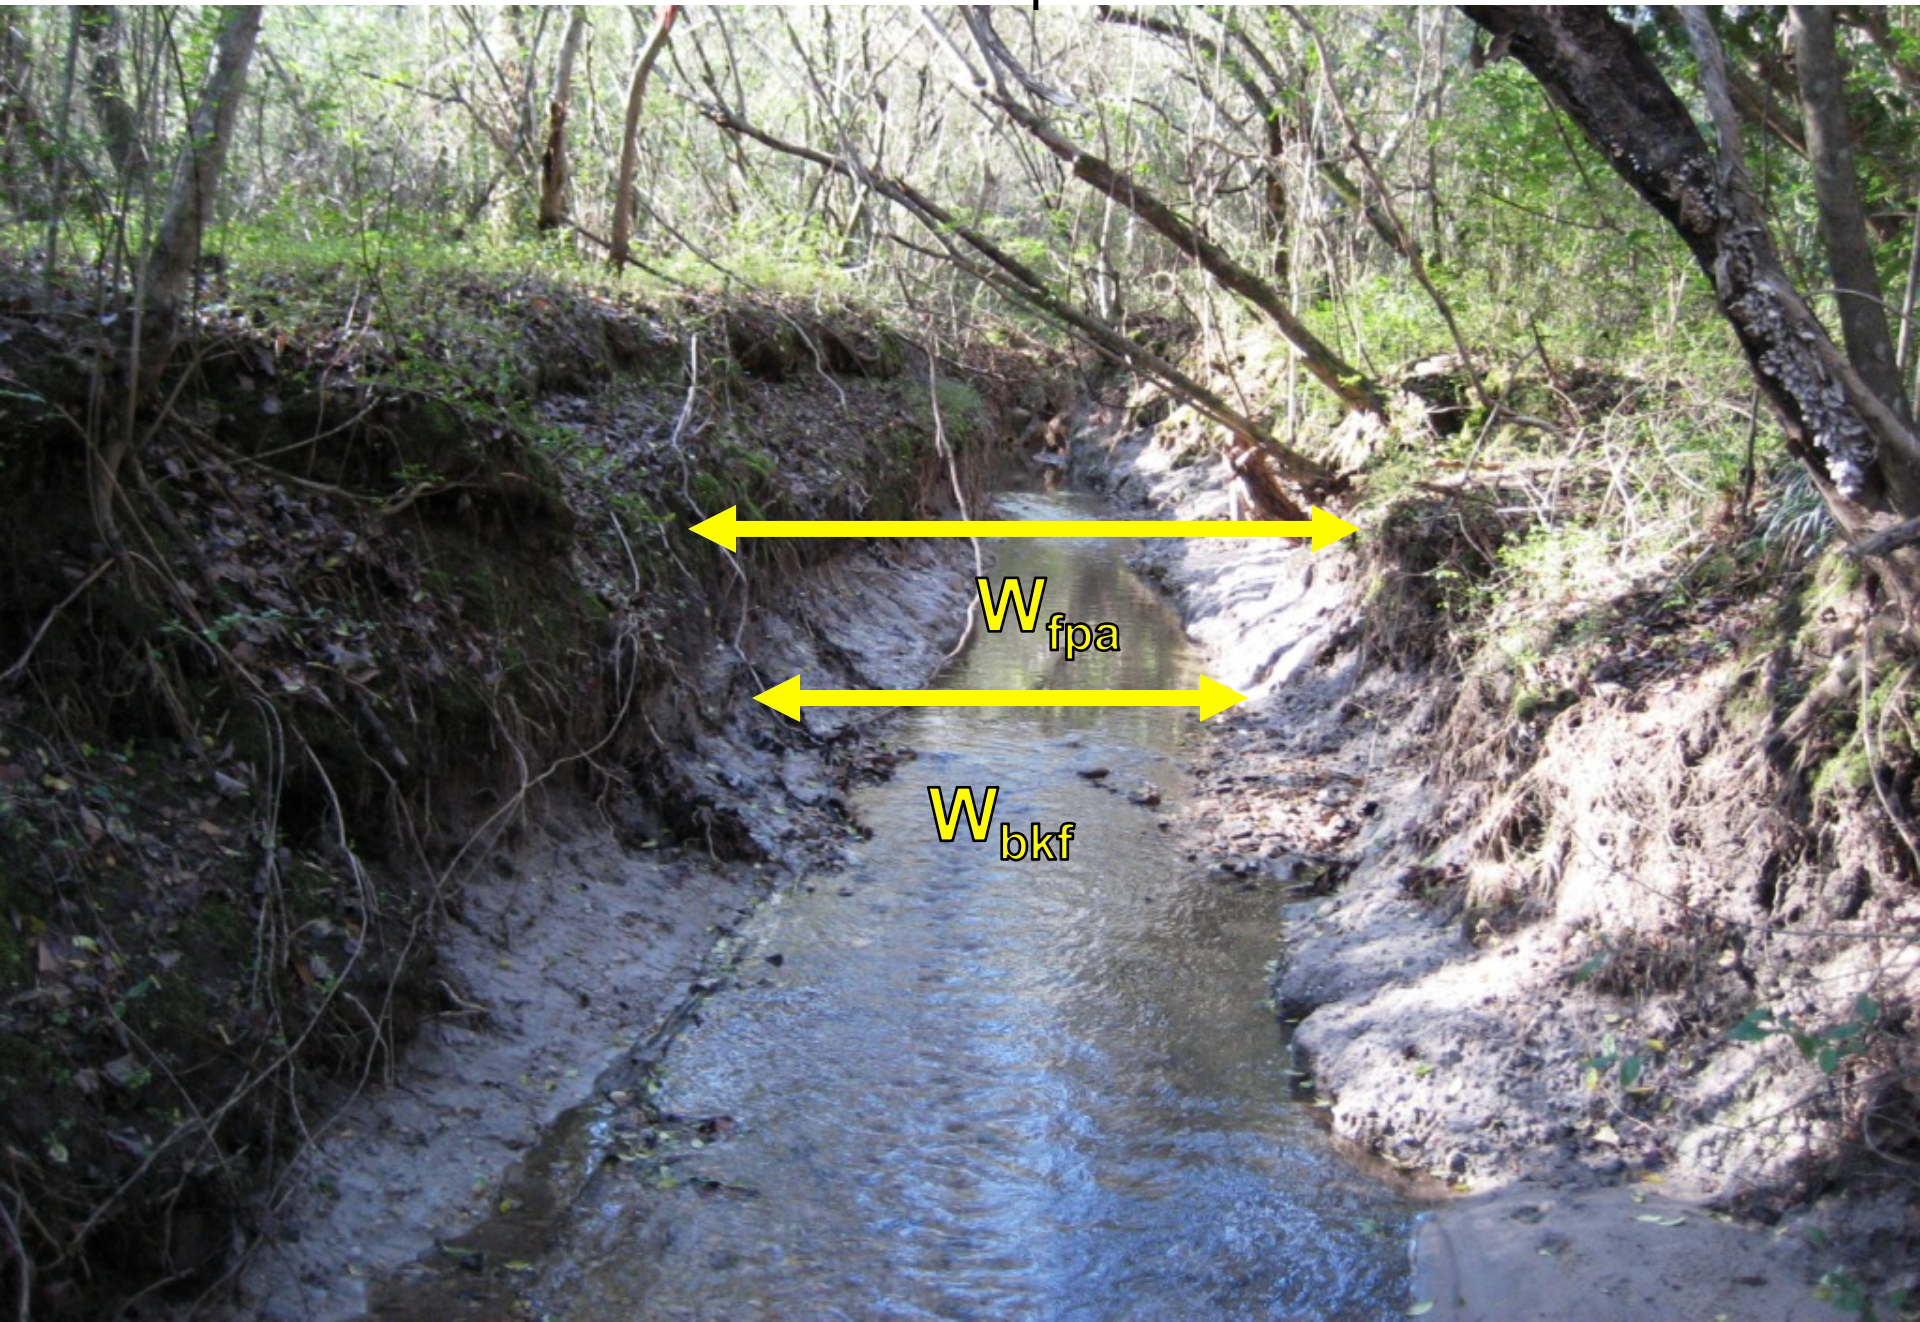
$$\text{Entrenchment Ratio} = W_{\text{fpa}} / W_{\text{bkf}} = 15/12 = 1.2$$

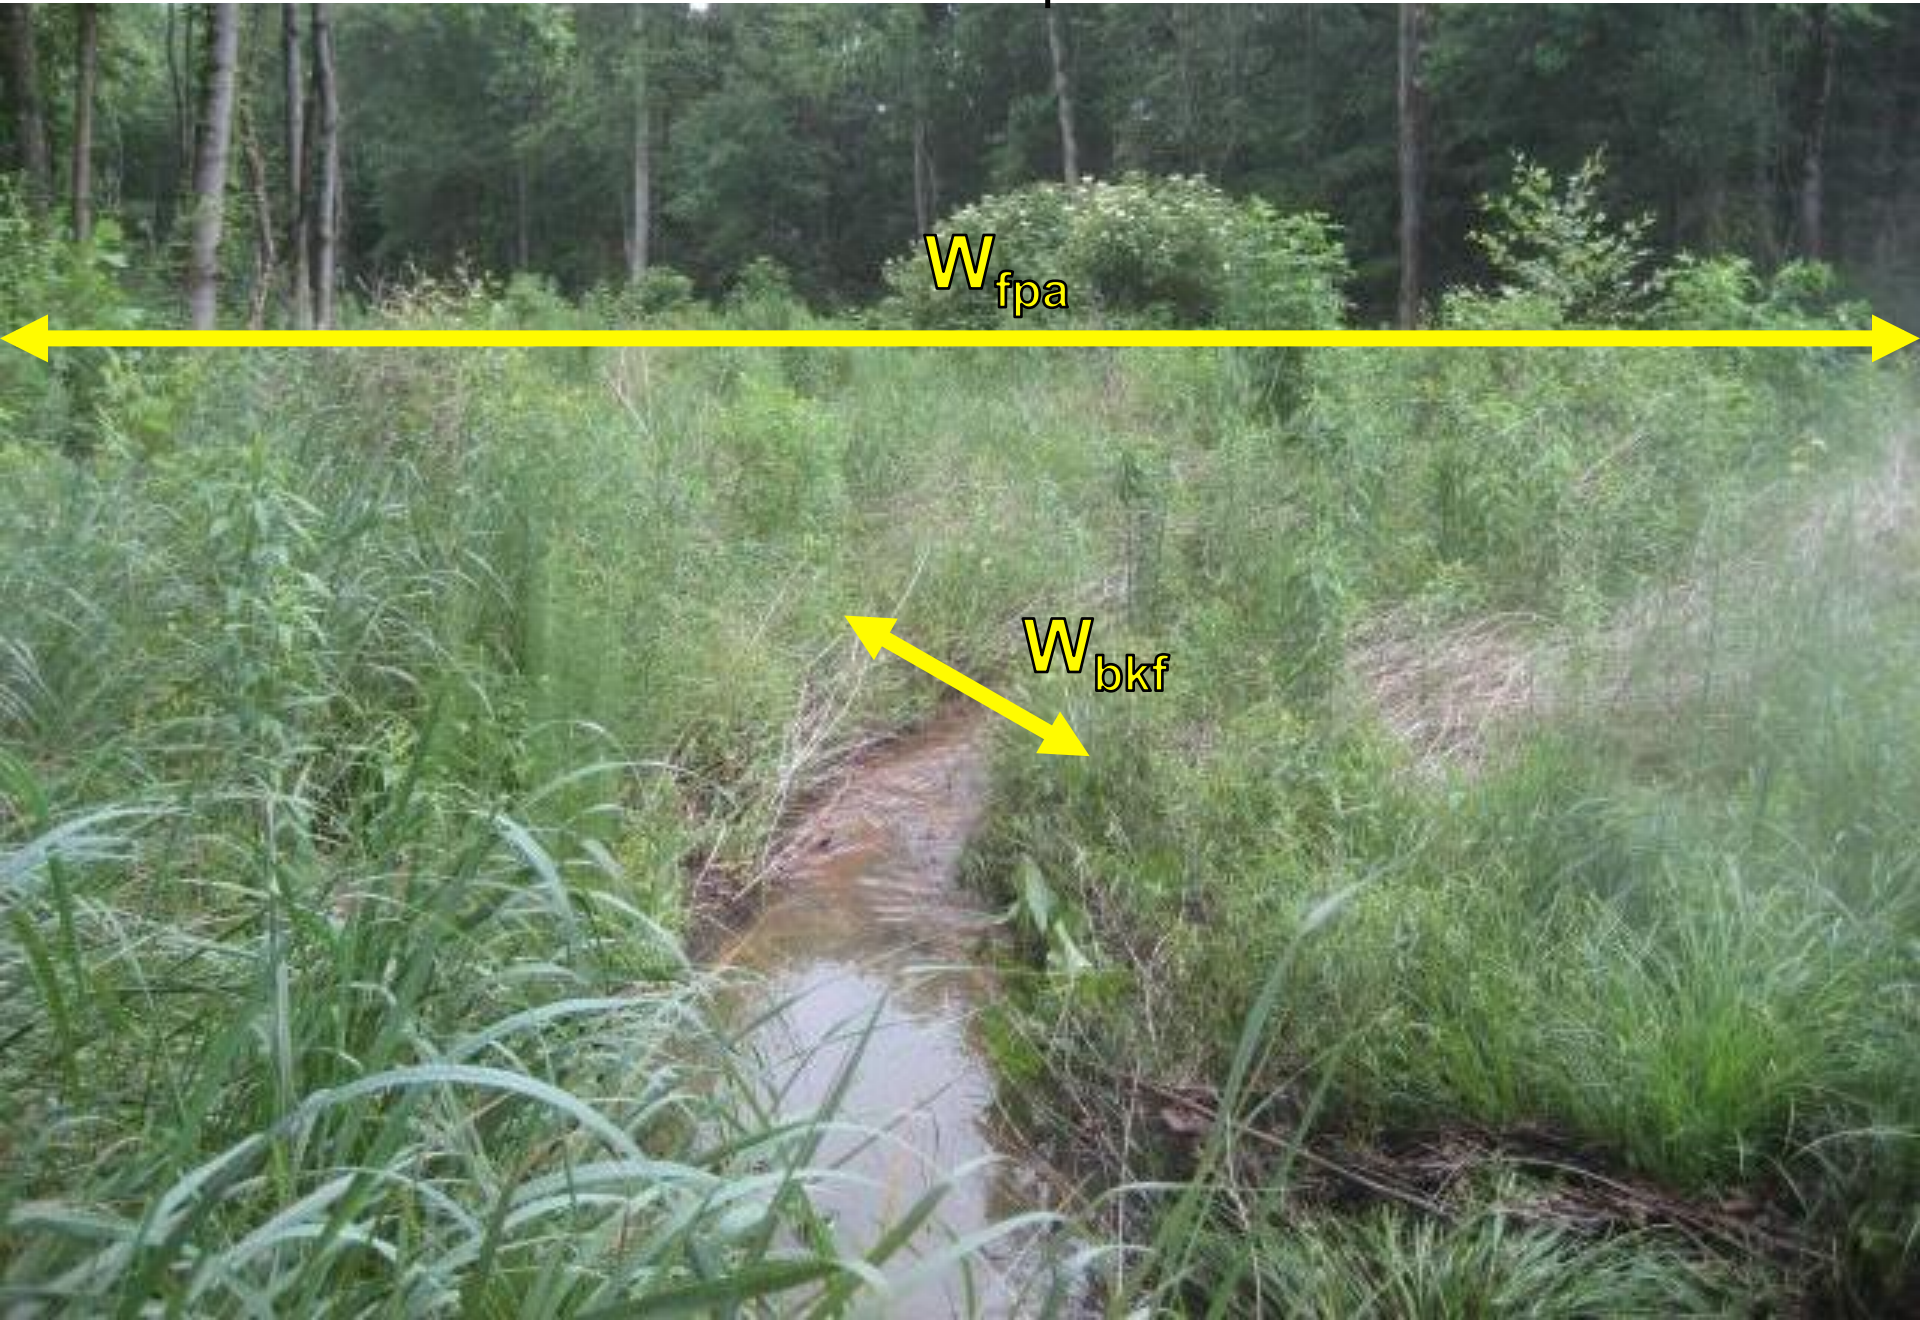
$$\text{Entrenchment Ratio} = W_{\text{fpa}} / W_{\text{bkf}} = 120/8 = 15$$

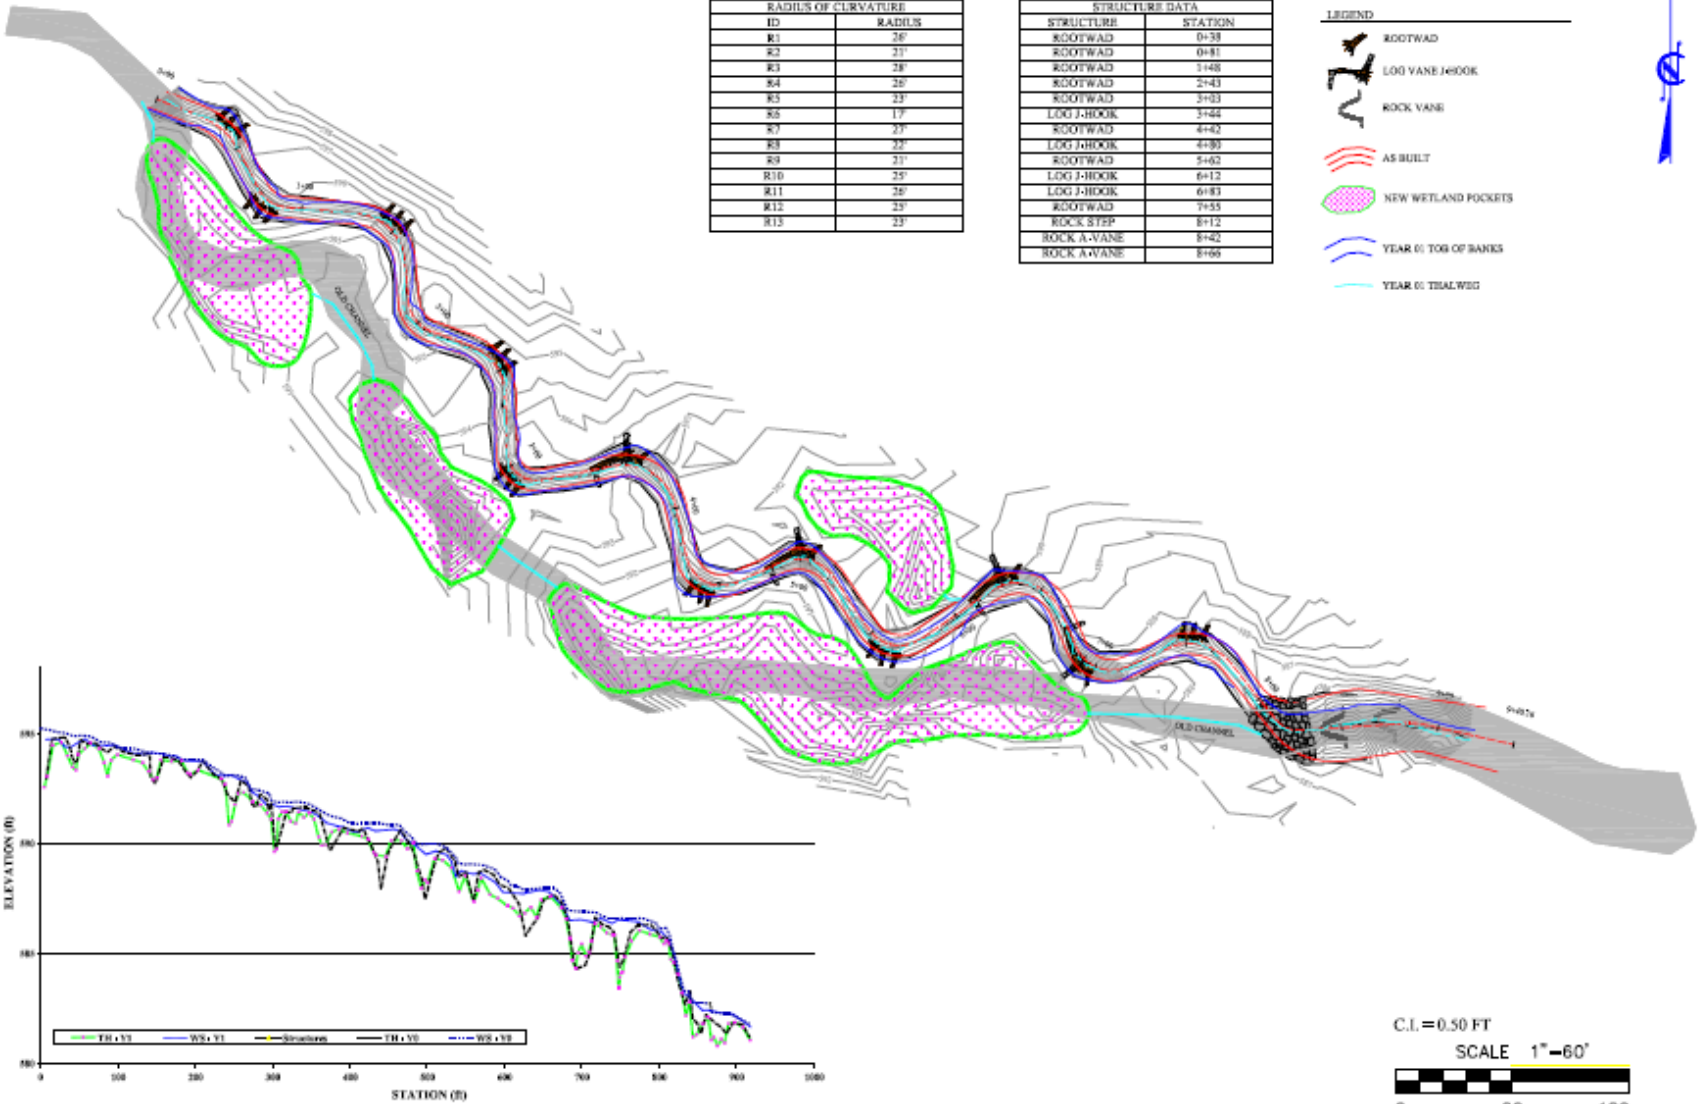
As-Built Survey

YEAR 01 MONITORING UT Town Creek SITE PLAN Auburn, AL Auburn University

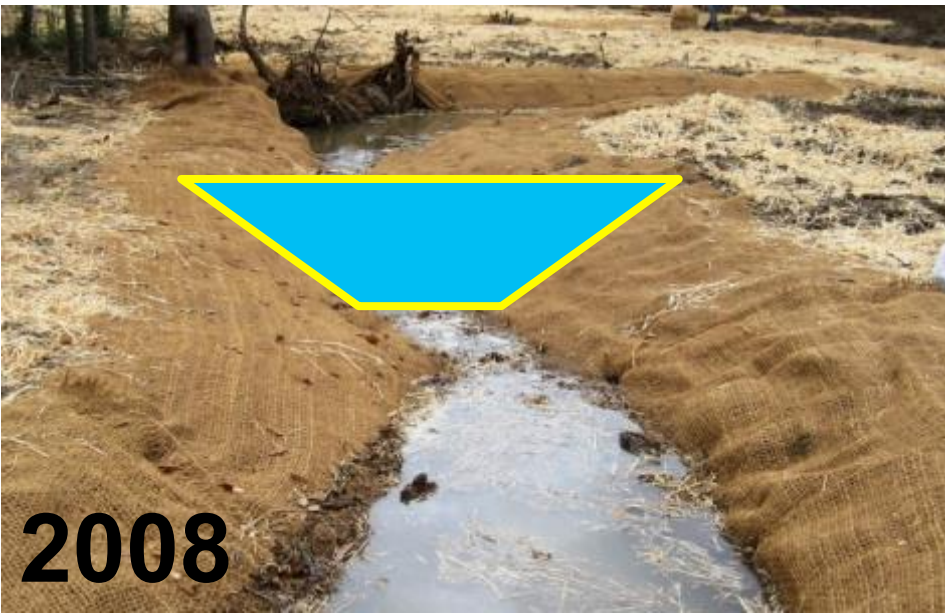
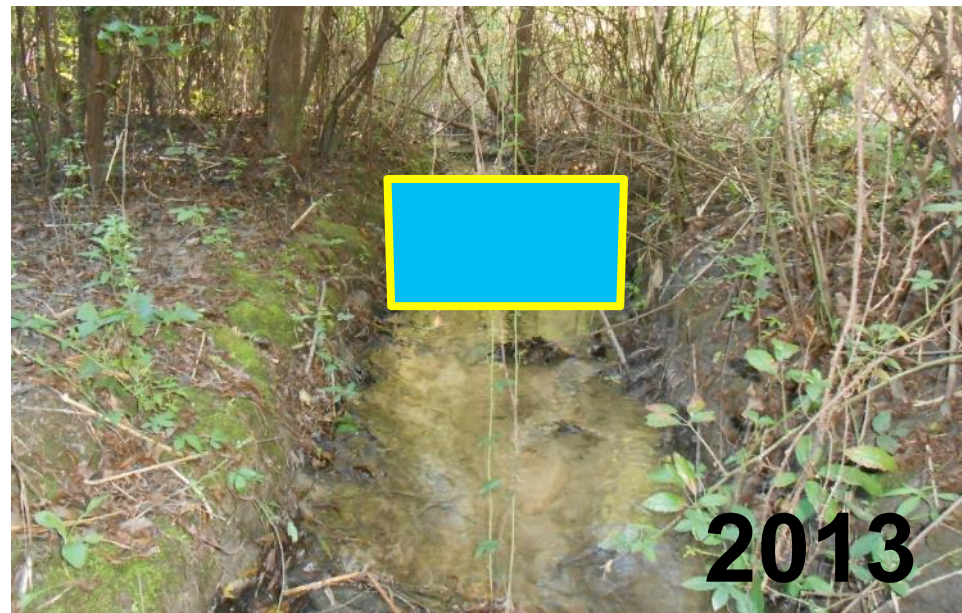
Channel Evolution: *Vegetation Effects*

- Width-to-depth ratio will decrease
- Banks will steepen

As-built:

$$A_{\text{bkf}} = 4.5 \text{ sq ft}$$

$$W_{\text{bkf}} / d_{\text{bkf}} = 7.6 / 0.6 = 13$$

Bank Angles: 3:1

5 Years Later:

$$A_{\text{bkf}} = 3.8 \text{ sq ft}$$

$$W_{\text{bkf}} / d_{\text{bkf}} = 5.4 / 0.7 = 8$$

Bank Angles: Near Vertical

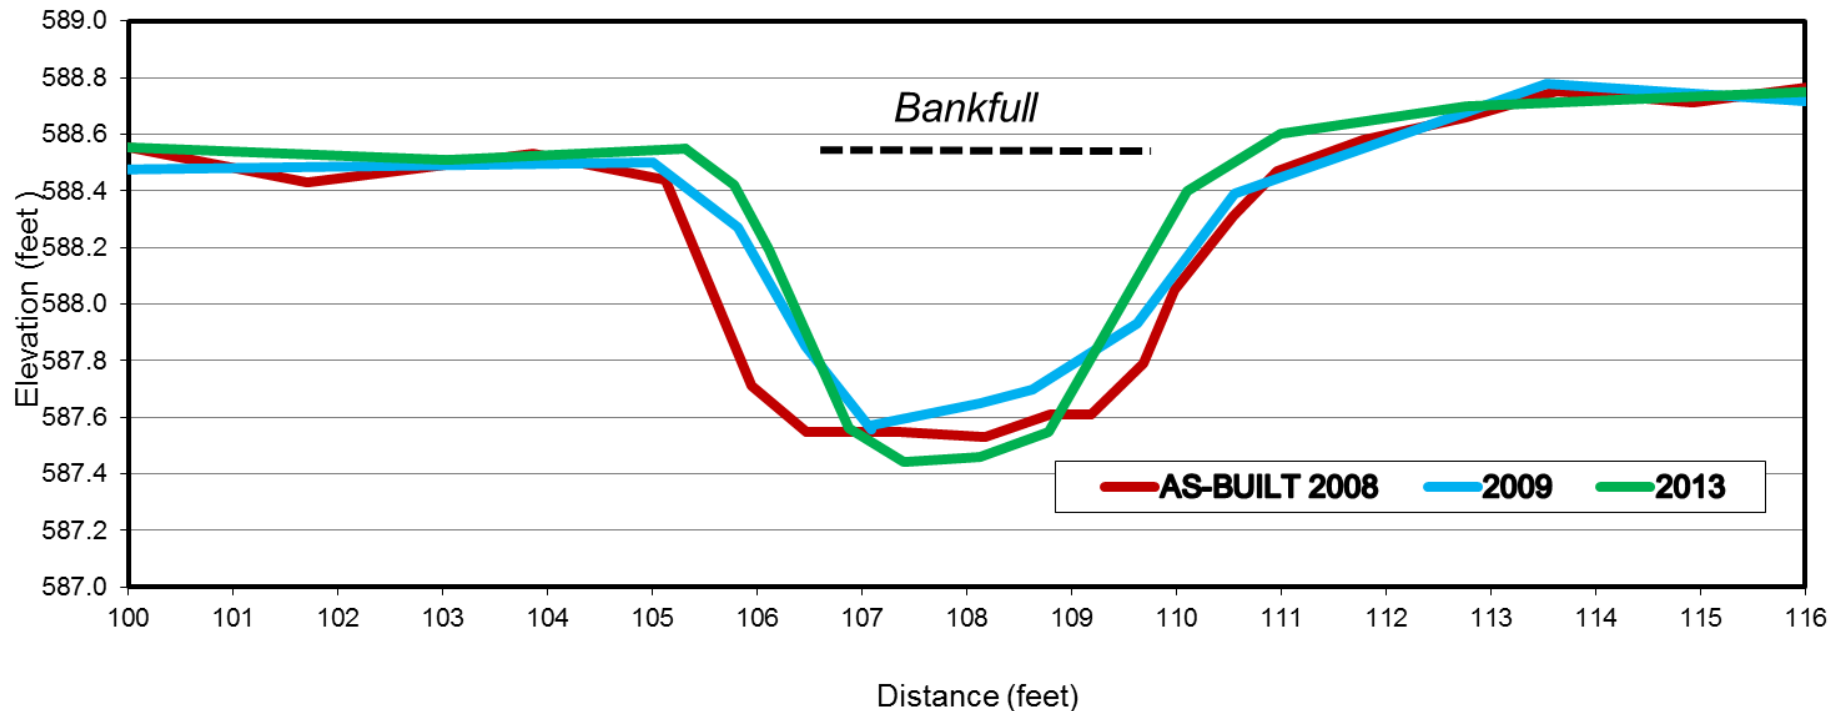
UT Town Creek, Auburn, Alabama
Riffle 1 Cross-Section

Channel Evolution: *Vegetation Effects*

- Width-to-depth ratio will decrease
- Banks will steepen

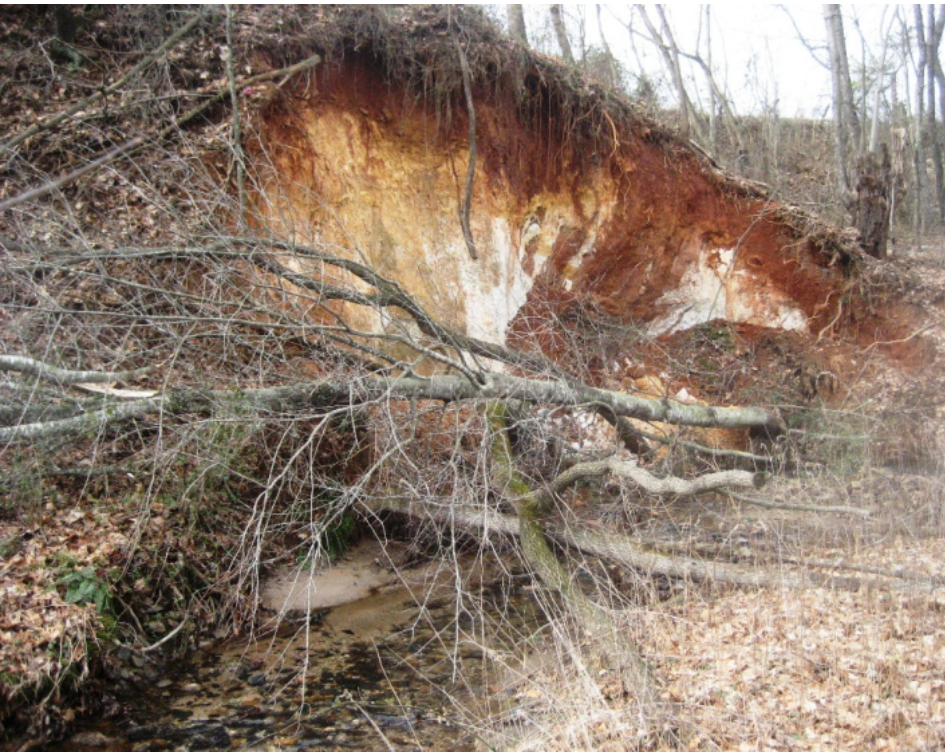
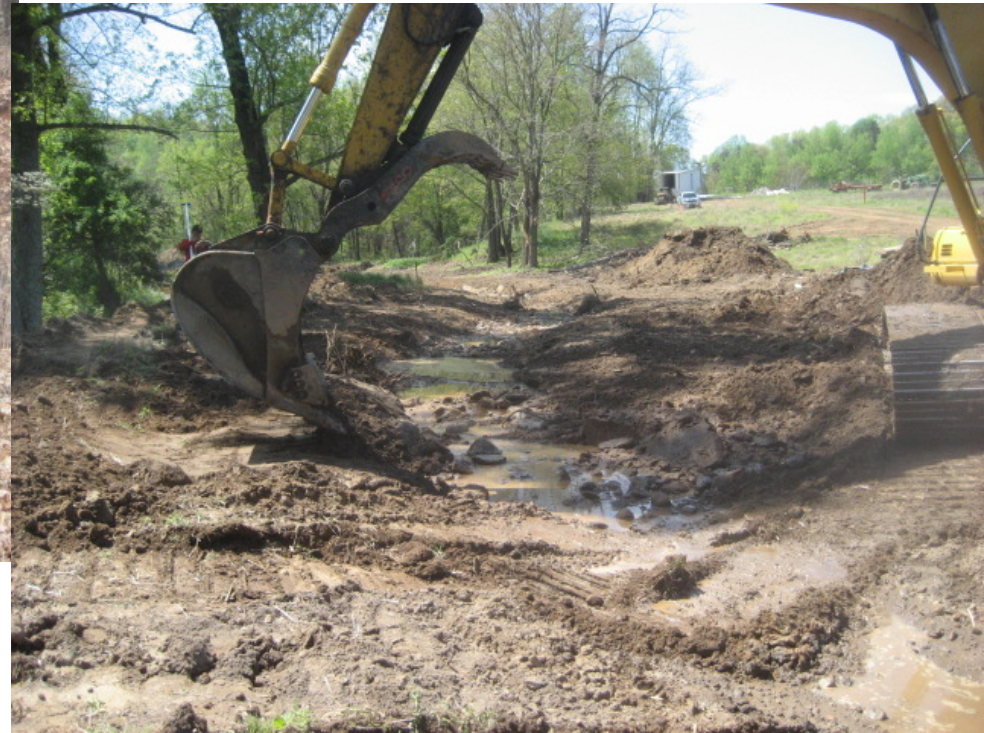
Purlear Creek

Priority 1: Raise channel to existing valley
and construct new meandering channel

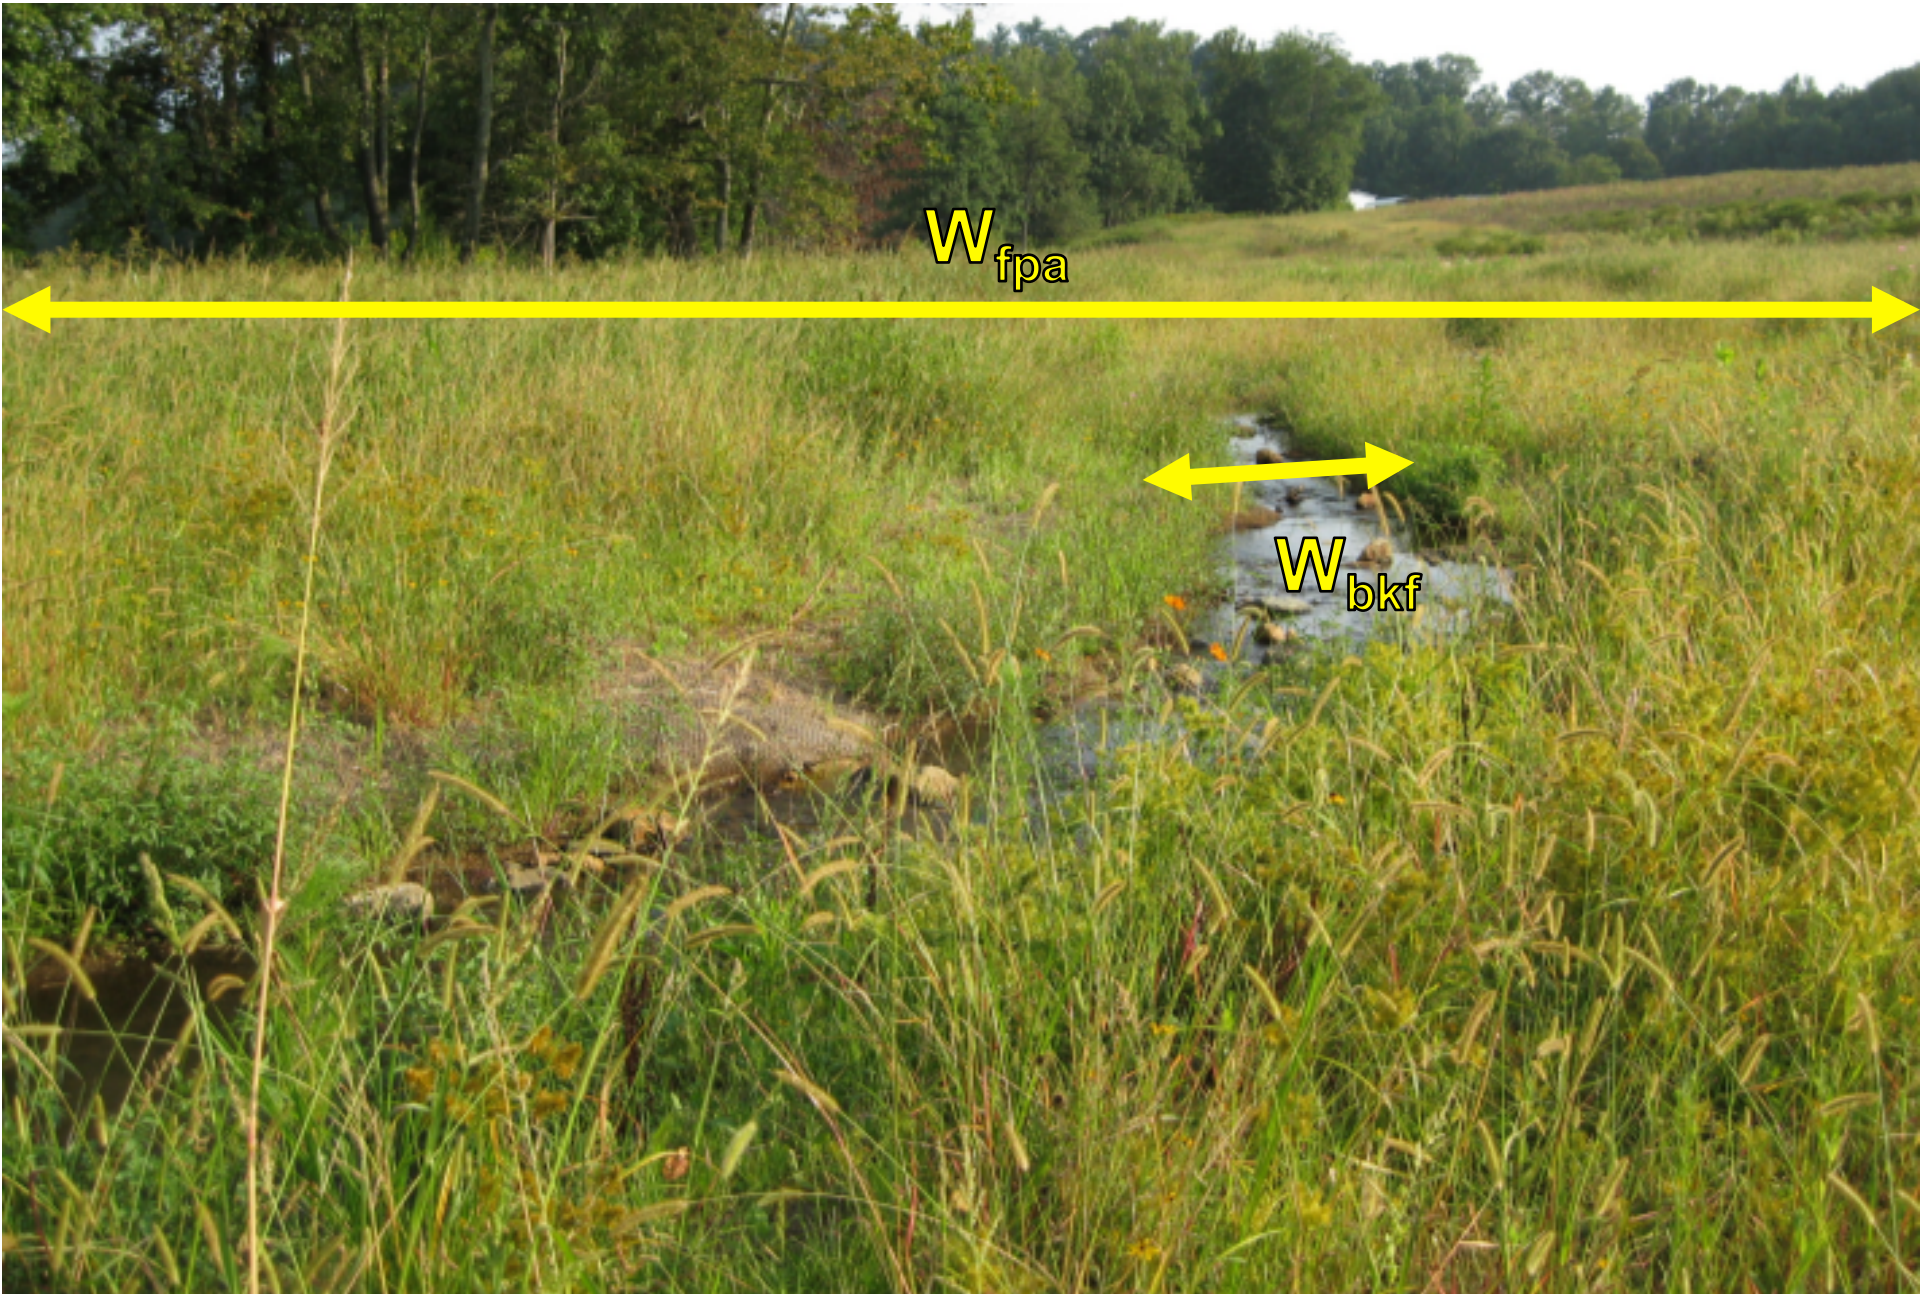
$$\text{Entrenchment Ratio} = W_{\text{fpa}} / W_{\text{bkf}} = 120/12 = 10$$

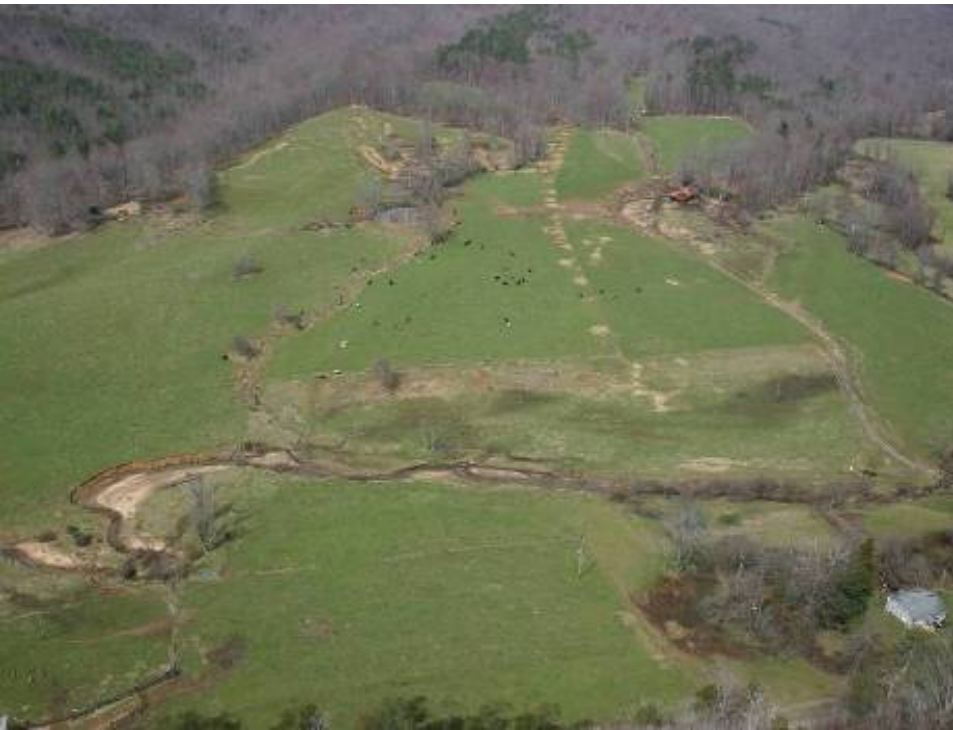
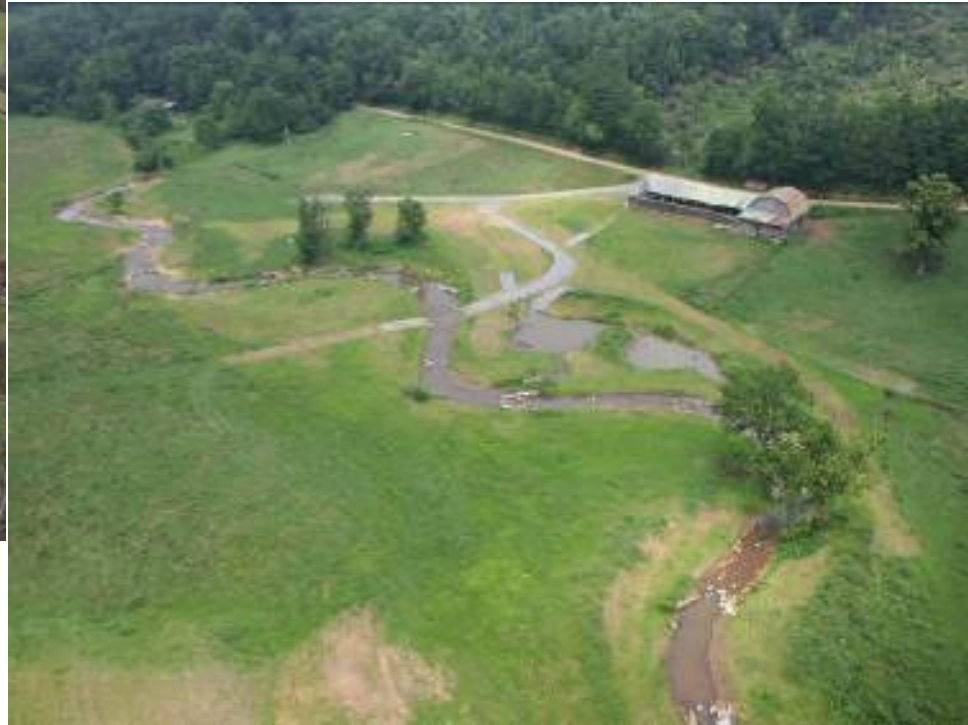
South Fork Mitchell River

Priority 1: Raise channel to existing valley
and construct new meandering channel

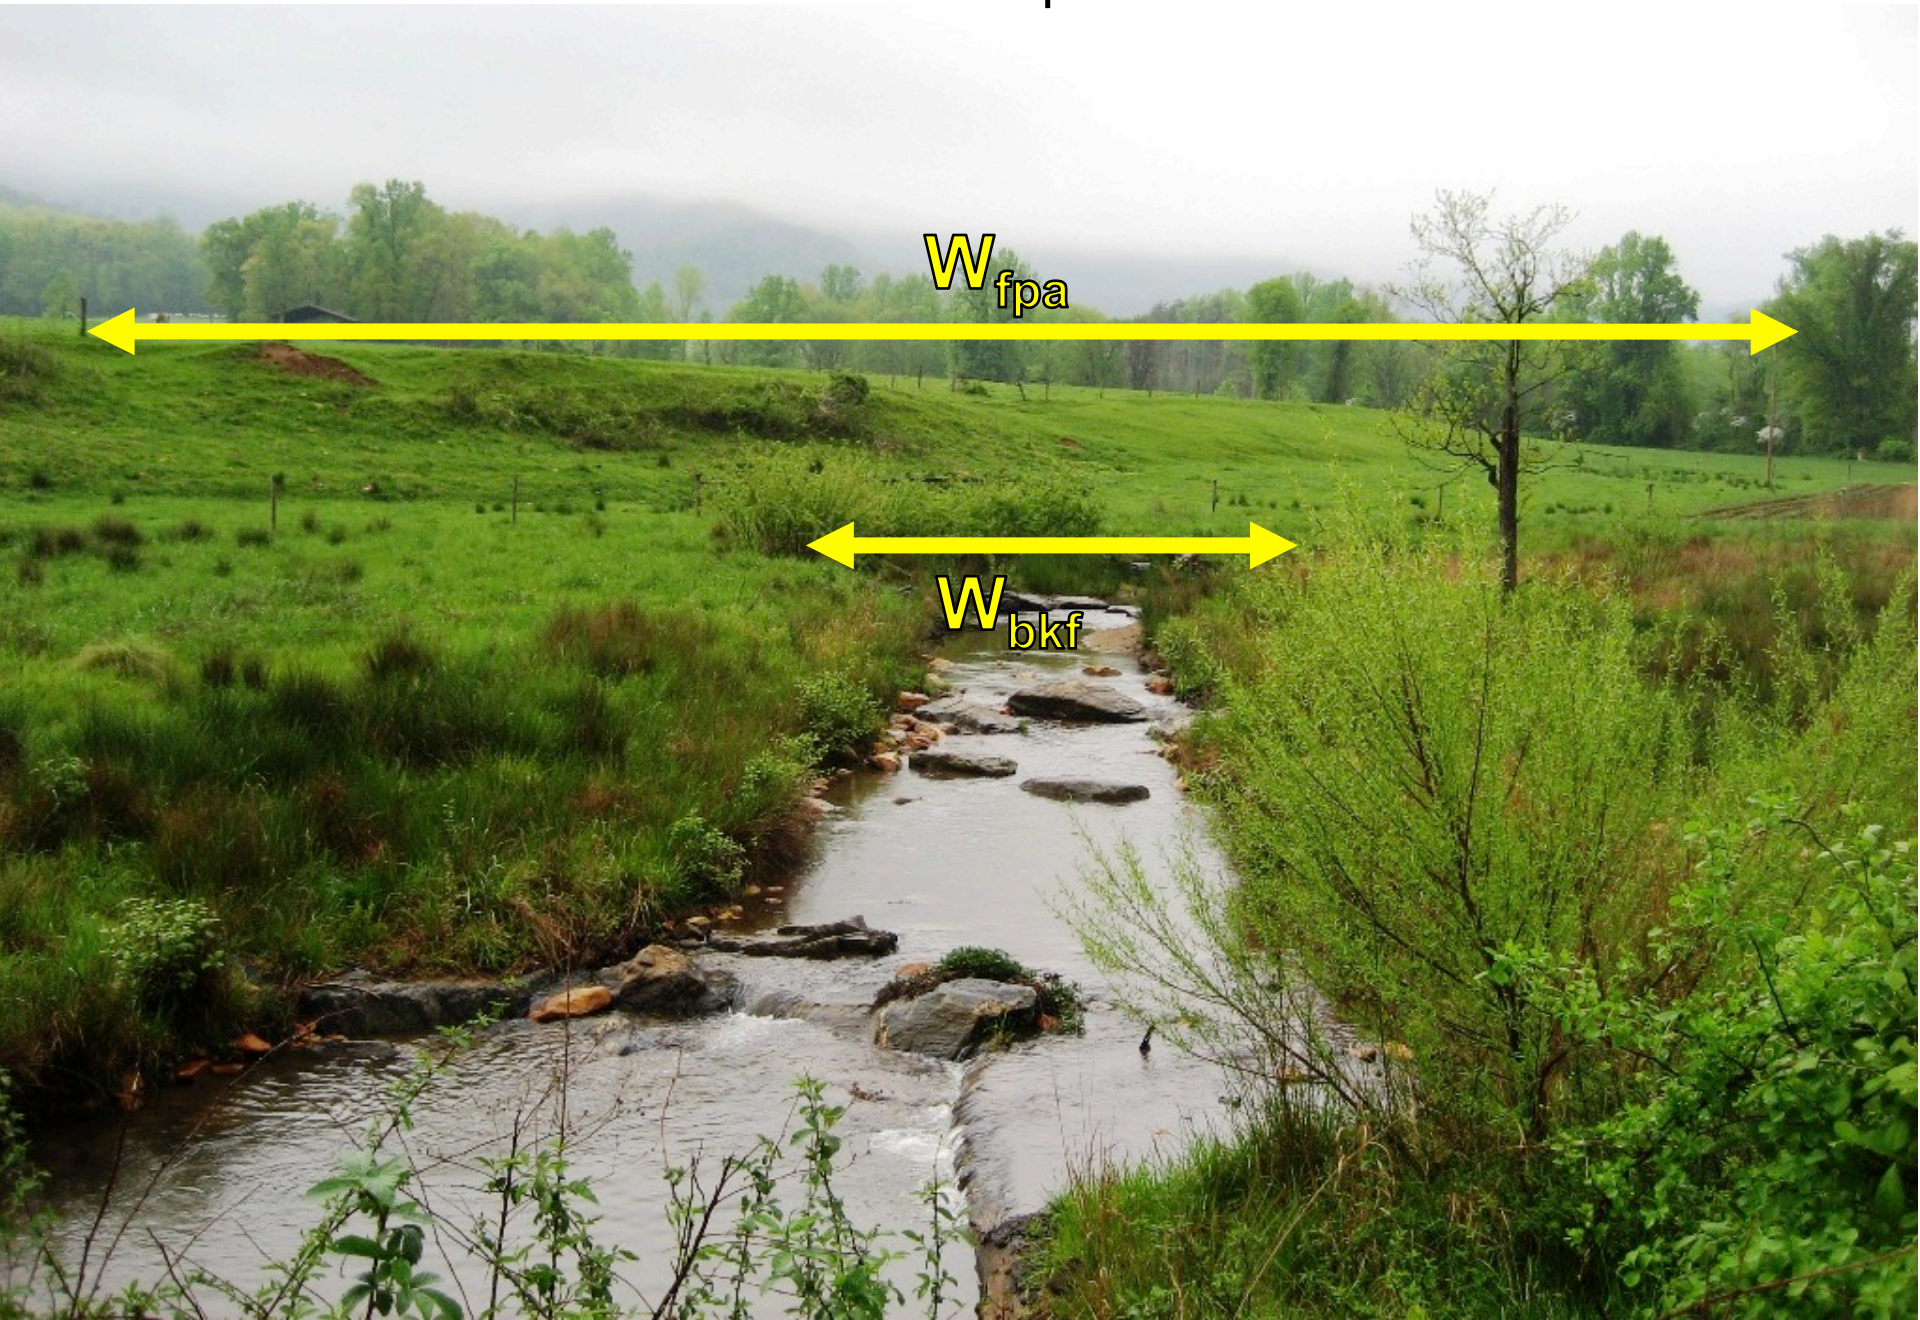
$$\text{Entrenchment Ratio} = W_{\text{fpa}} / W_{\text{bkf}} = 120/20 = 6$$

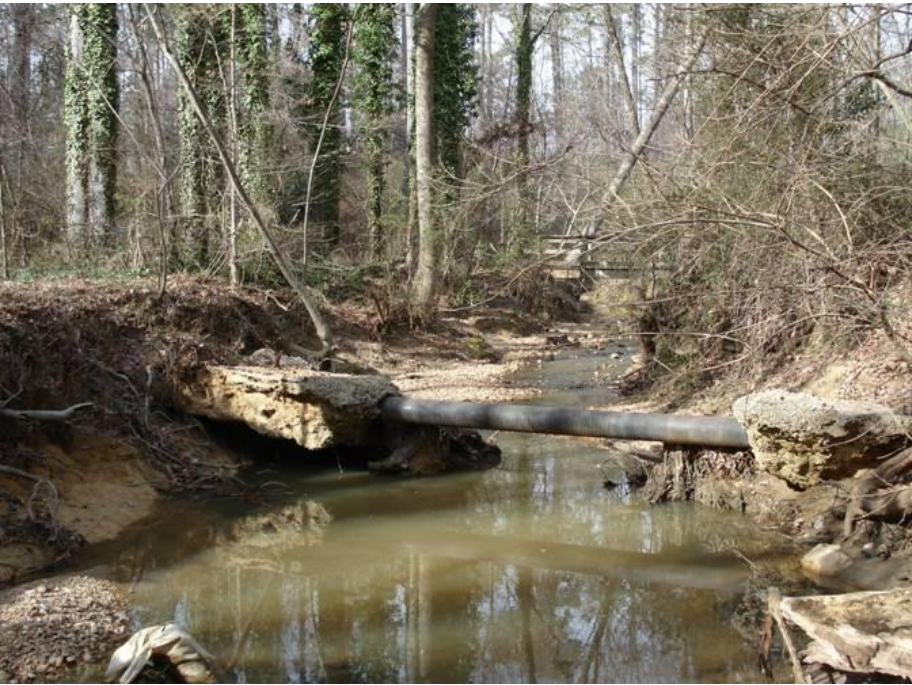
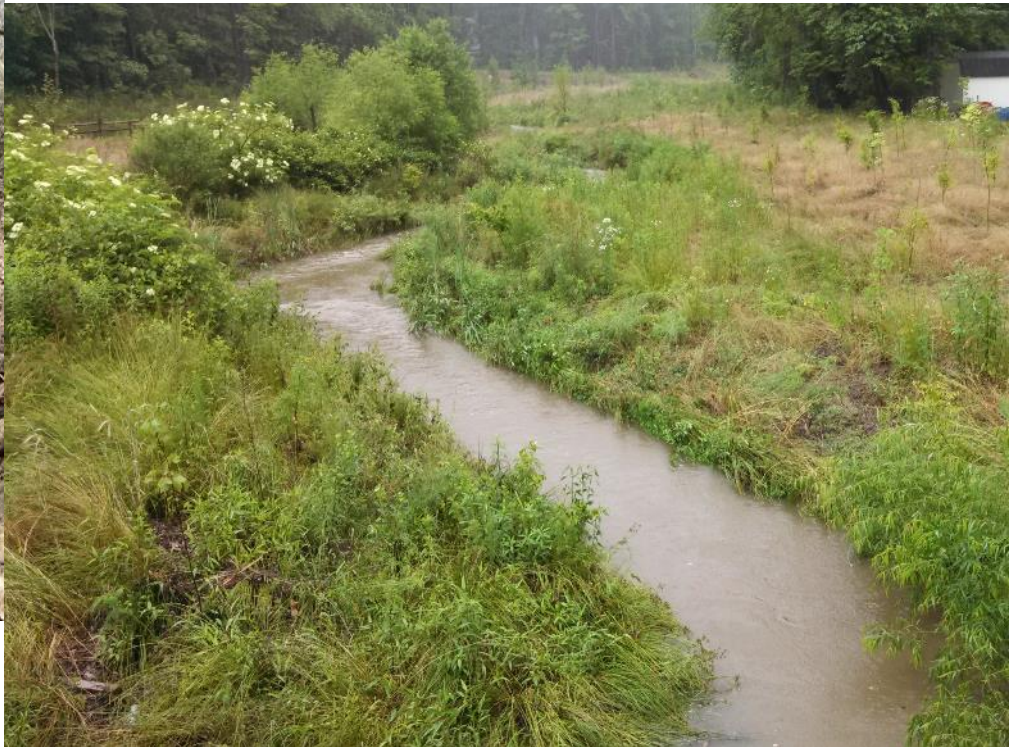
Cary Walnut Creek Tributary

Priority 2: Excavate lower floodplain and construct new meandering channel
