Stream Restoration Implementation

Greg Jennings, PhD, PE
jenningsenv@gmail.com

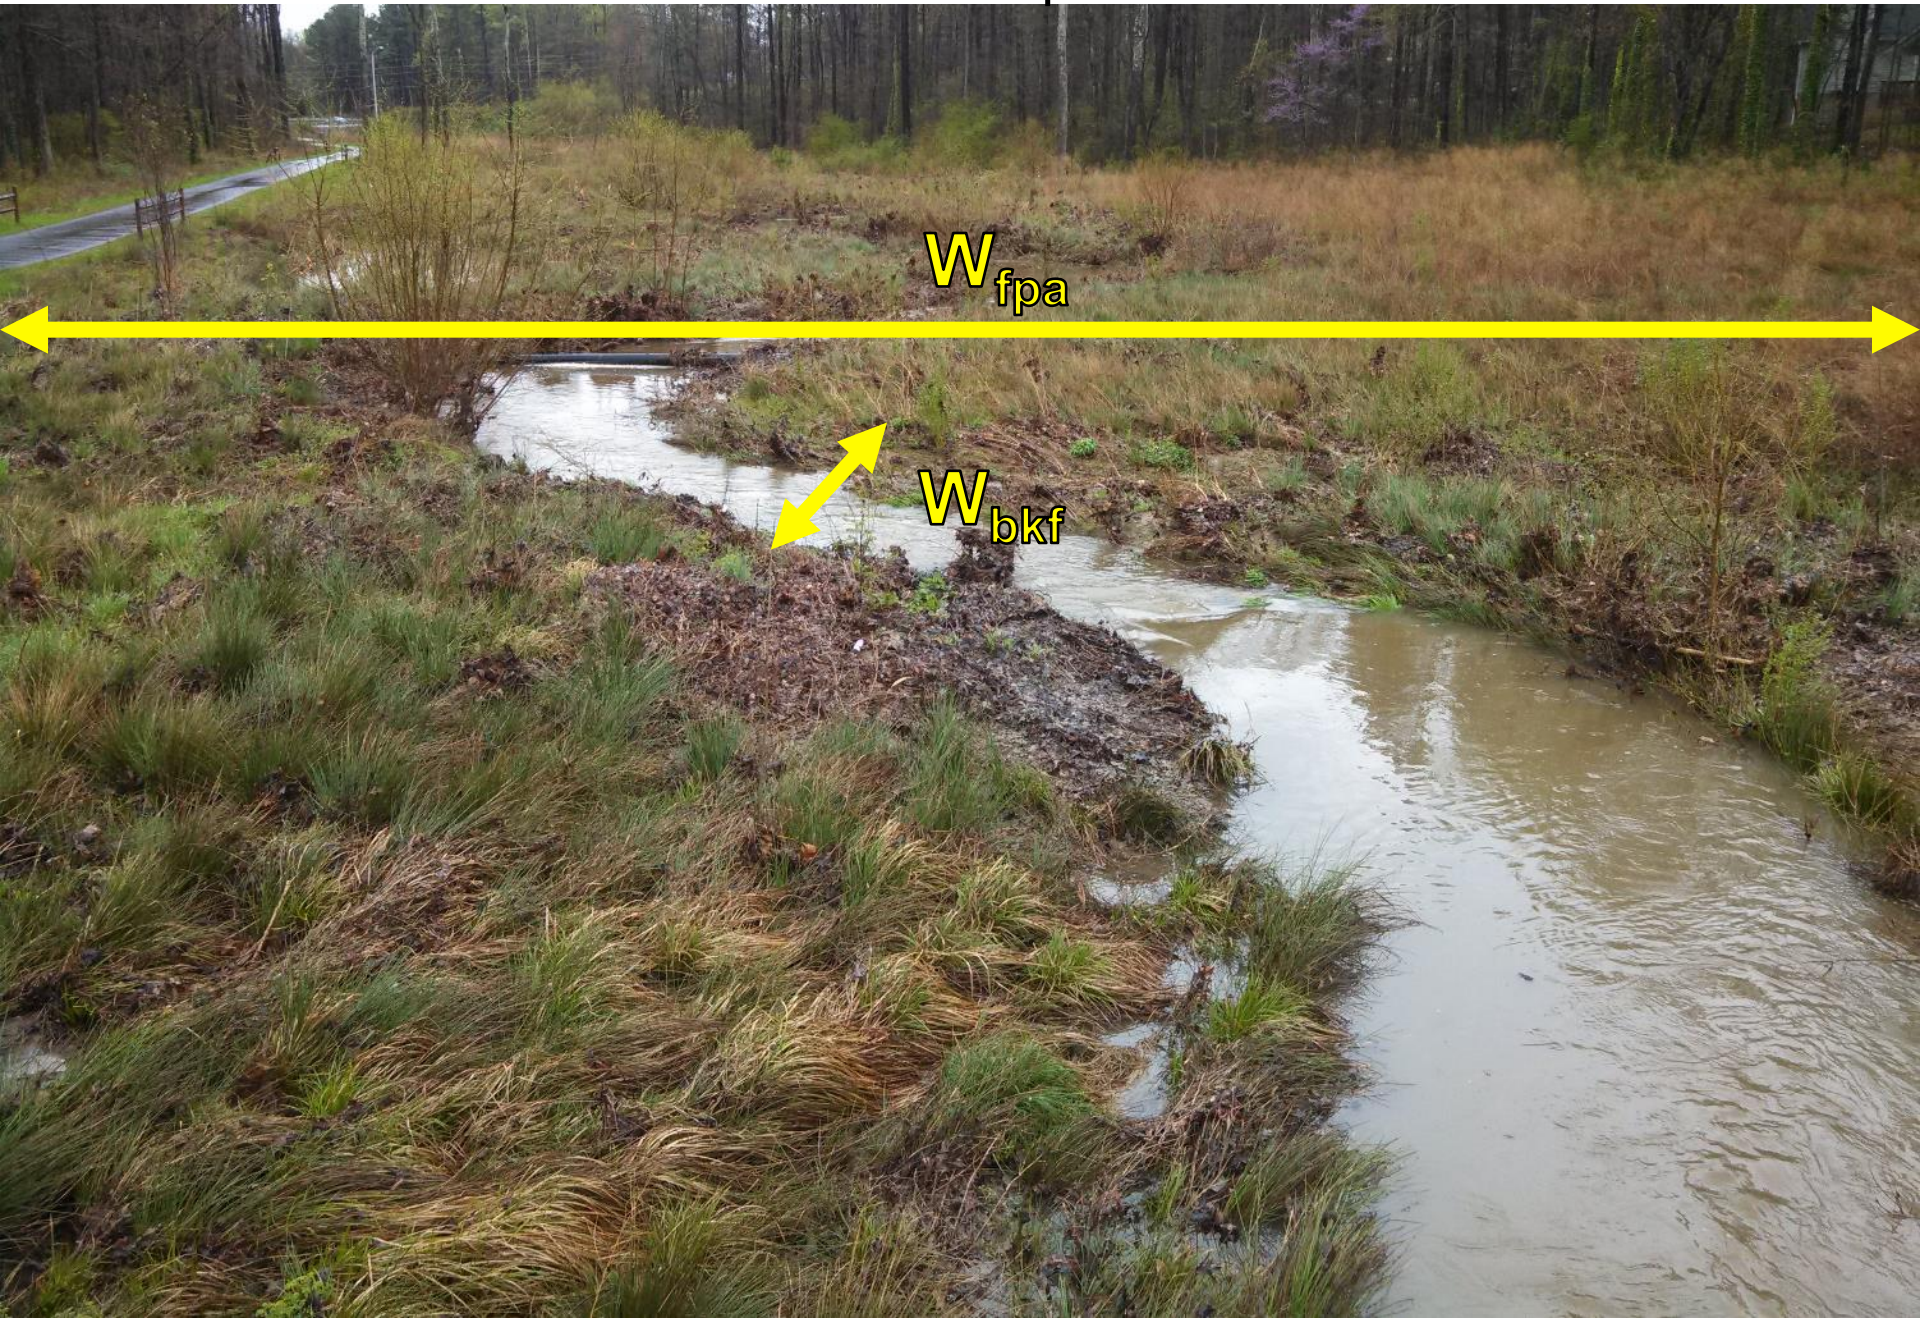
$$\text{Entrenchment Ratio} = W_{\text{fpa}} / W_{\text{bkf}} = 120/15 = 8$$

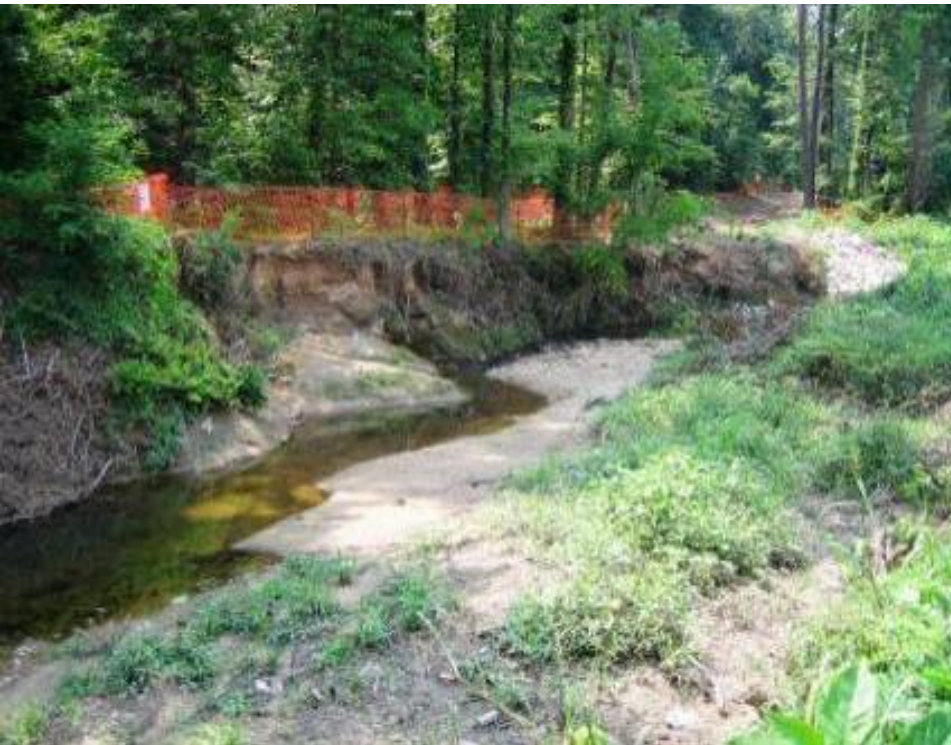
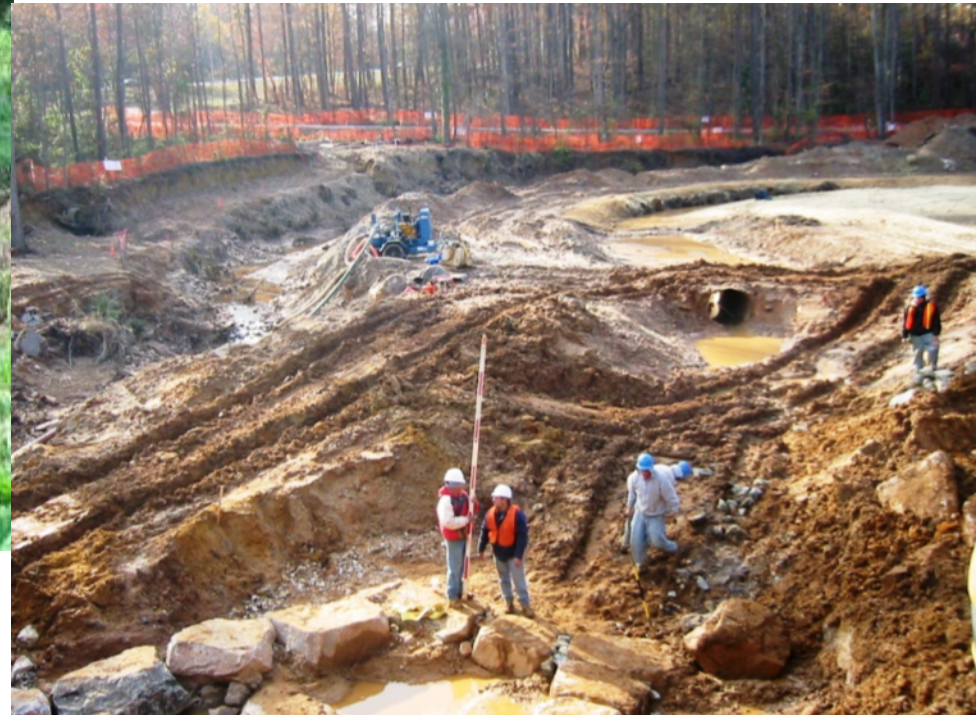
NCSU Rocky Branch

Priority 2: Excavate lower floodplain and construct new meandering channel

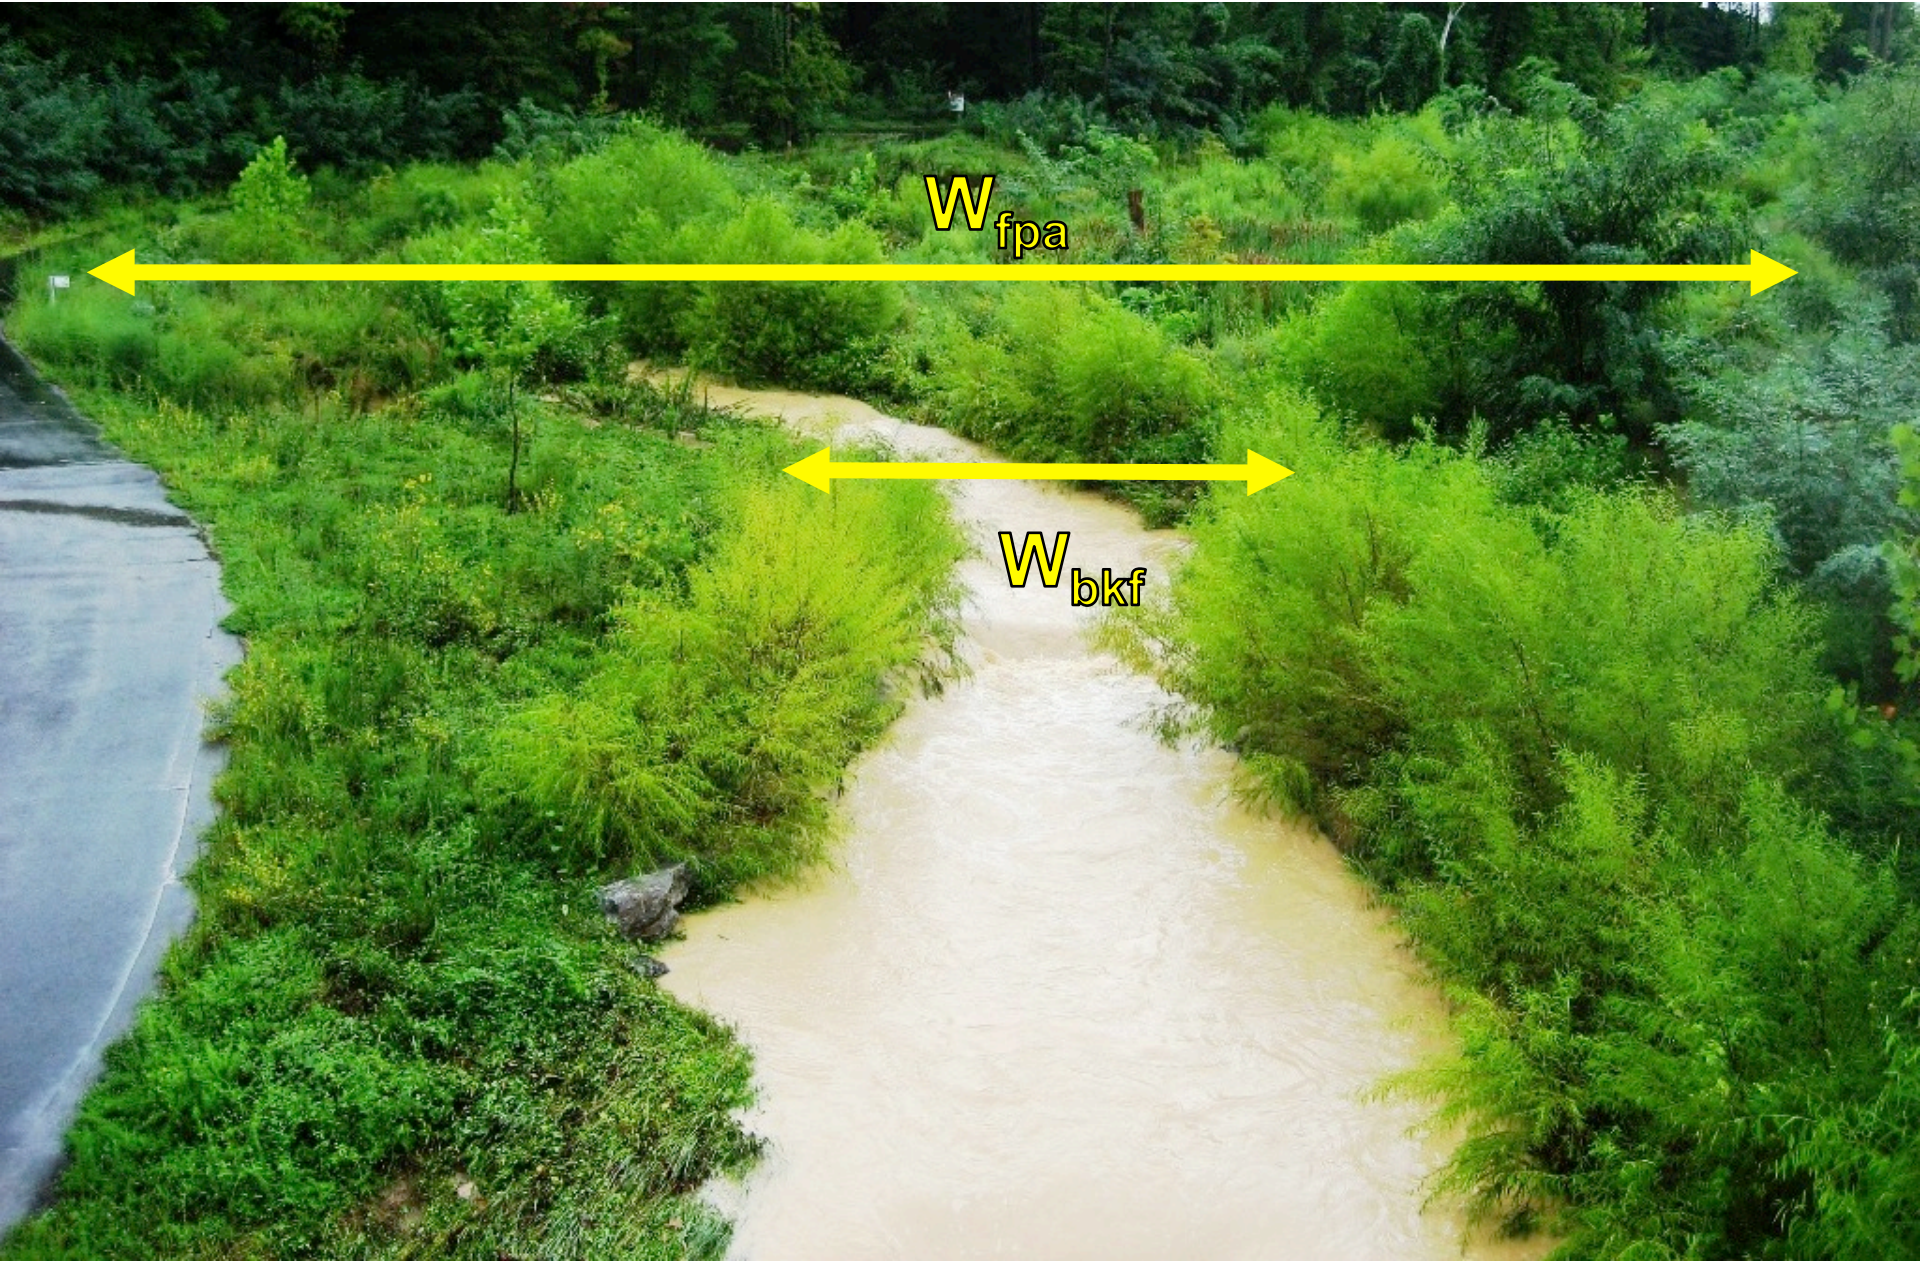
$$\text{Entrenchment Ratio} = W_{\text{fpa}} / W_{\text{bkf}} = 65/16 = 4$$

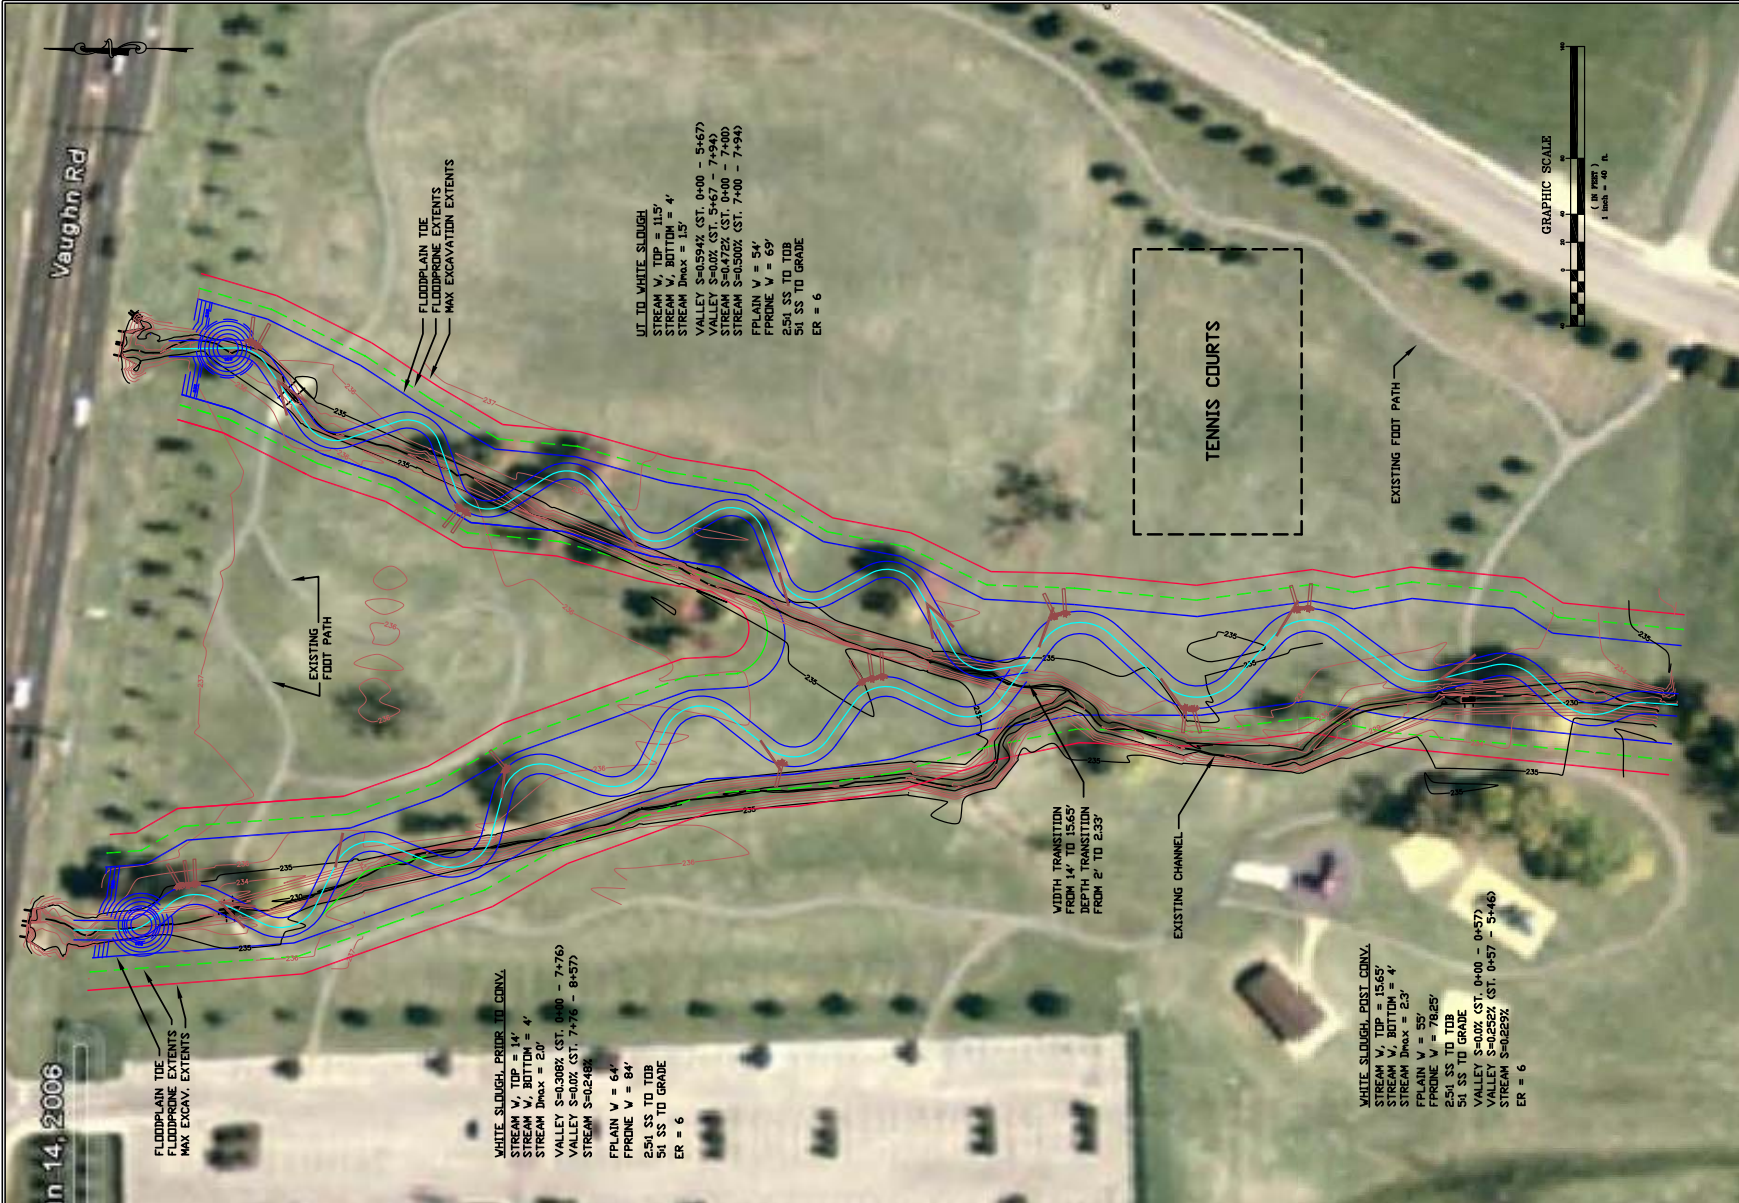
AERIAL PHOTOGRAPH WITH PROPOSED CHANNEL LAYOUT

Engineering Design: William McLemore, PE, GMC

WHITE SLOUGH RESTORATION PHASE I
 IDA BELLE YOUNG PARK

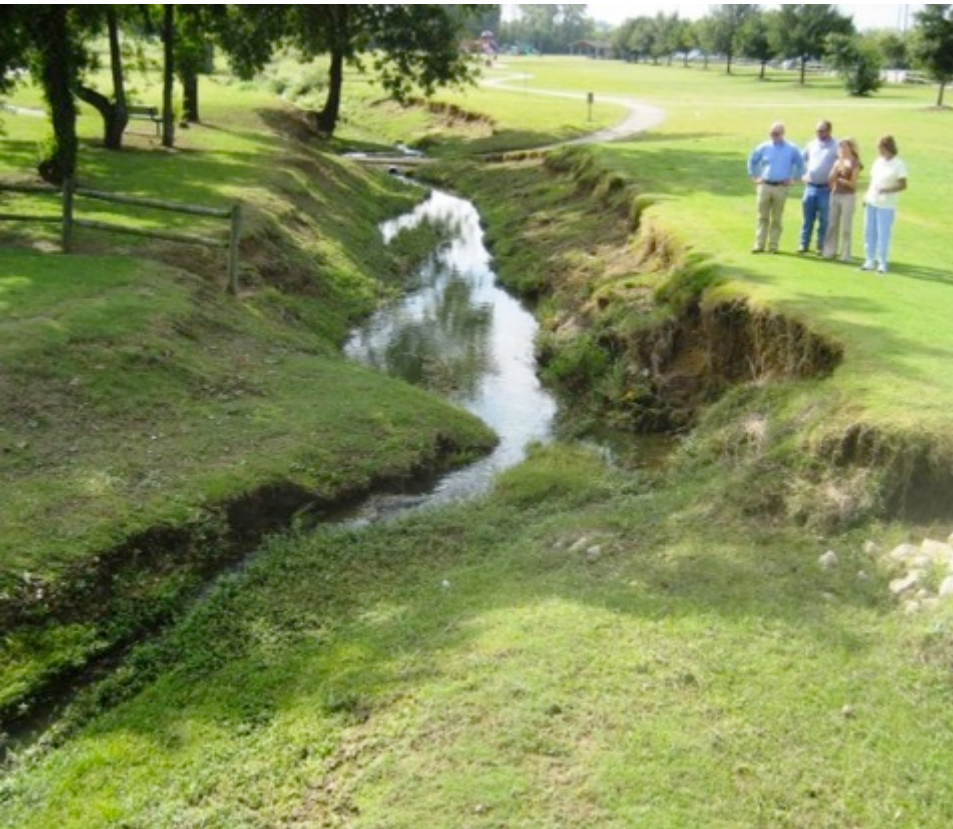
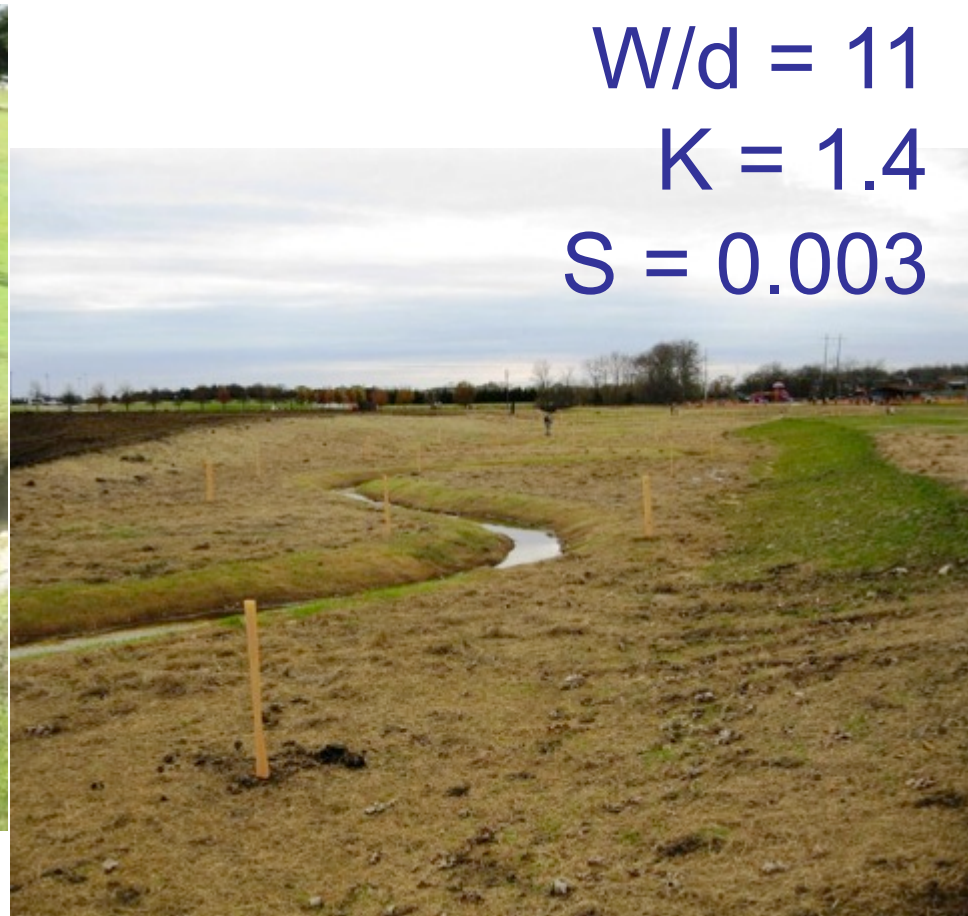
White Slough

Priority 2: Reconnect Floodplain

Excavate wide floodplain and meander channel at a lower elevation

$$ER = 6$$

$$W/d = 11$$

$$K = 1.4$$

$$S = 0.003$$

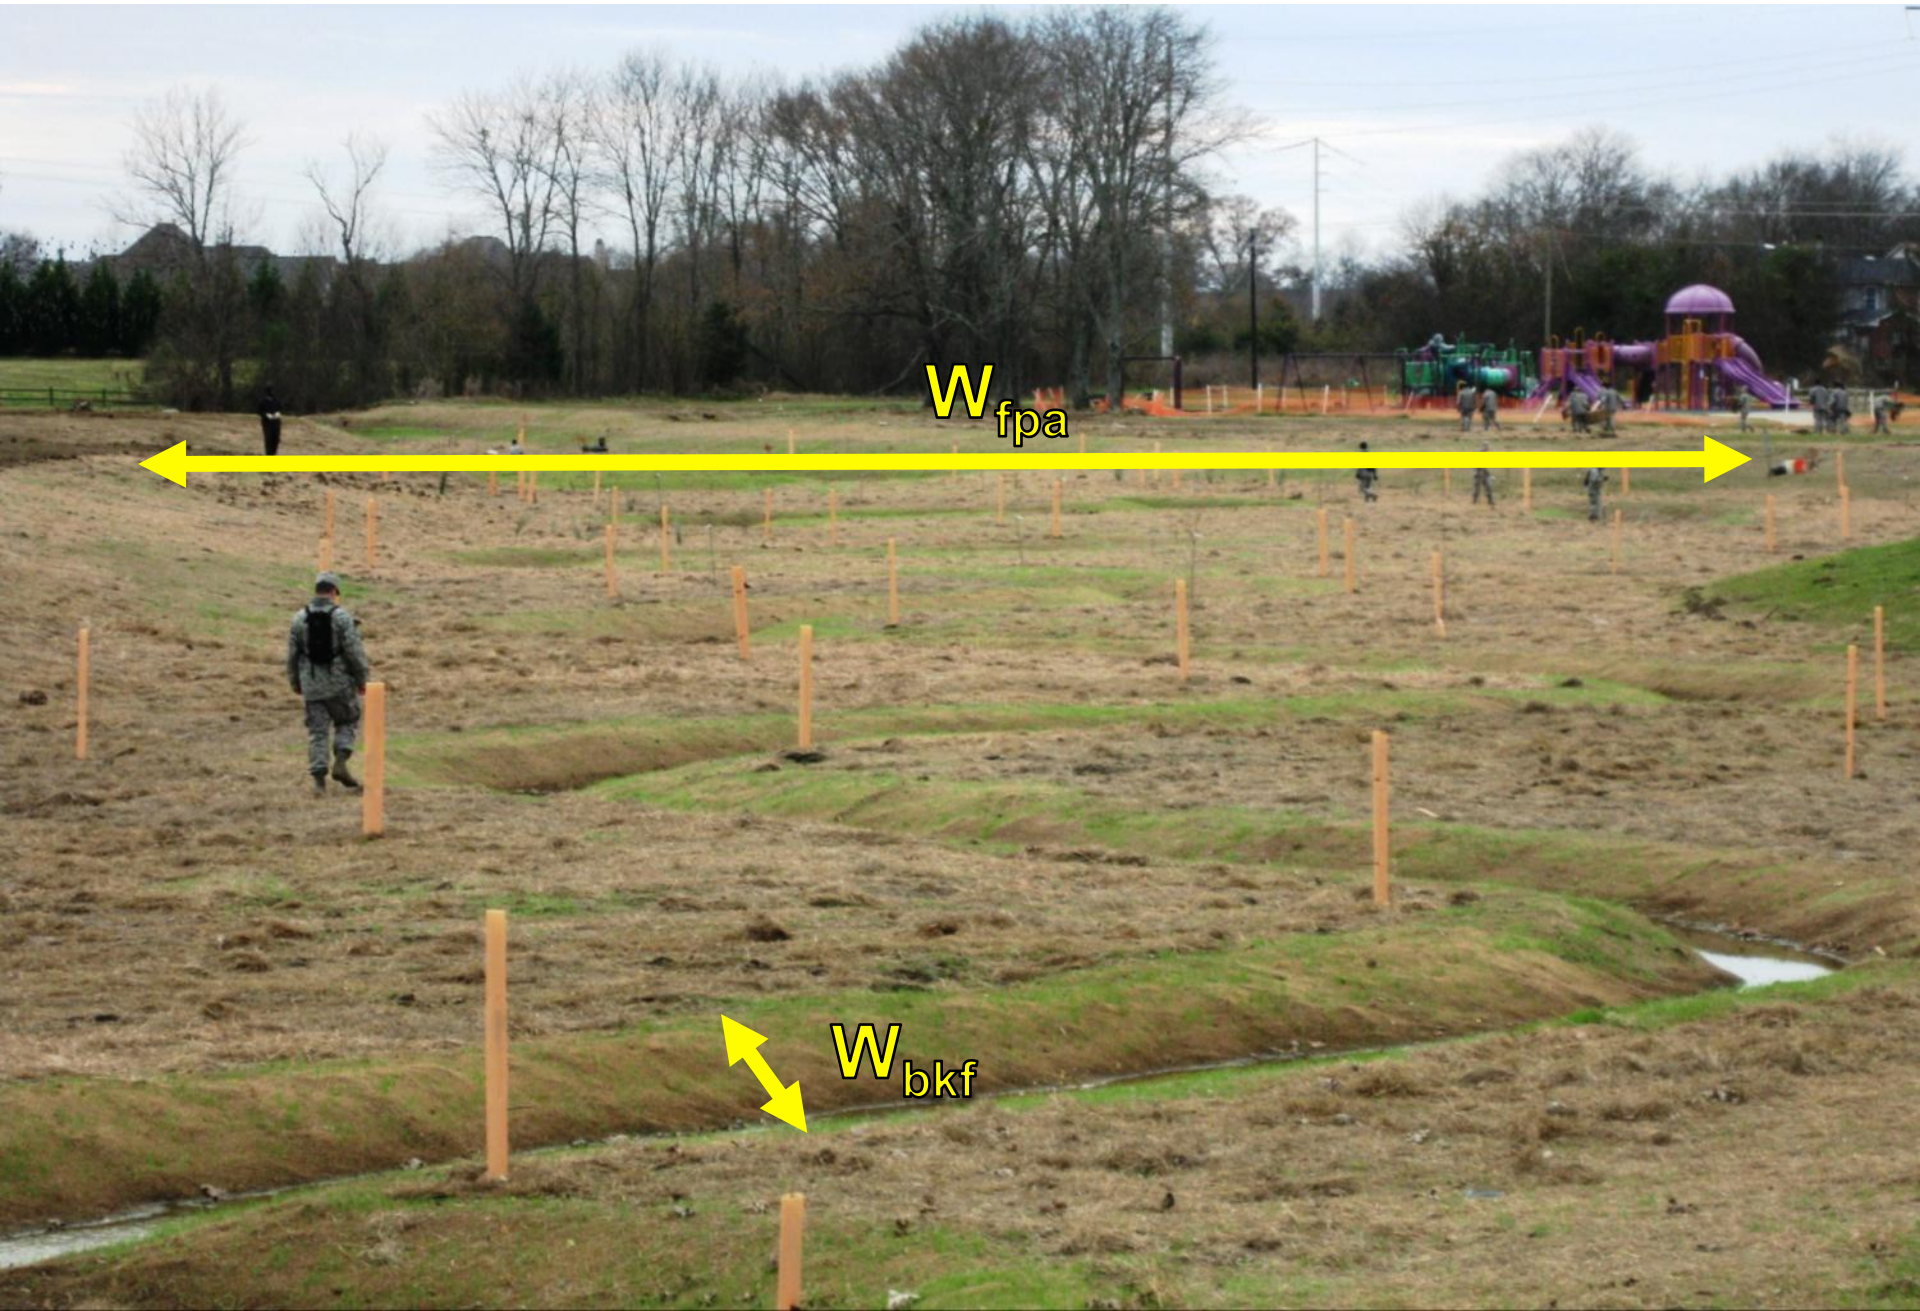
$$\text{Entrenchment Ratio} = W_{\text{fpa}} / W_{\text{bkf}} = 84/14 = 6$$

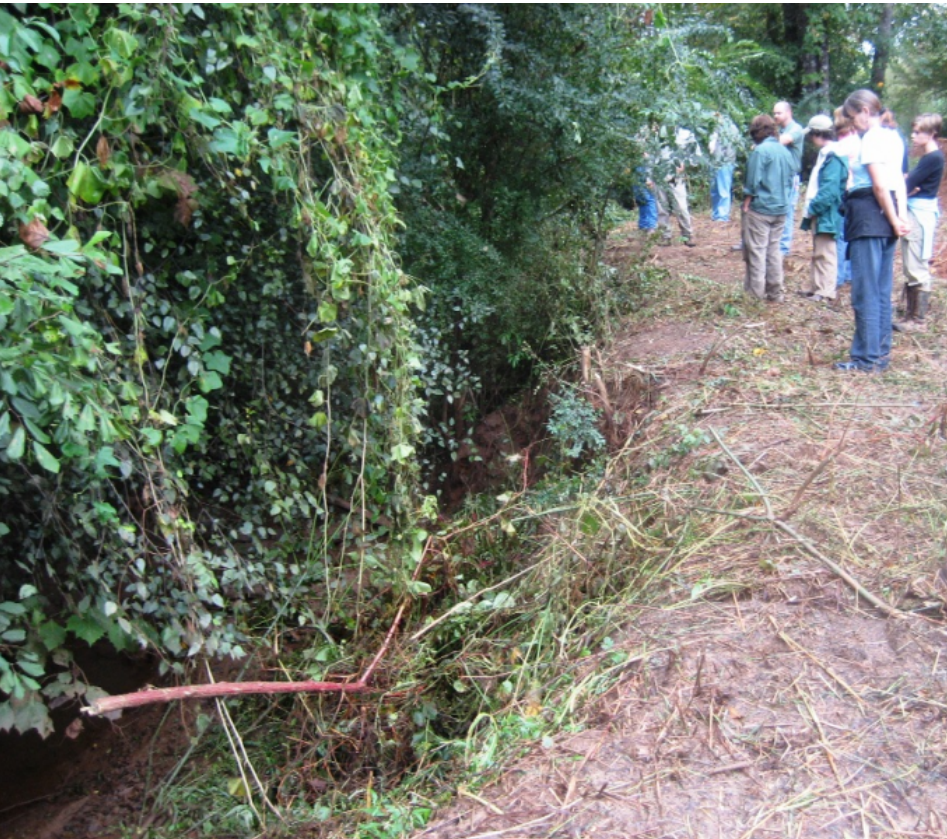
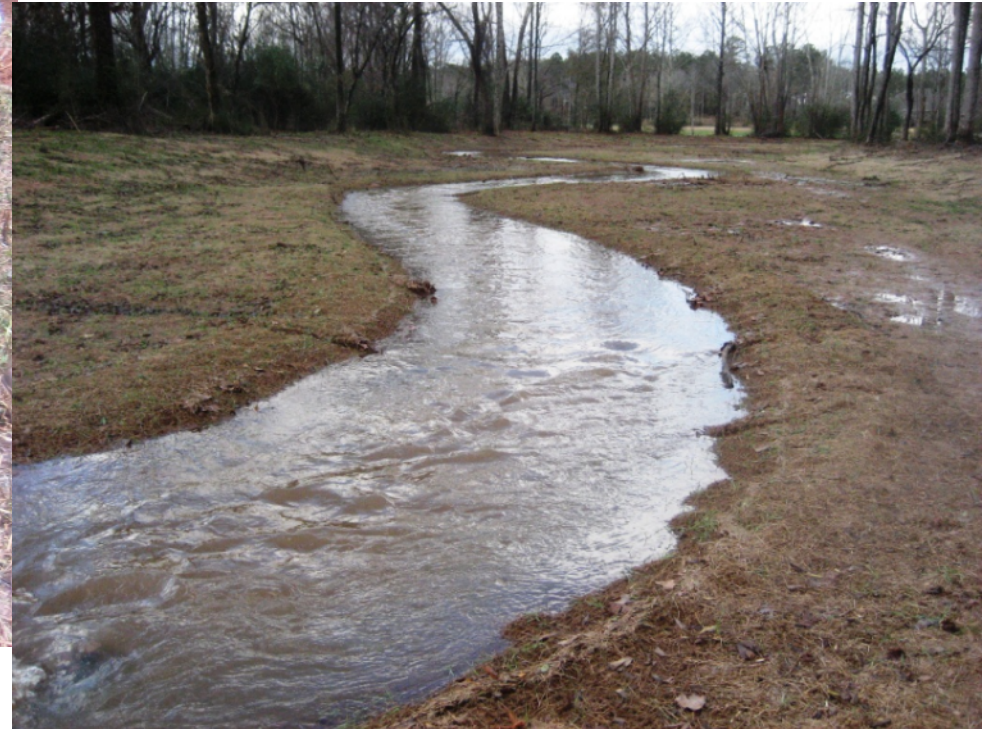
Trib to Saugatchee Creek

Priority 2: Excavate lower floodplain and construct new meandering channel

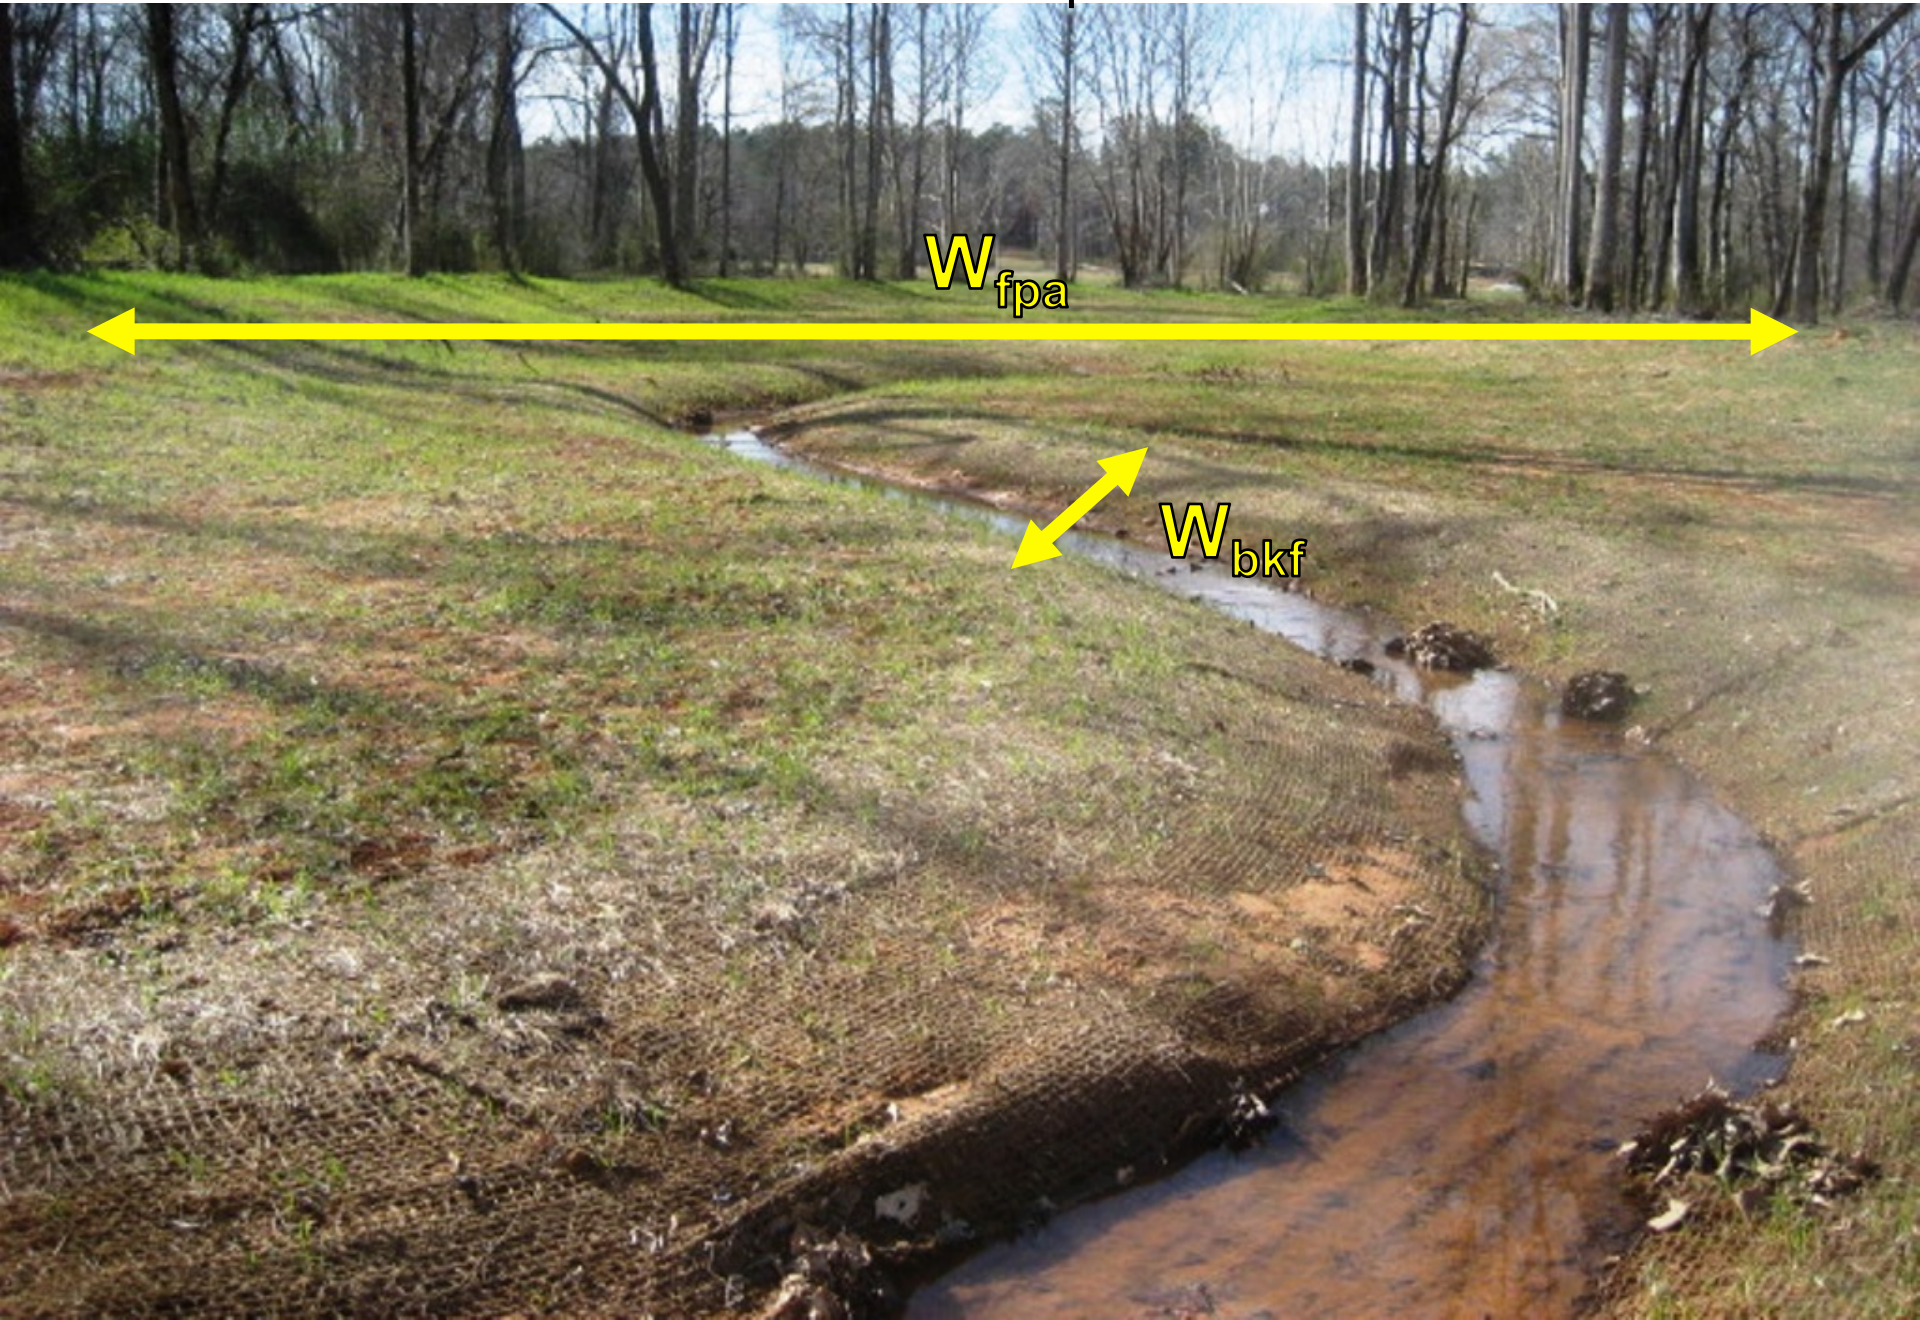
$$\text{Entrenchment Ratio} = W_{fpa} / W_{bkf} = 75/15 = 5$$

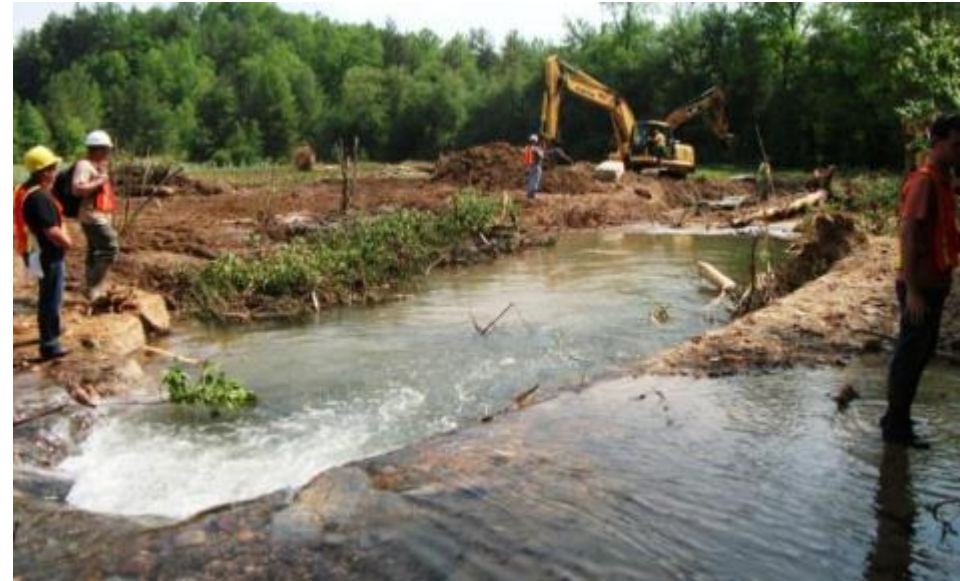
In-Stream Structures

- Boulders and logs sized to resist washout
- Vanes oriented to provide bank protection & maintain position
- Footers, splash rocks, backer logs, sills, chinking, geotextiles, backfilling to maintain structure stability
- Drops/steps support aquatic organism passage & structure stability

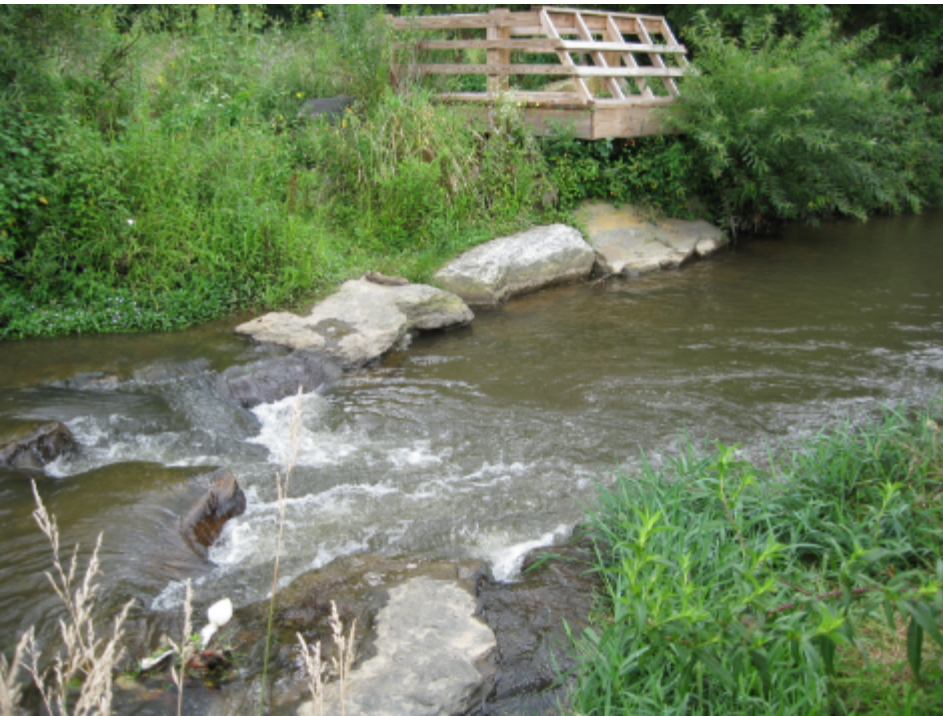
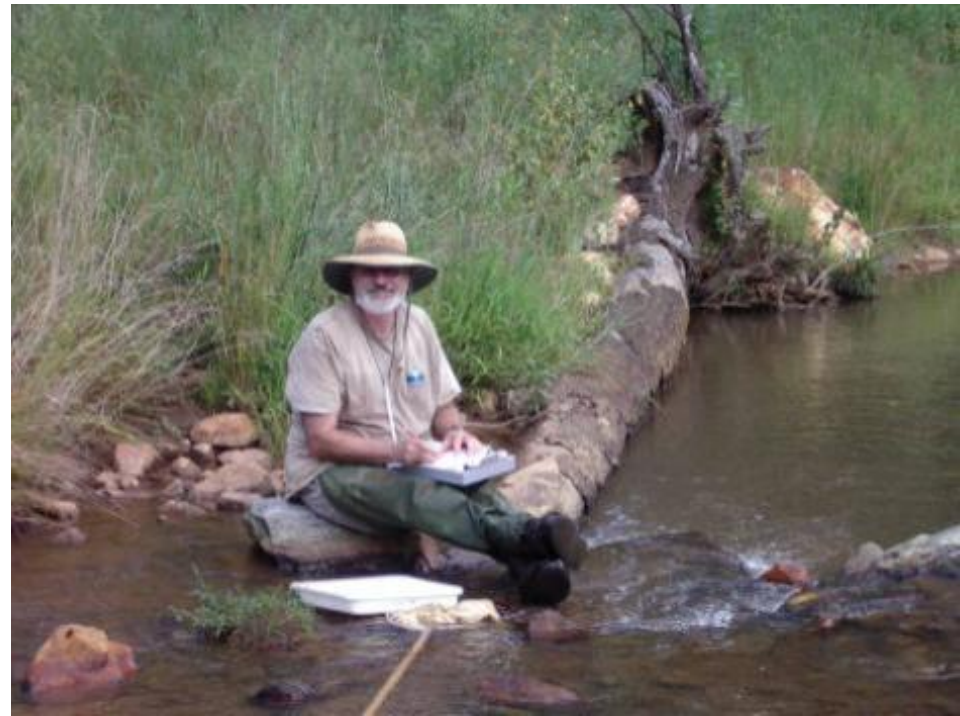
Functions: *Flow Direction & Revetment*

- Streambank protection
- Grade control
- Sediment transport
- Habitat enhancement (pools, aeration, cover)

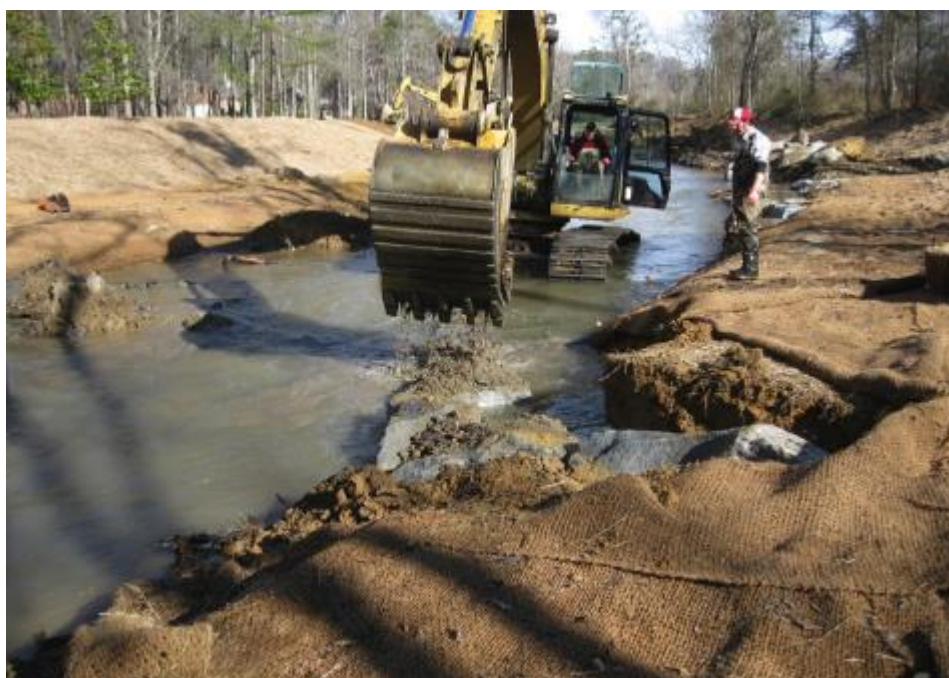
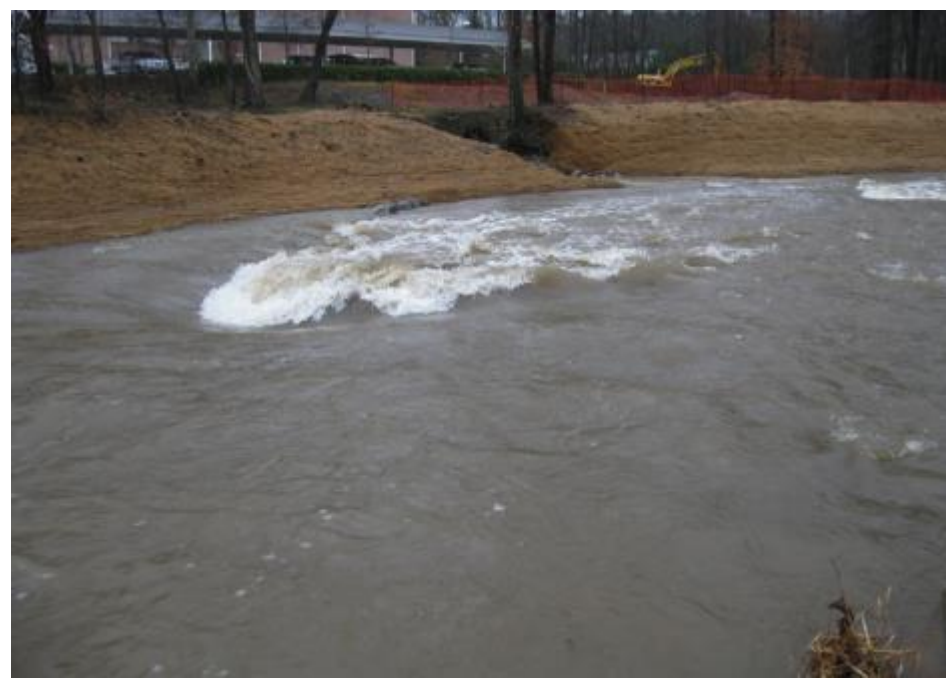
Vanes (Boulder or Log)

- Oriented upstream at 20-30 degrees from bank tangent
- Sloping up from channel invert at 3-5 % arm toward bank
- May control grade using J-hook (< 0.5 ft drop)
- May need footers, sills, geotextile to avoid piping/washout

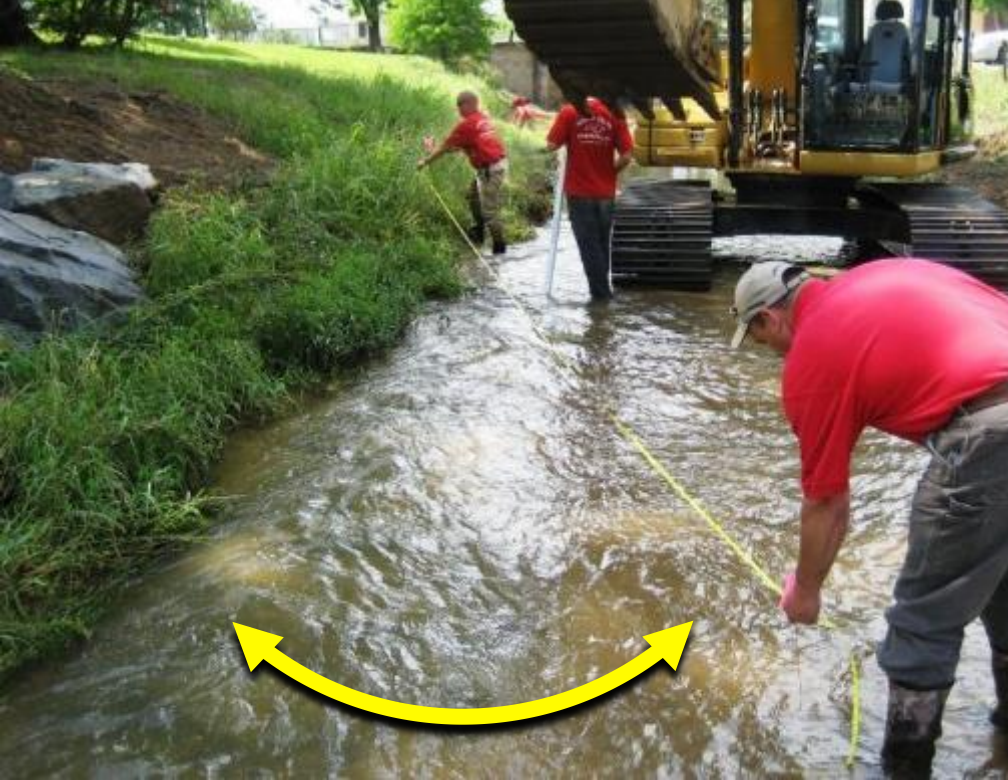
Boulder Vanes

- Single-arm
- J-hook
- Cross-vane

20-30 degrees

3-5 % arm slopes
