Stream Restoration Implementation

Greg Jennings, PhD, PE
jenningsenv@gmail.com

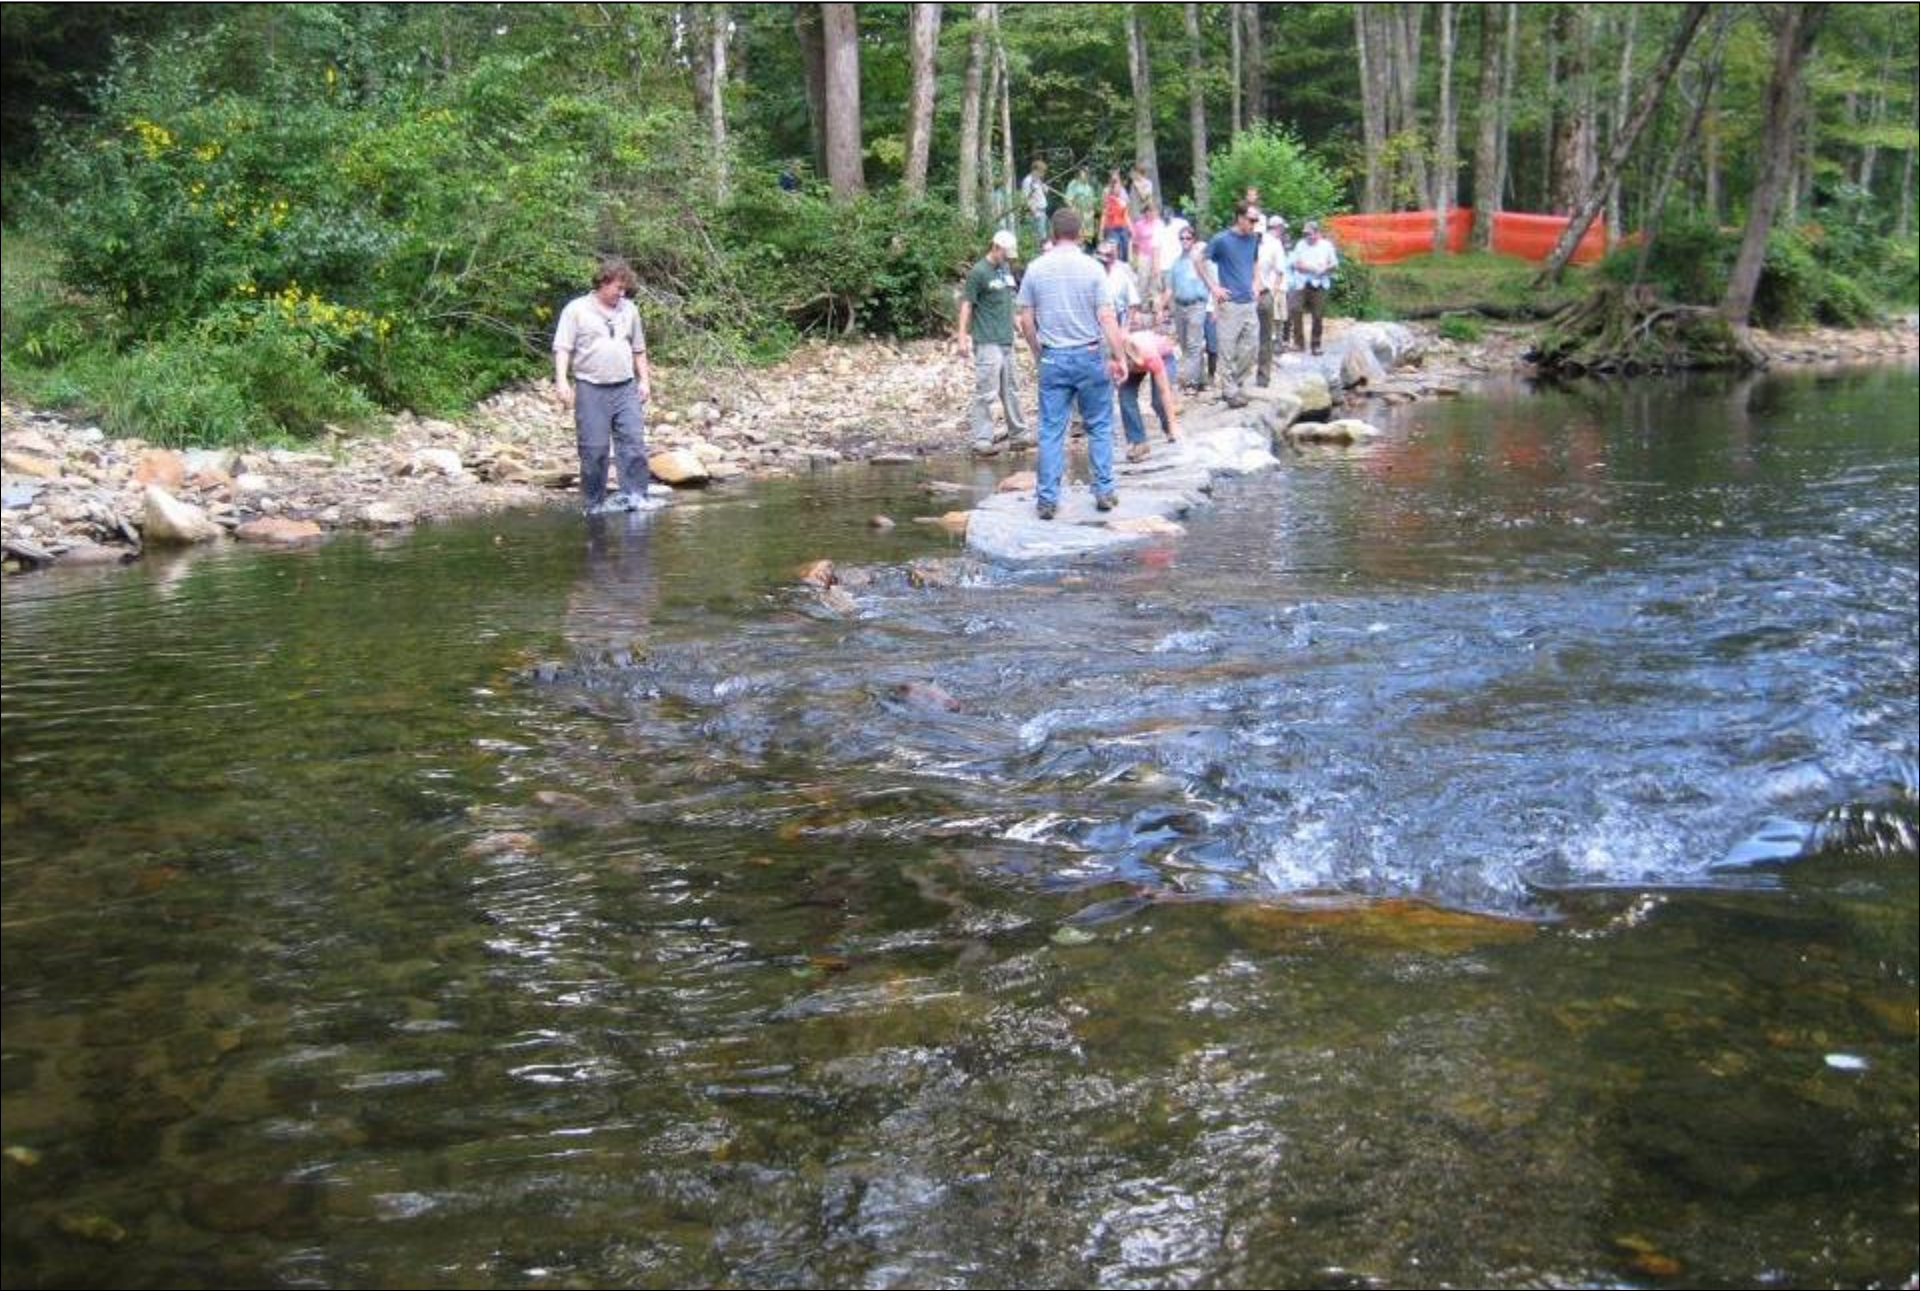
Boulder J-Hook Vane

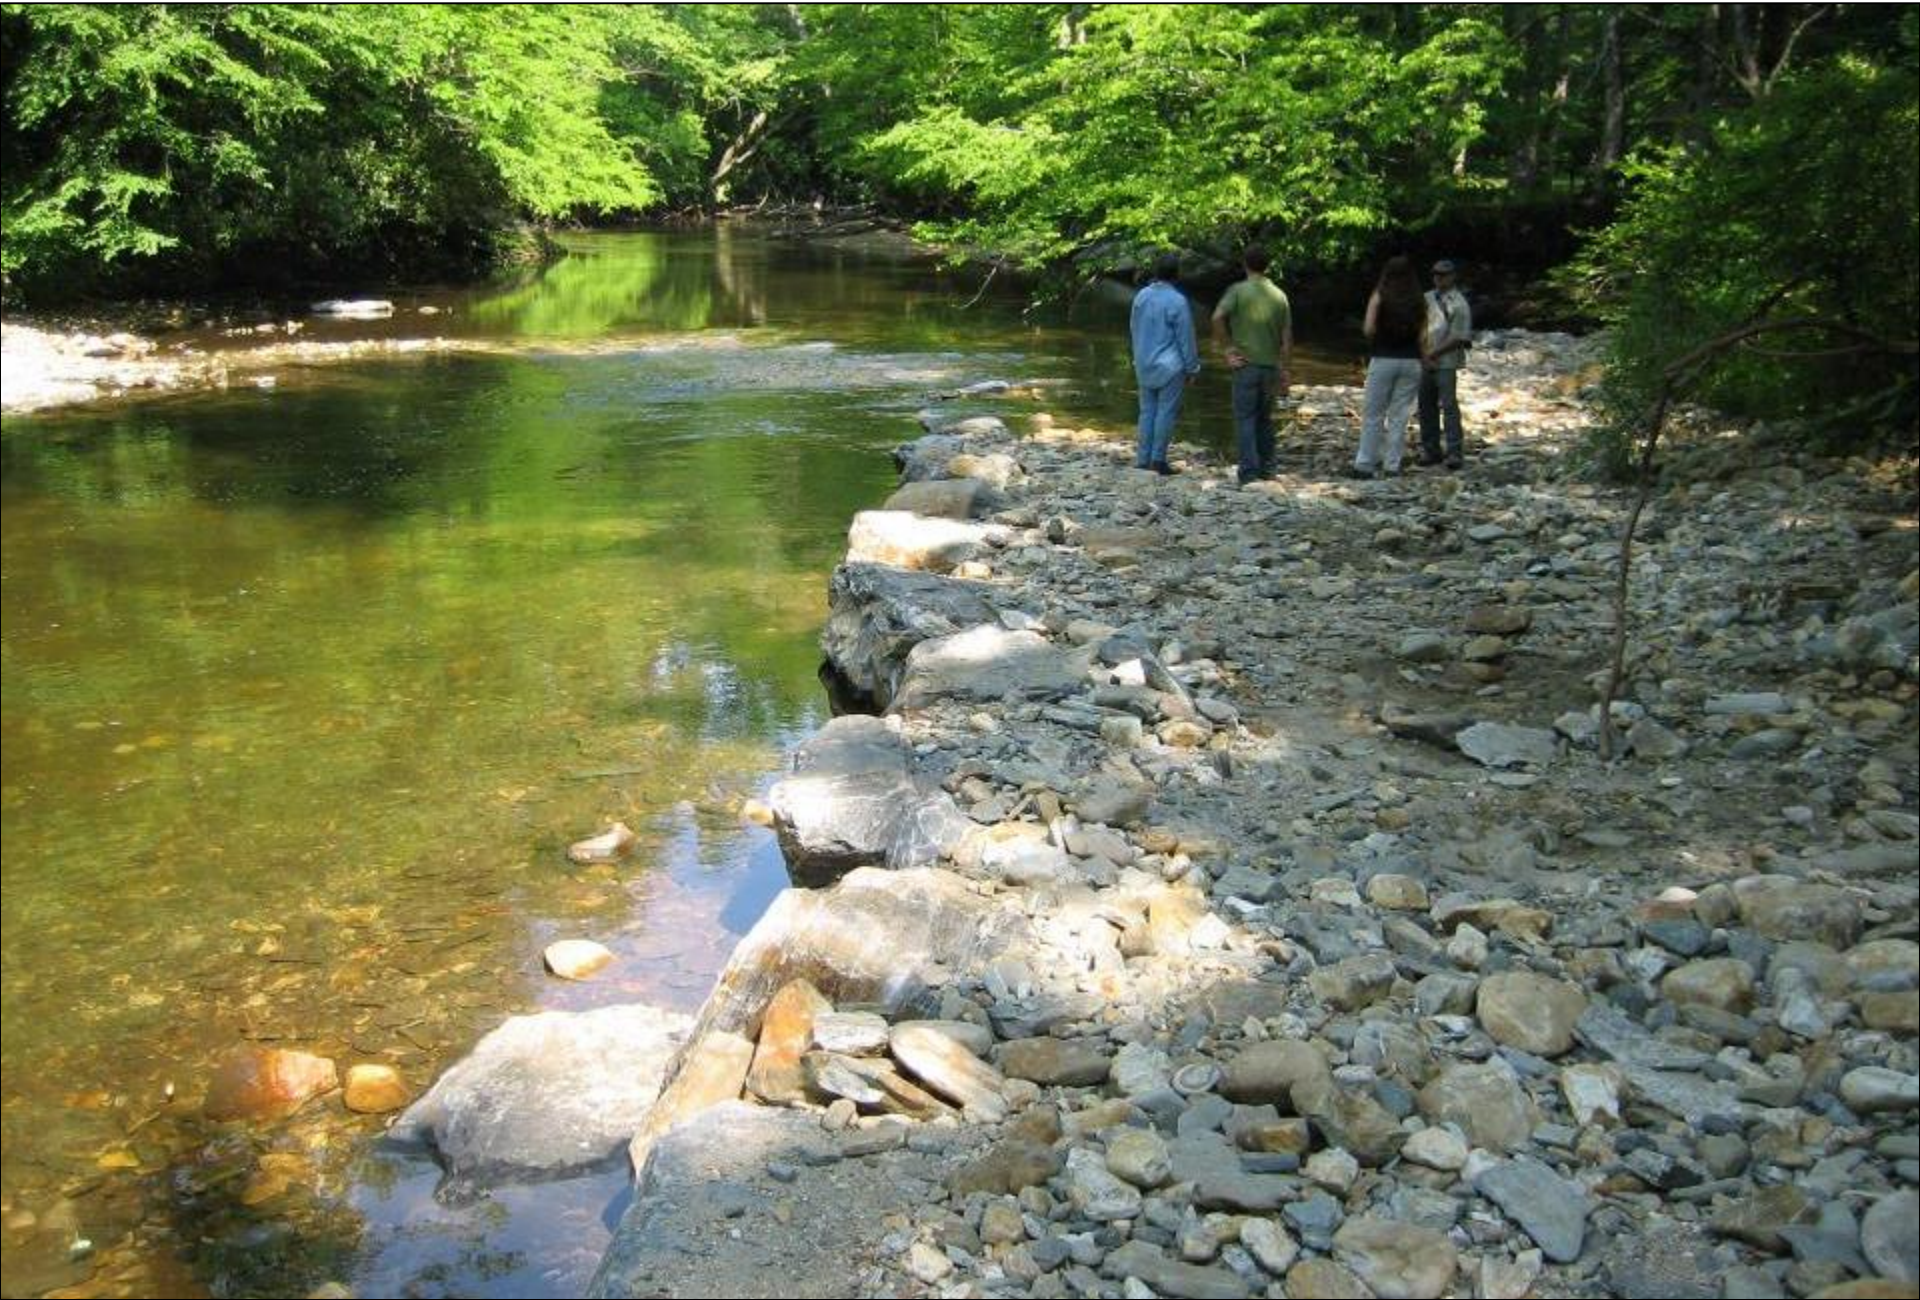
Chinking Boulders to Prevent Piping

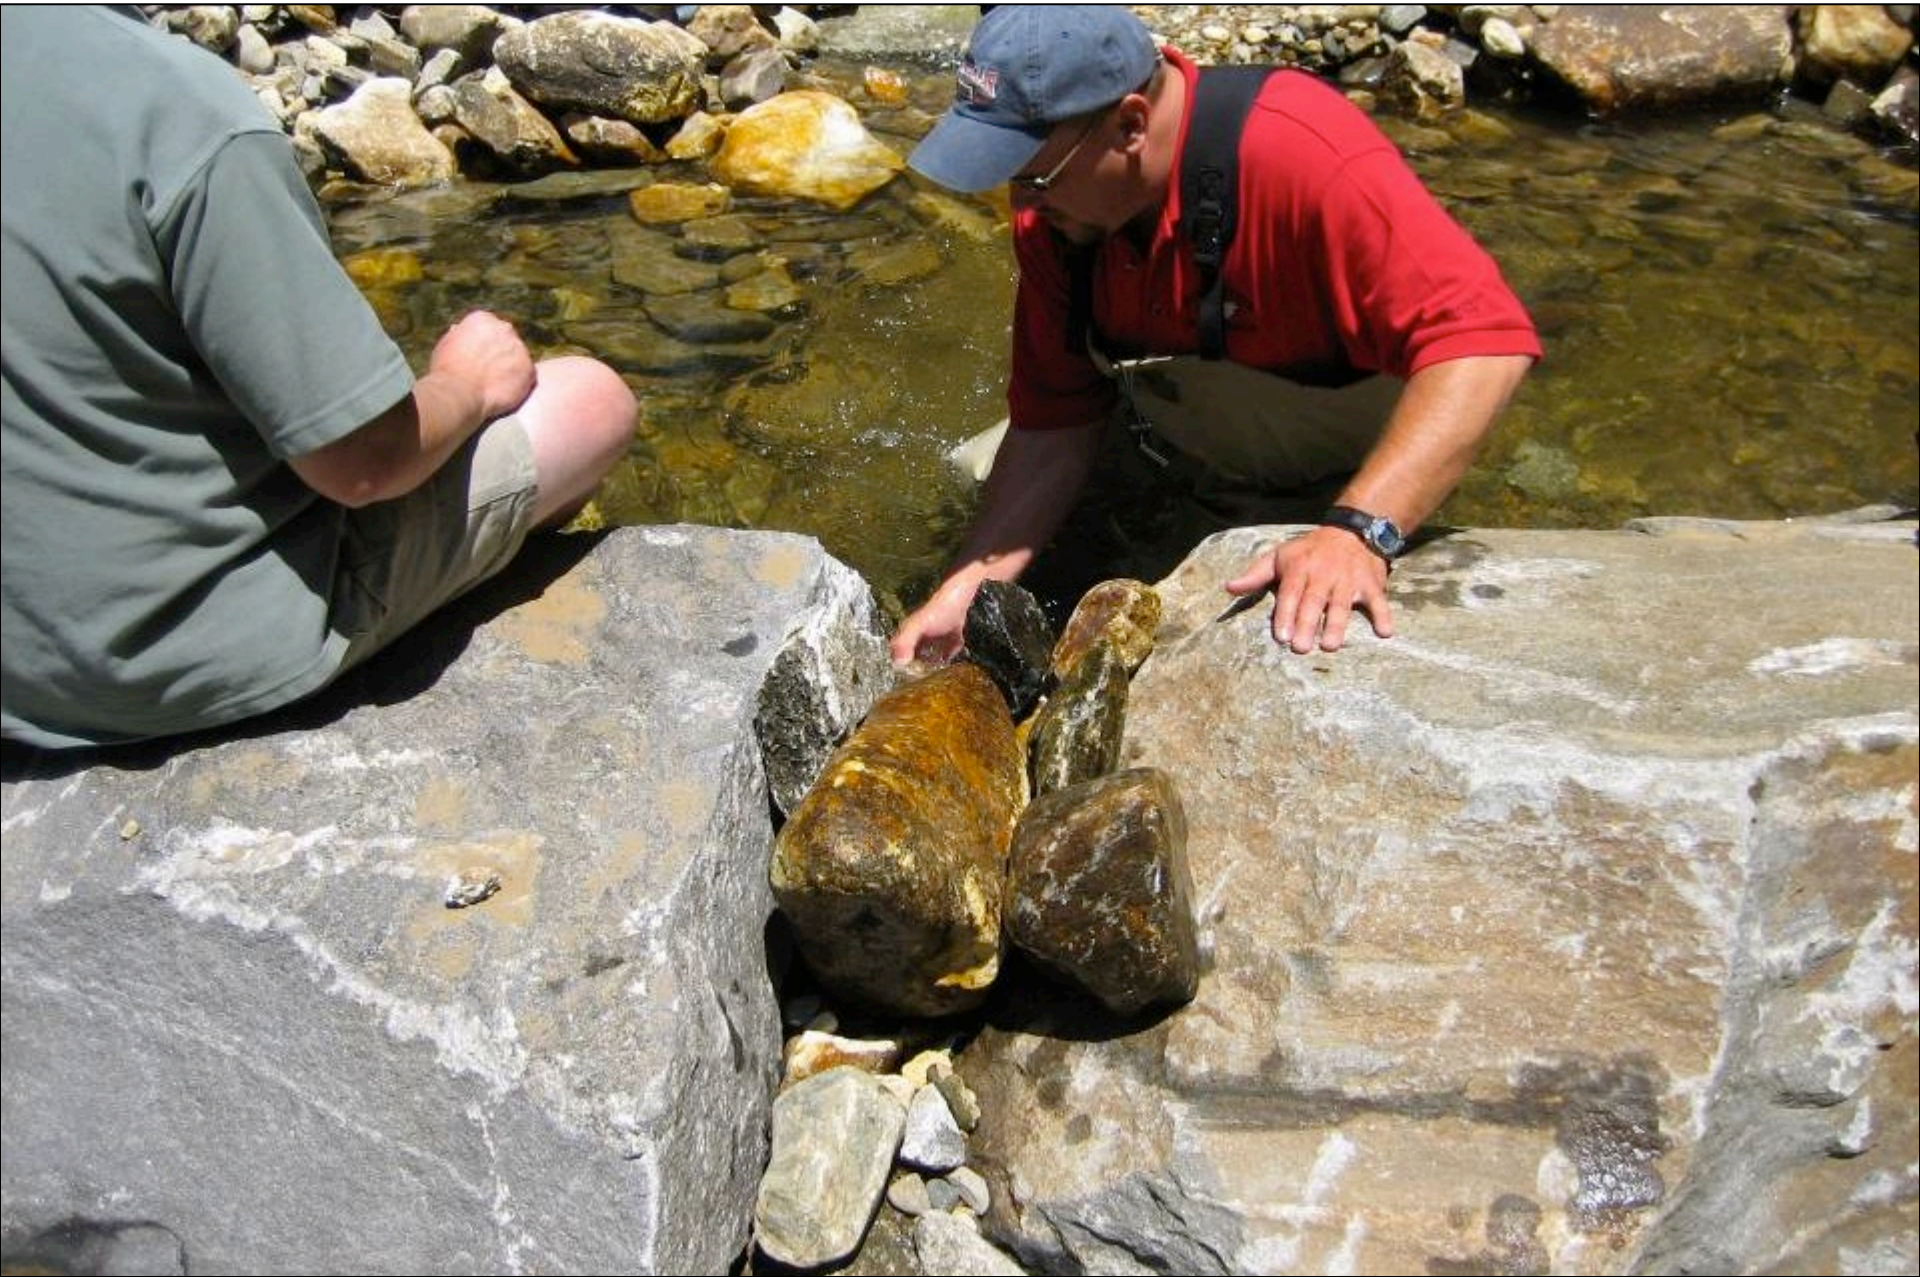
Geotextile Curtain to Prevent Piping

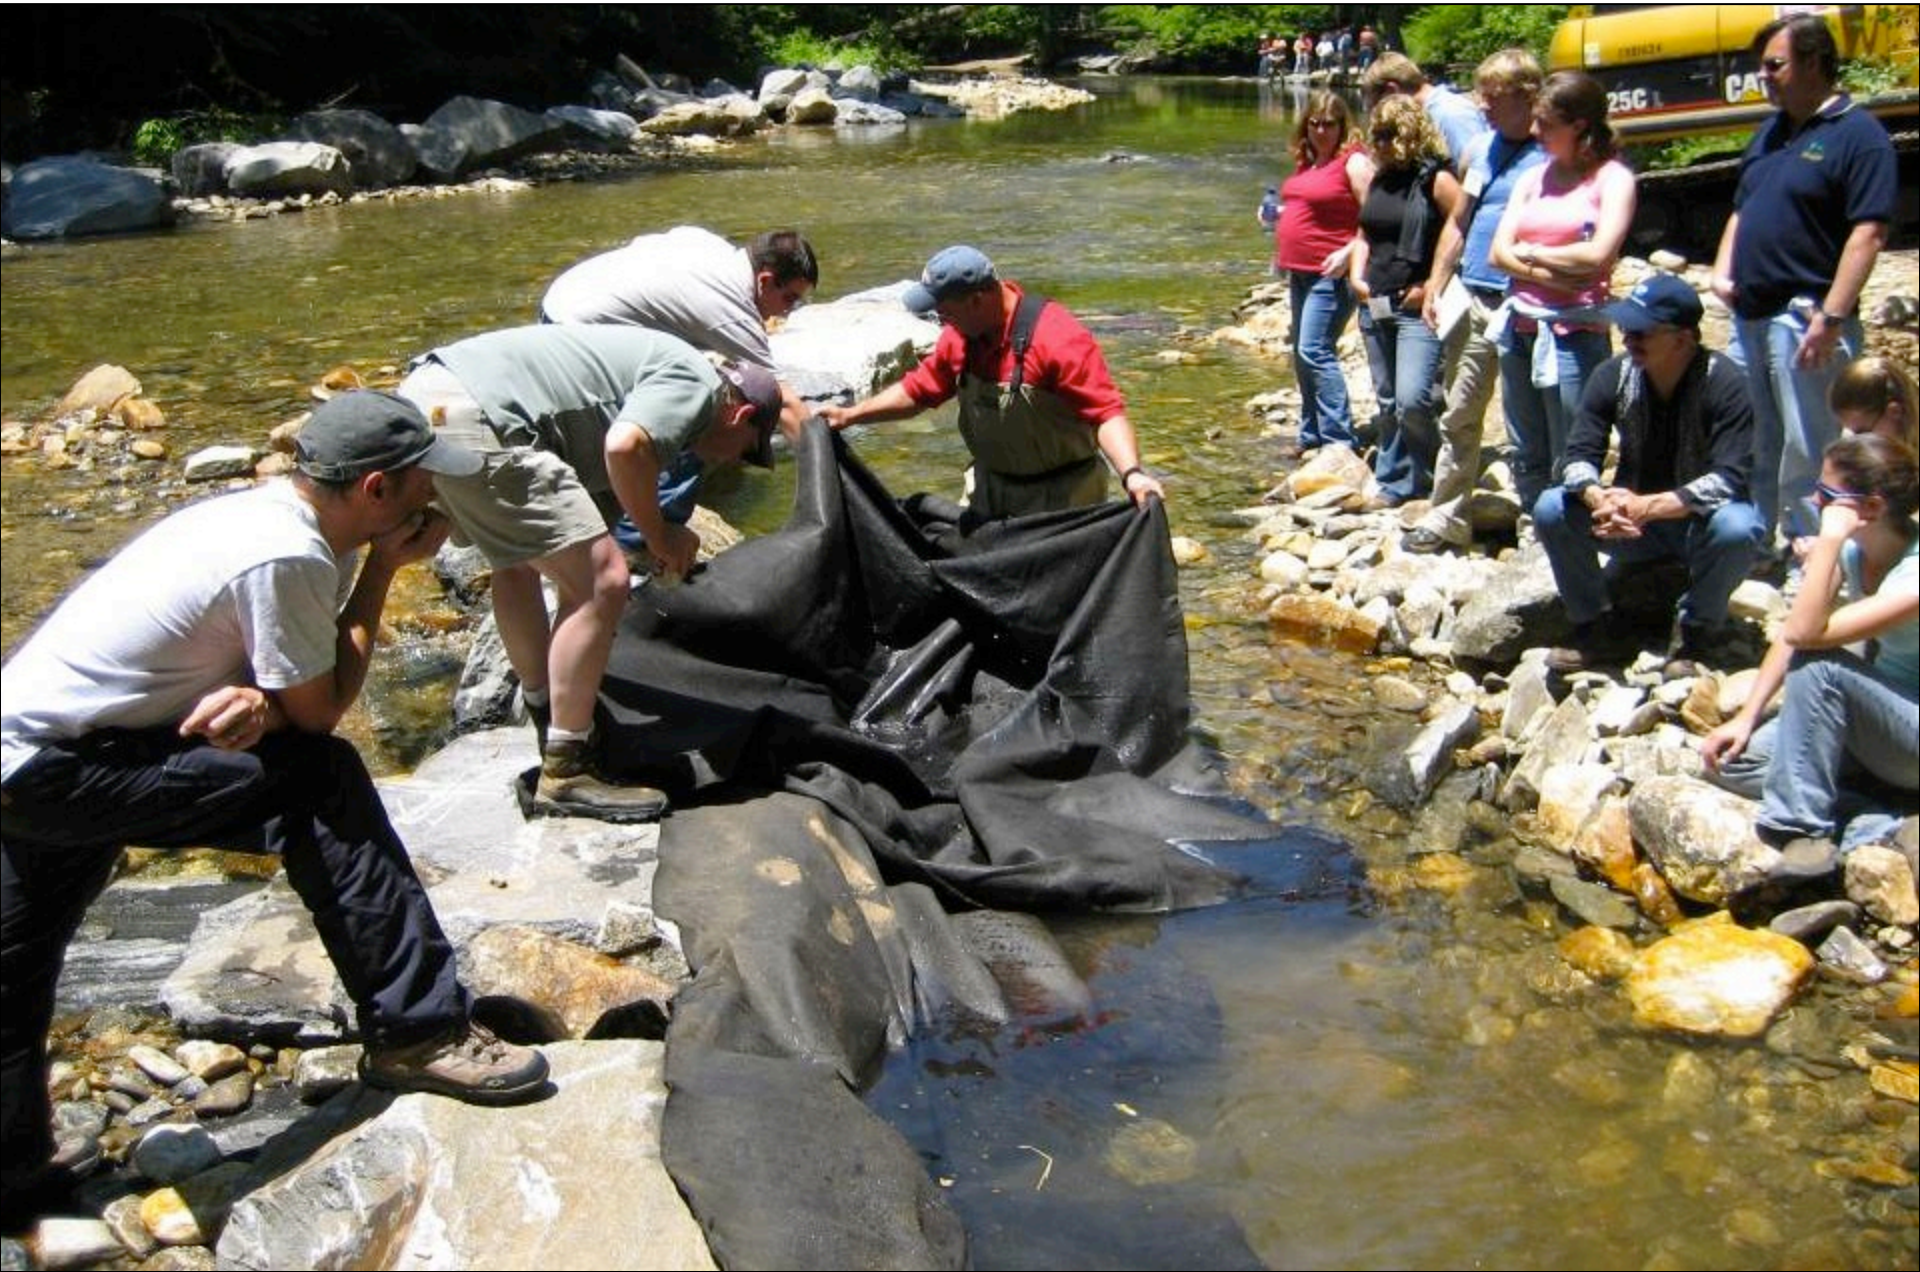
Log J-hook Vanes for flow direction & habitat

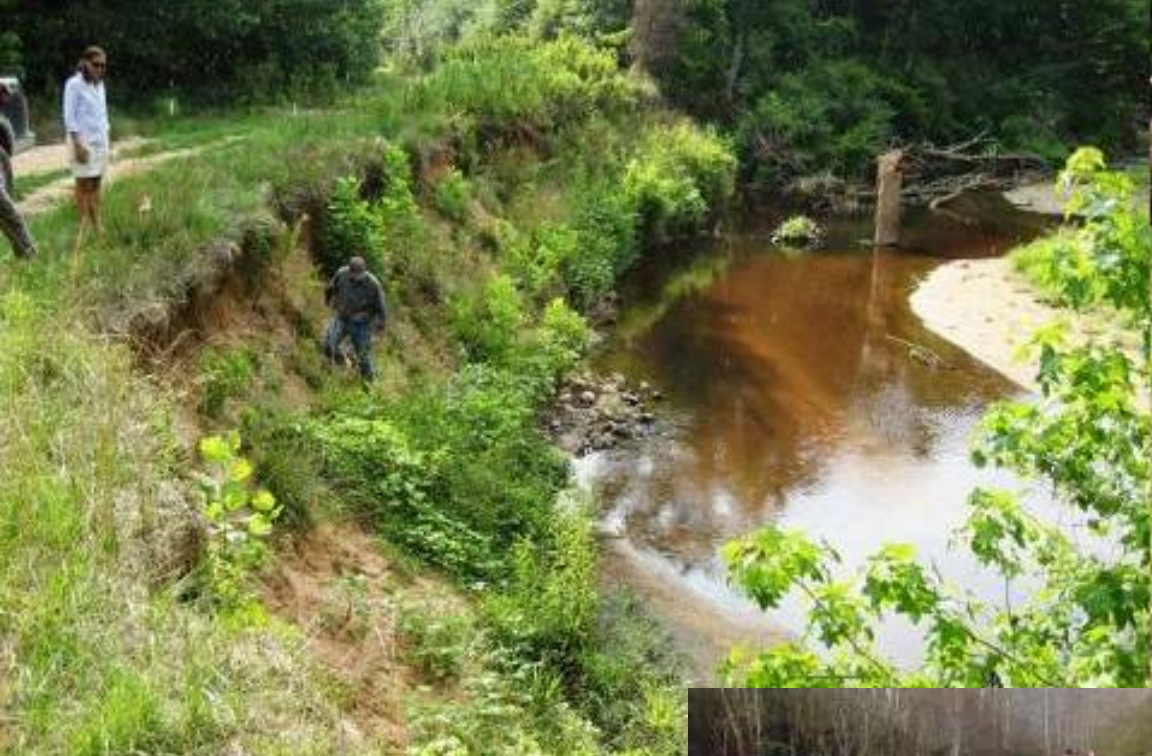
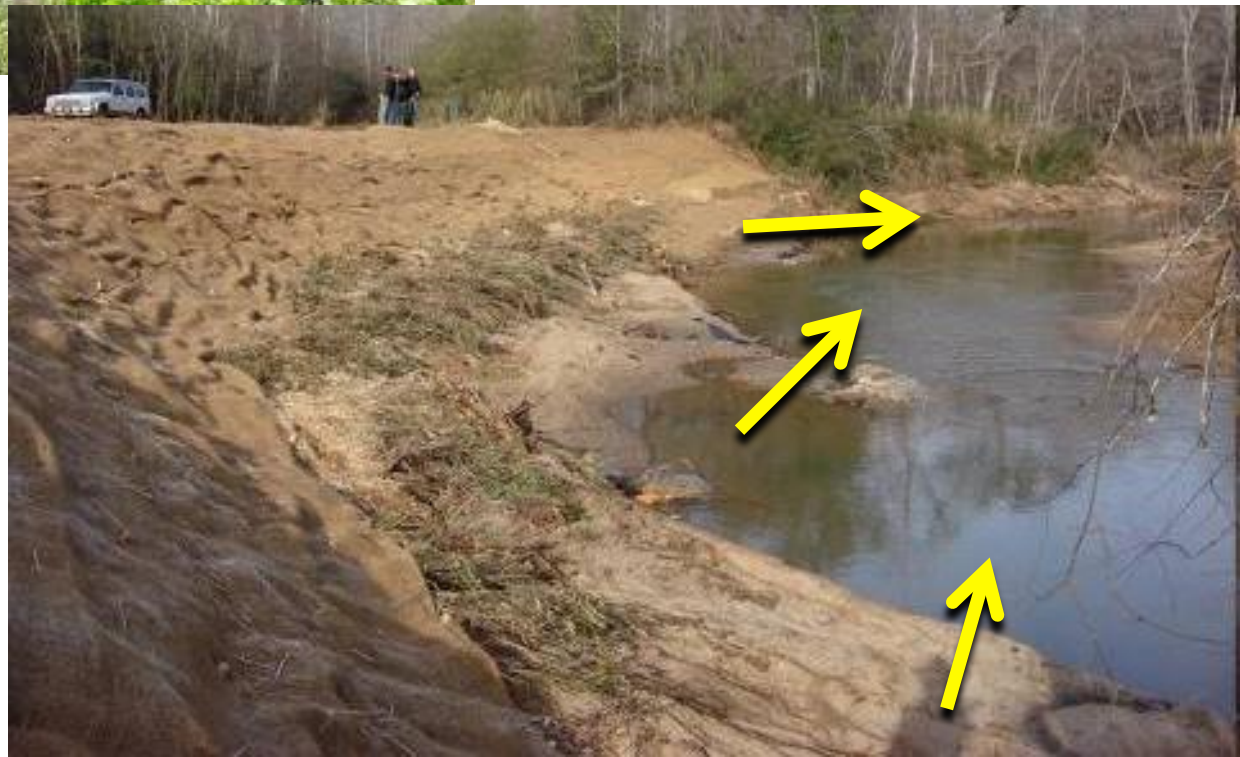
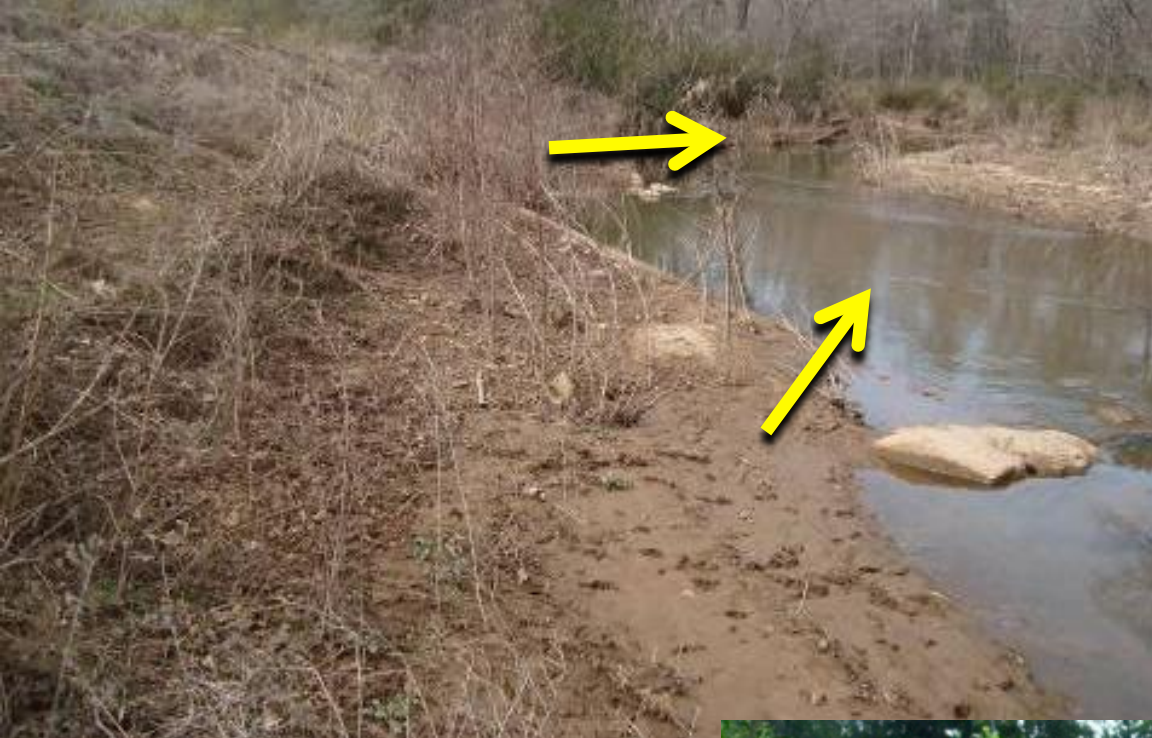
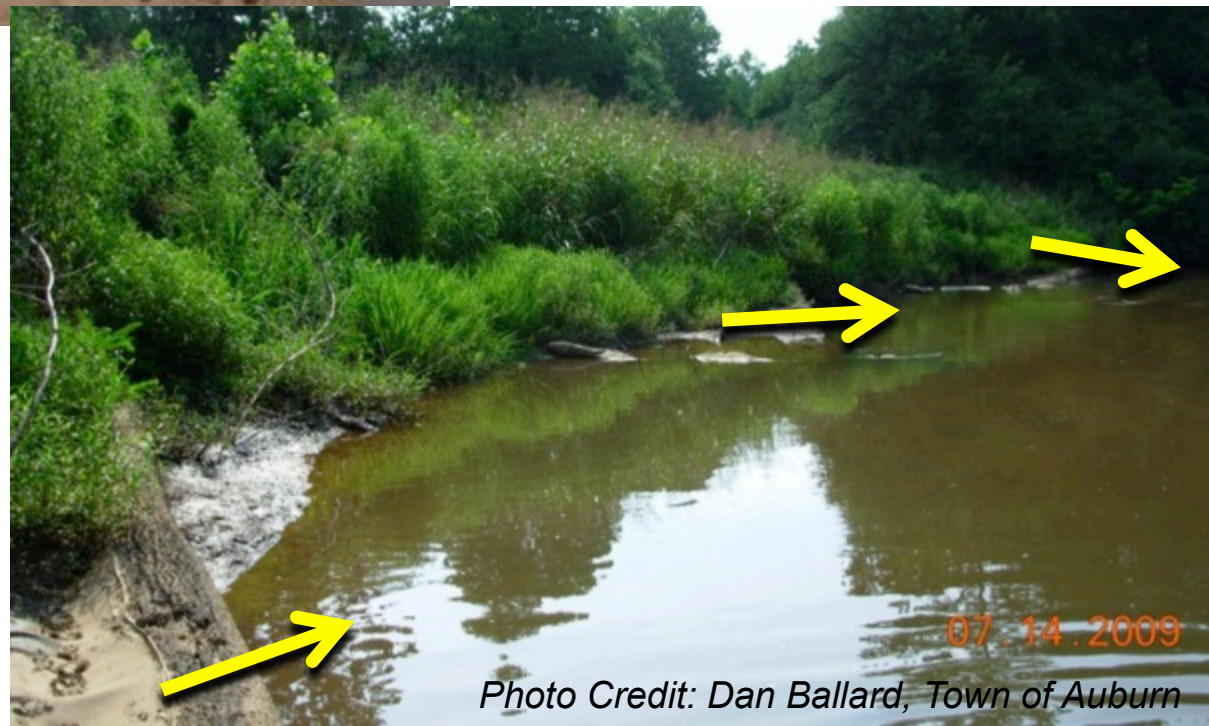
Multiple Log Vanes

Saugahatchee Creek

Multiple Log Vanes: Saugahatchee Creek

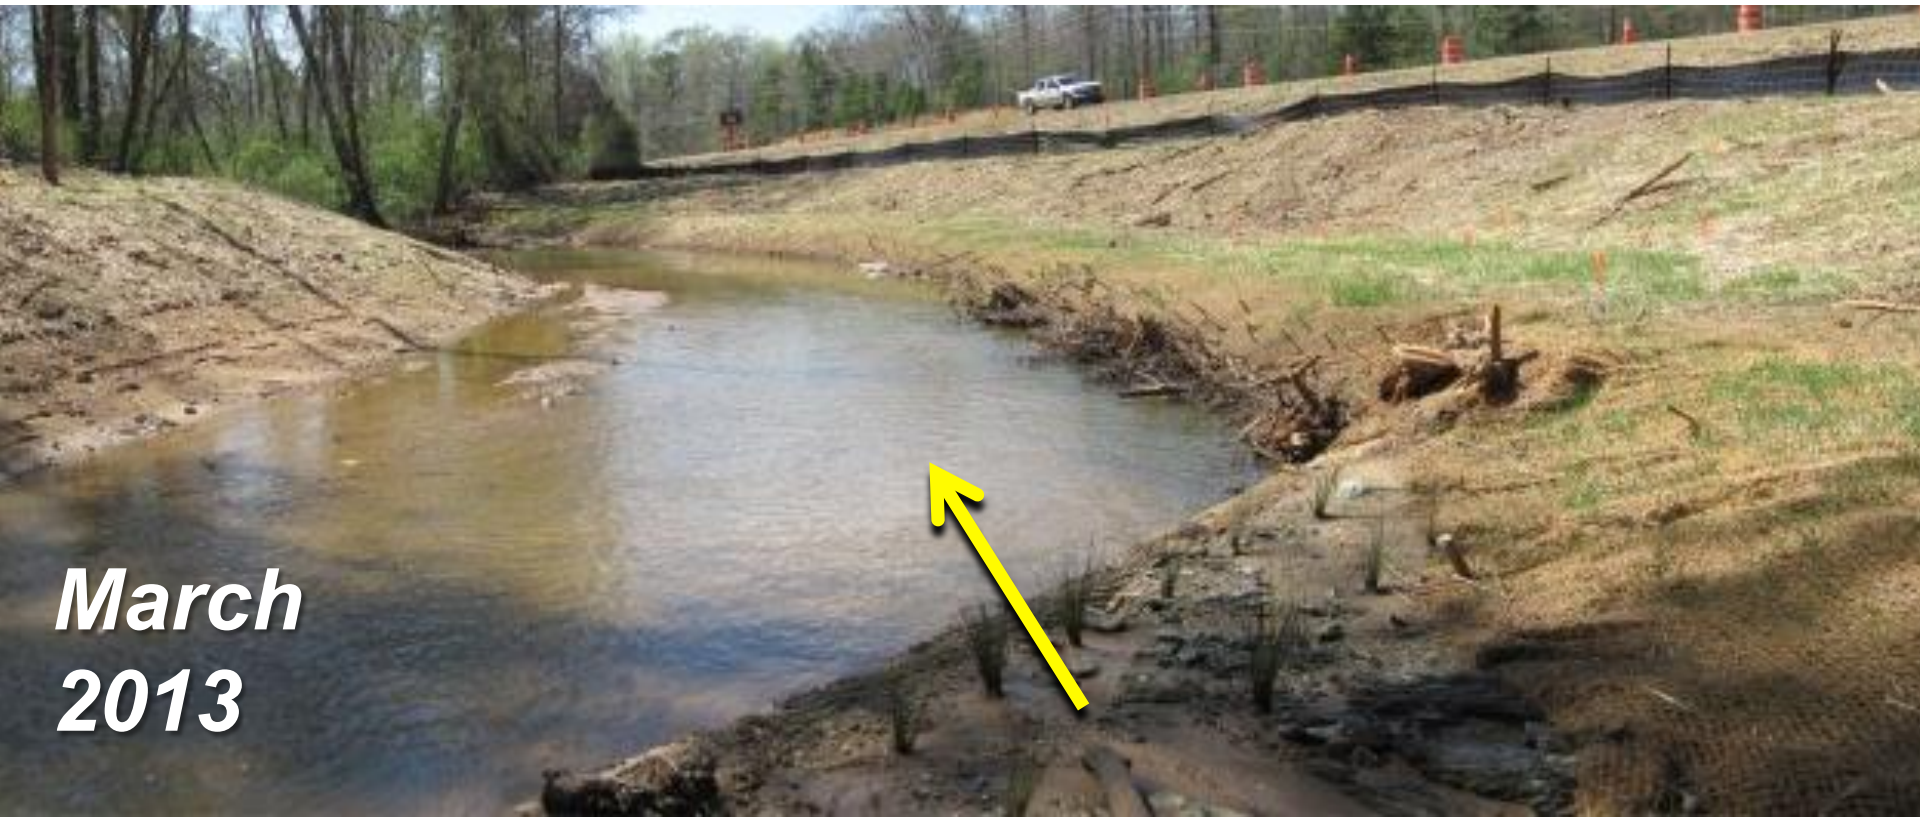
Log Vanes (with Toe Wood downstream)

- Auburn NE Sewer
- Redirect flow to allow natural vegetation to stabilize bank

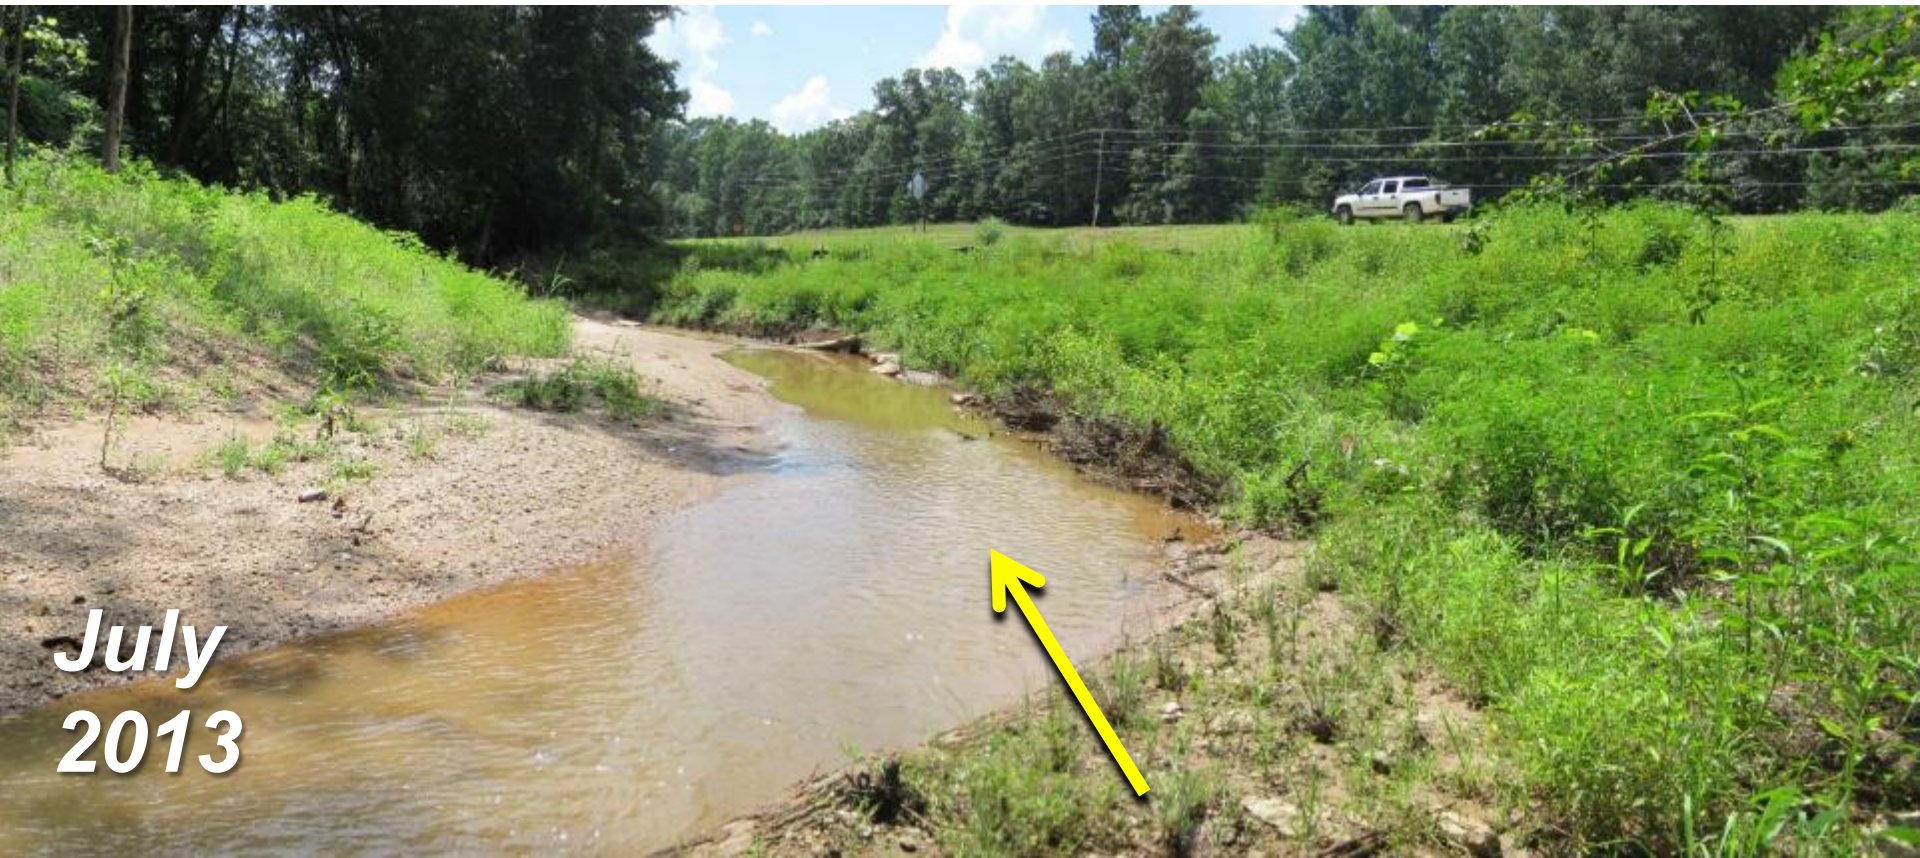
Log Vanes (with Toe Wood downstream)

- 2-4 % arm slopes
- 20-25 degree arm angles
- Sealed with woven geotextile & backer logs

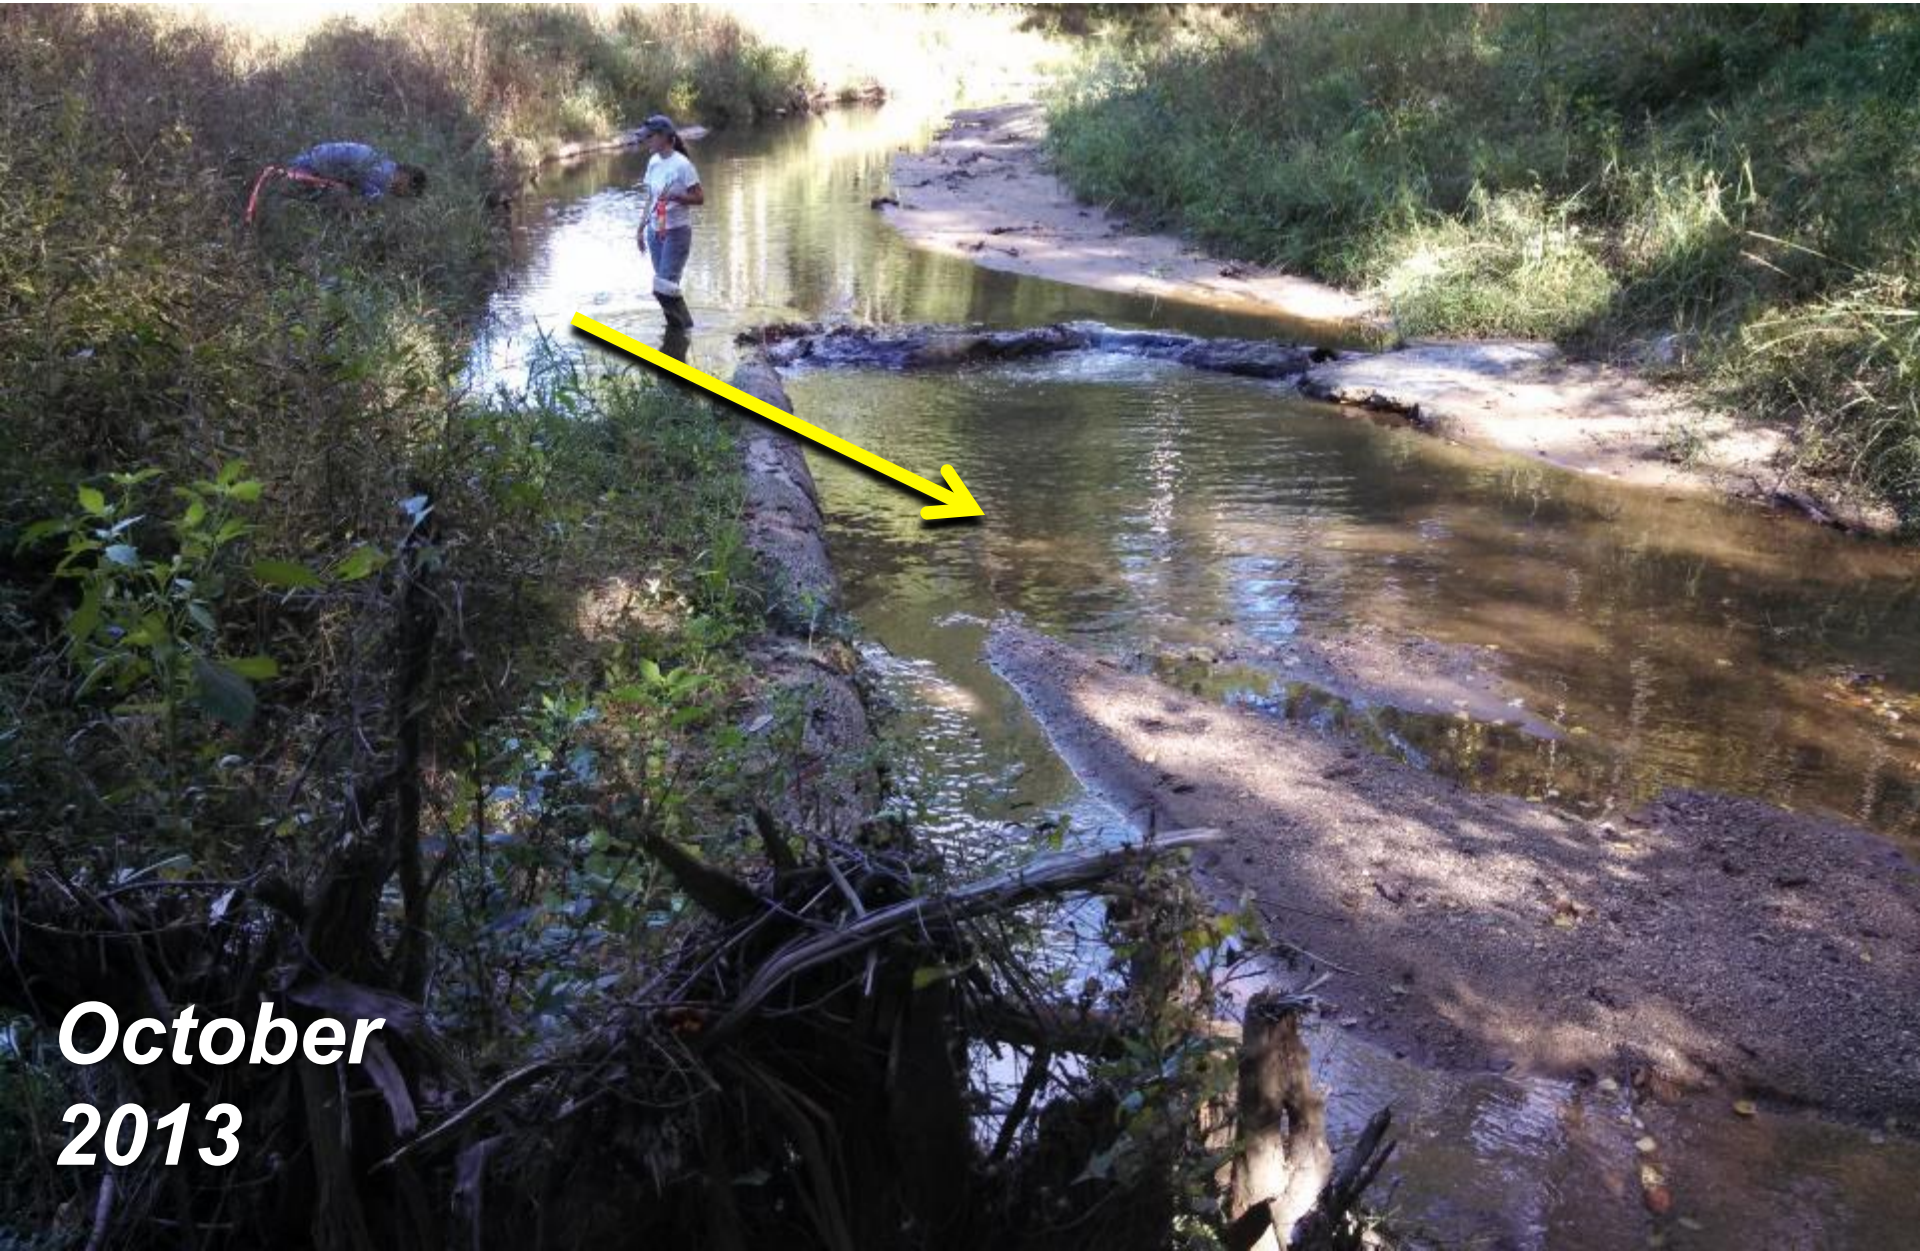
Log Vane (with J-Hook)

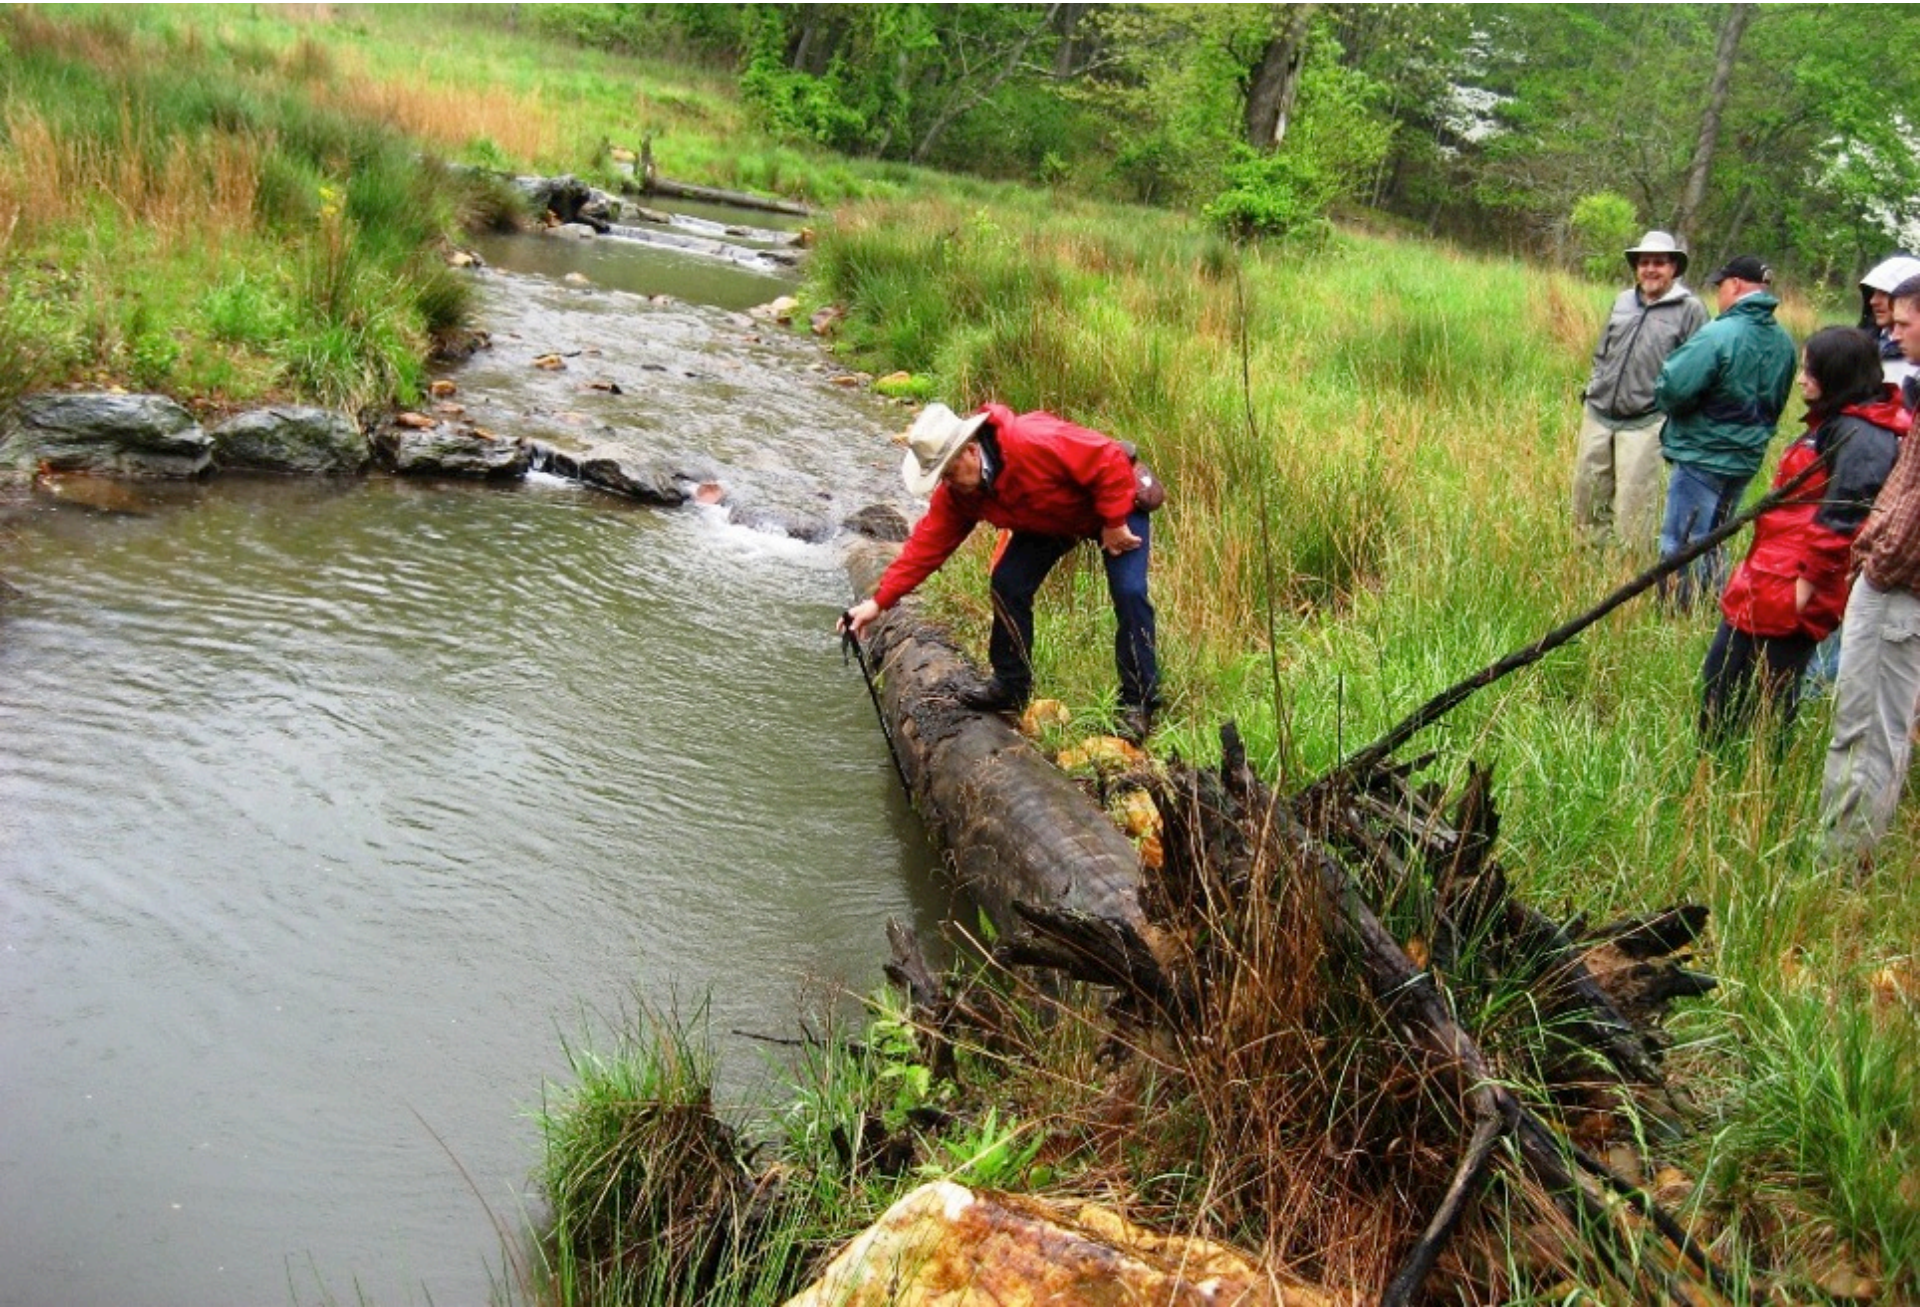
Log J-Hook Vane: Flow direction, bank protection, habitat

Arm slope = $1.2 / 30 = 4\%$; Arm angle = 25 degrees
