Stream Restoration Implementation

Greg Jennings, PhD, PE
jenningsenv@gmail.com

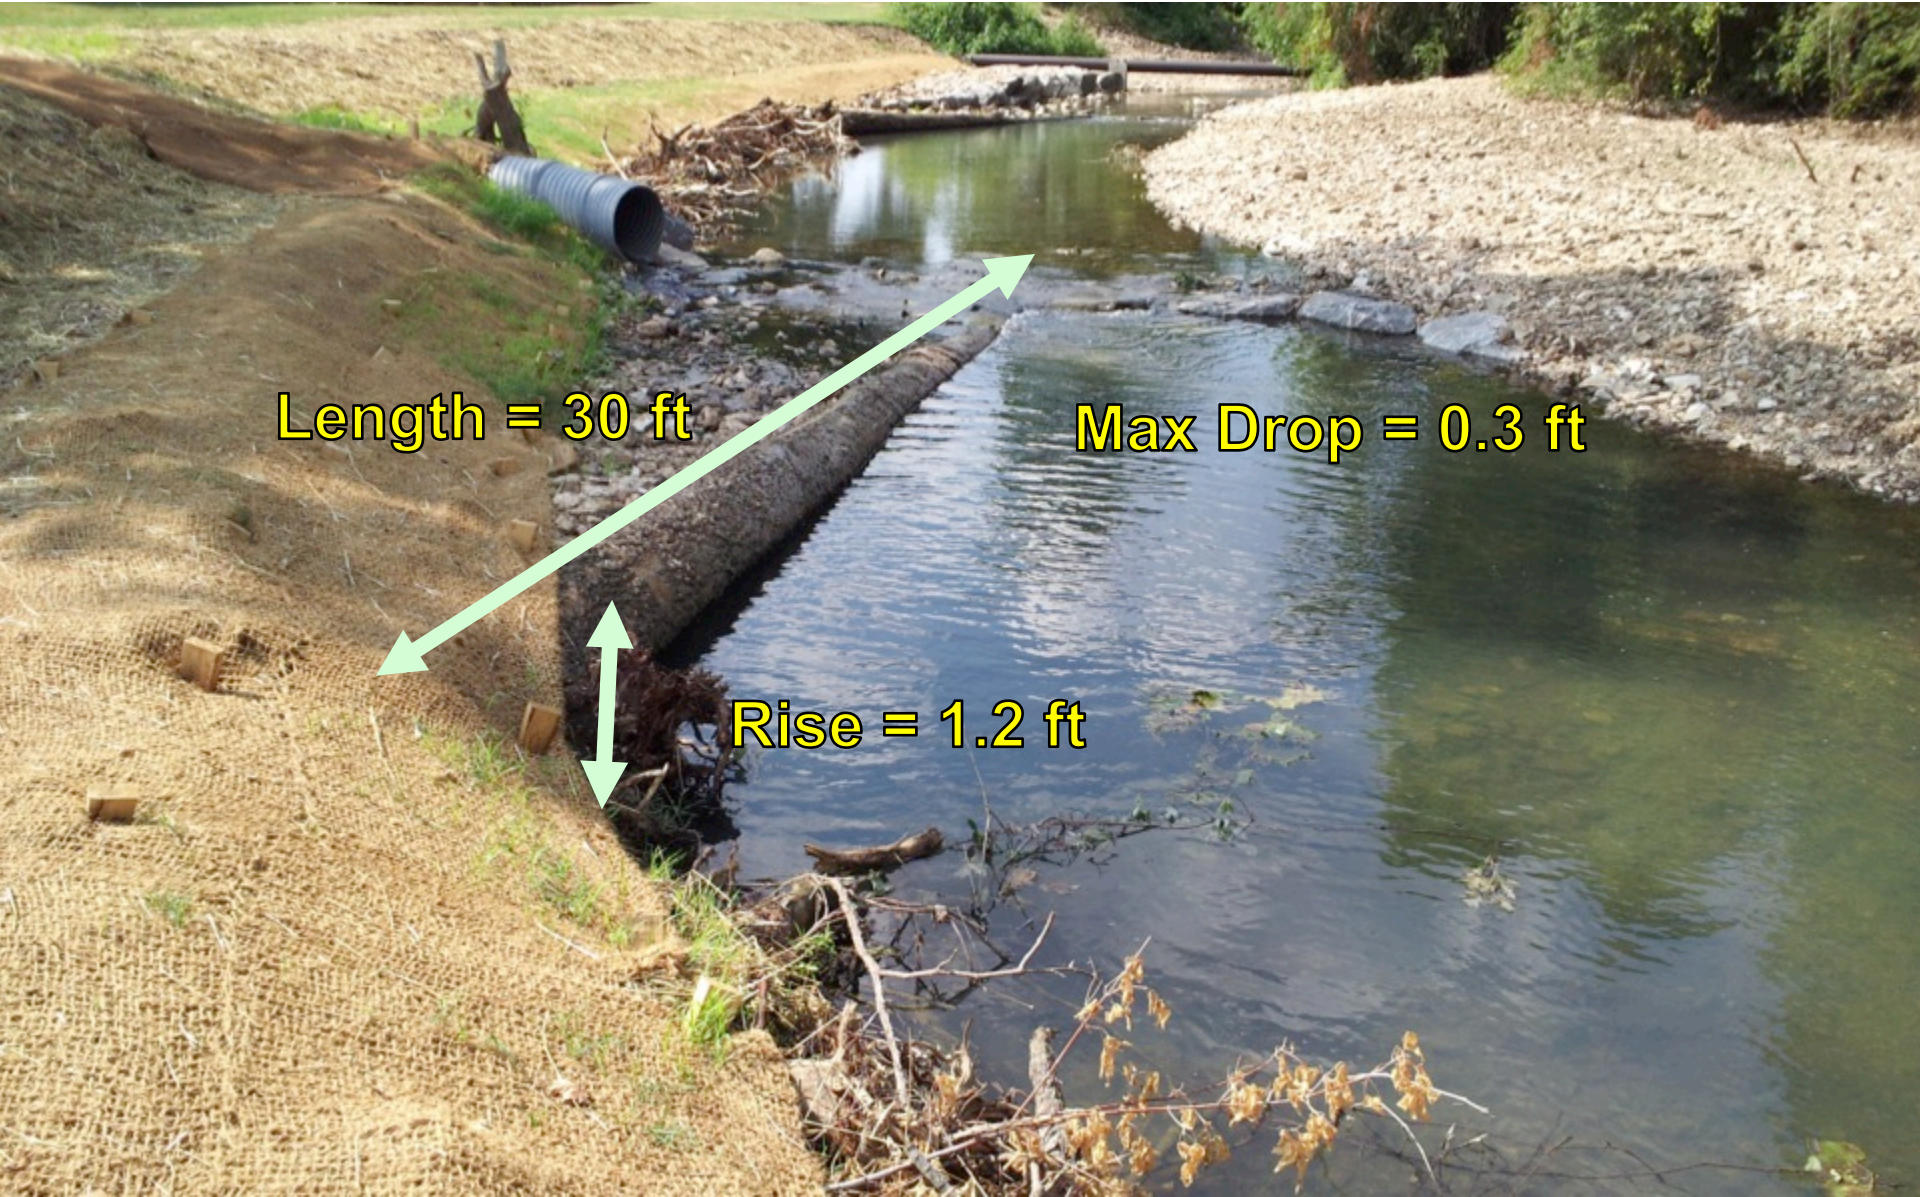
Storm Flow: Flow direction + Bank protection

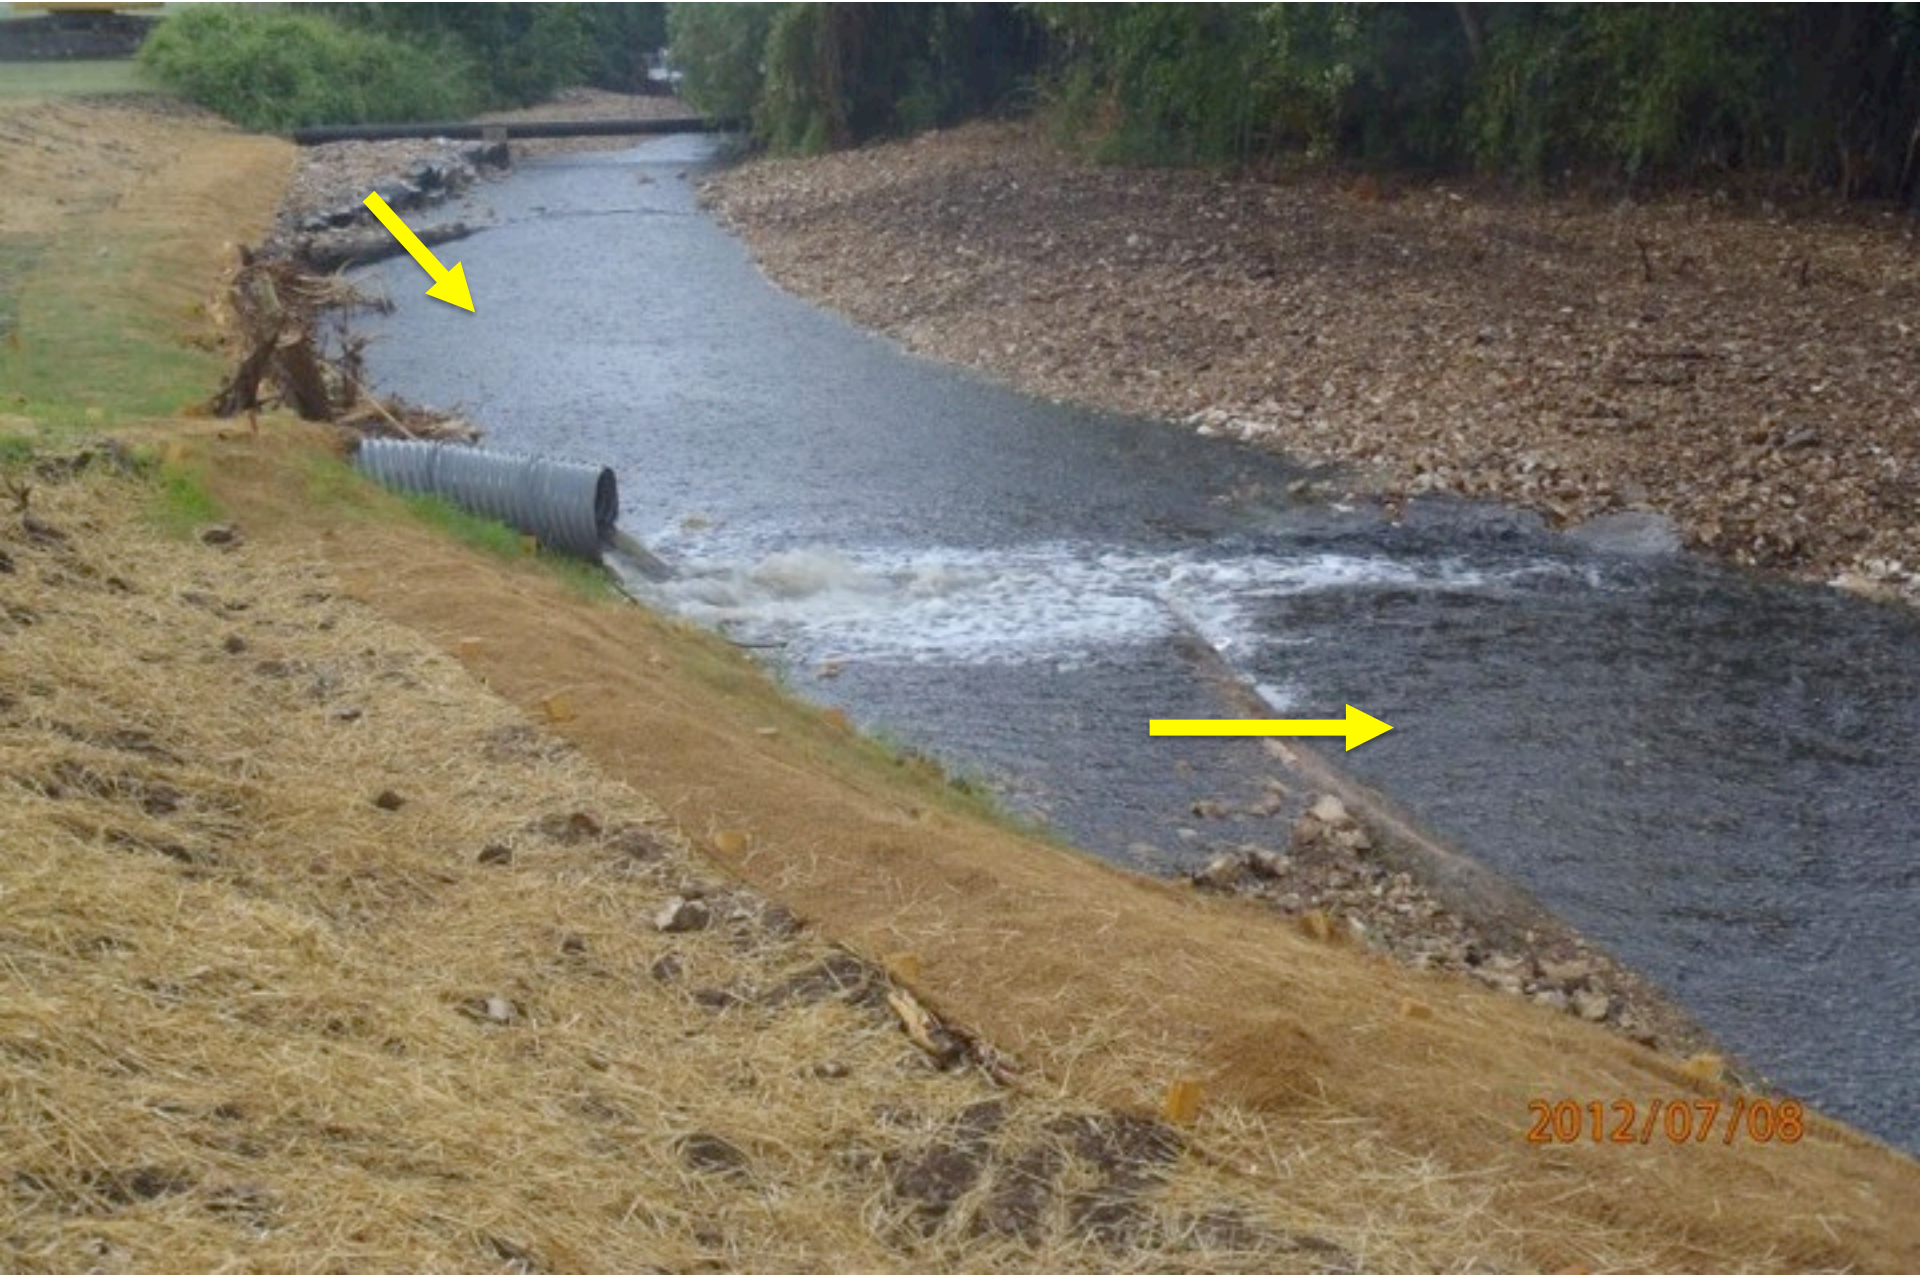
Boulder Cross Vane

- Direct flow in new channel alignment
- Grade control and scour pool
- Footer boulders & geotextile

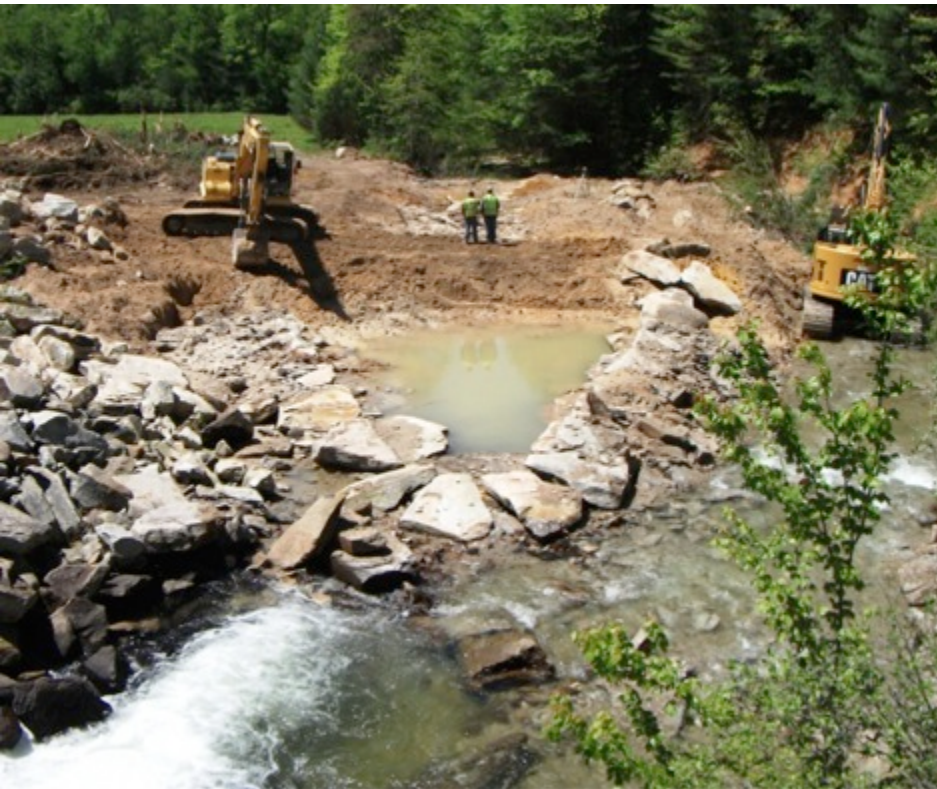
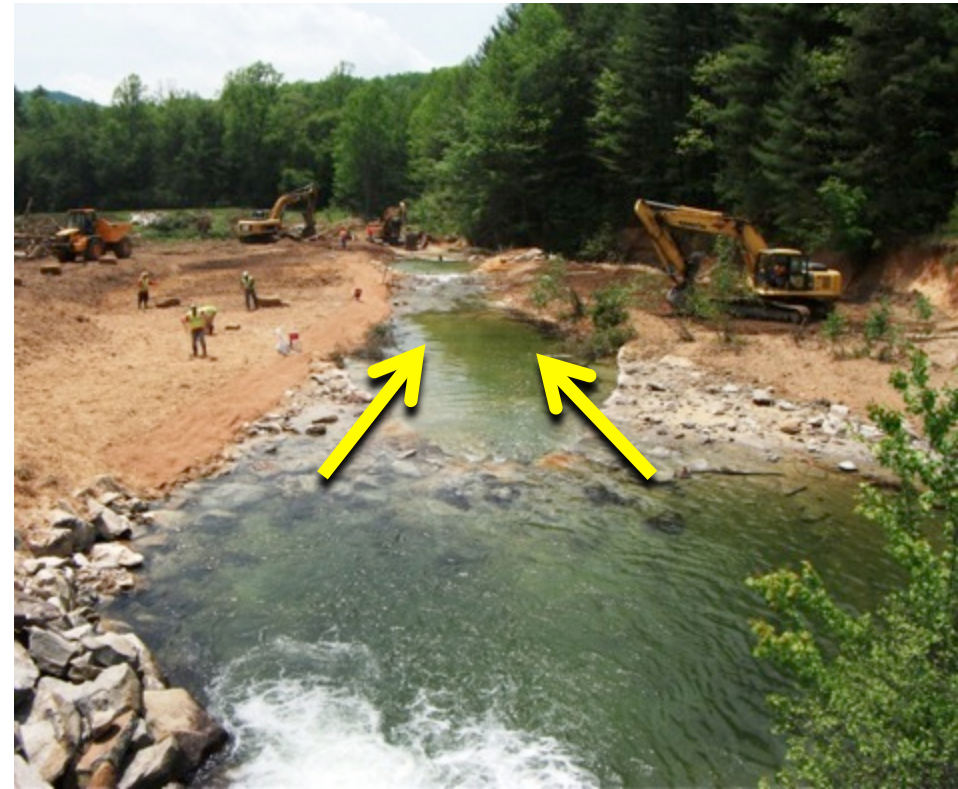
Cross Vanes for flow direction & grade control

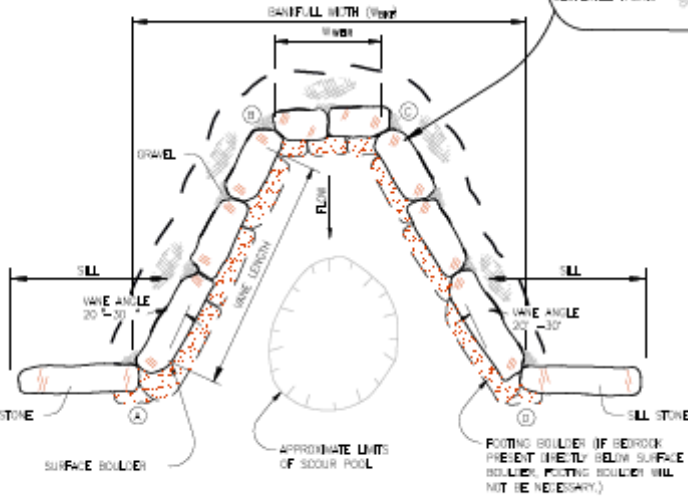
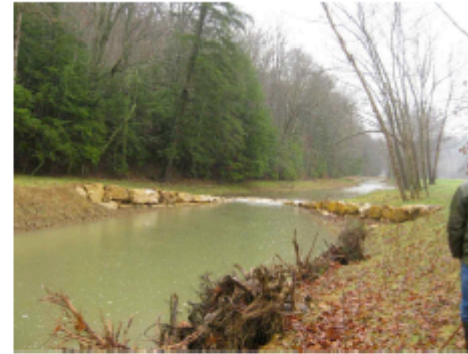
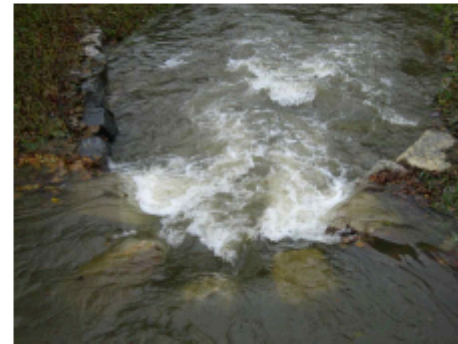
CROSS-VANE PLAN VIEW

CROSS VANE TYPICAL CROSS-SECTION

CROSS VANE LONGITUDINAL PROFILE

1. FOOTING BOLLIER ARE BOLLIER PLACED TO PROVIDE A FOUNDATION FOR THE SURFACE BOLLIER IN EACH STEP CROSS VANE. FOOTING BOLLIER SHALL BE DURABLE LIME-STONE OR DOLOMITE WITH A MINIMUM DIAMETER OF 4 FT. TYPICALLY, FOOTING BOLLIER ARE BURIED IN THE CHANNEL BOTTOM AND NOT SEEN WHEN THE STRUCTURE IS COMPLETED. ALL SURFACE BOLLIER FOR ALL ROCK STRUCTURES REQUIRE FOOTING BOLLIER. IF BEDROCK IS PRESENT SHORTLY BELOW THE SURFACE BOLLIER, THE FOOTING BOLLIER MAY BE OMITTED AT THE DISCRETION OF PM/SA.

2. SURFACE BOLLIER ARE THE TOP MOST COURSE OF BOLLIER USED IN EACH STEP CROSS VANE. ALL SURFACE BOLLIER CAN BE SEEN PROTRUDING FROM THE WATER SURFACE DURING EXTREMELY LOW FLOWS. SURFACE BOLLIER SHALL BE DURABLE LIME-STONE OR DOLOMITE WITH A MINIMUM DIAMETER OF 4 FT.

3. THE VANE LENGTH IS THE STRAIGHT LINE PORTION OF CROSS VANE STRUCTURE, MEASURED FROM THE STREAM BANK AT BANKFULL ELEVATION TO THE CHANNEL BED.
4. THE VANE ANGLE IS THE SMALLEST ANGLE MEASURED BETWEEN A VANE AND A LINE TANGENT TO BANKFULL ELEVATION AT THE POINT WHERE THE VANE INTERSECTS THE BANK.

5. CONSTRUCT STEP CROSS VANE STRUCTURES BY FIRST SHARPEN THE BANK TO THE GRADES SPECIFIED. NEXT EXCAVATE ENOUGH BED MATERIAL TO PLACE THE BOLLIER, GEOTEXTILE FABRIC AND GRAVEL OVERLAY. ONCE THE HEIGHT HAS BEEN ESTABLISHED, THE REMAINDER OF THE FOOTING AND SURFACE BOLLIER SHALL BE PLACED, MINORING VOIDS. PLACE GEOTEXTILE FABRIC AT THE UPSTREAM FACE OF THE STRUCTURE AS SHOWN AND BANKFULL (OVERLAY) WITH GRAVEL. FILL THE VOIDS ON THE UPSTREAM SIDE OF SURFACE BOLLIER WITH GRAVEL. DO NOT LEAVE EXPOSED GEOTEXTILE FABRIC AND THEN EXPOSED GEOTEXTILE FABRIC. ONCE STRUCTURE IS INSTALLED, EXCAVATE SCOUR POOL AND PLACE GRAVEL SUBSTRATE AS REQUIRED. RE-WEDGING OF CHANNEL AND BANKFULL BEHIND FLOODPLAIN WILL LIKELY BE REQUIRED FOLLOWING INSTALLATION OF IN-STREAM STRUCTURE AND SHALL BE CONSIDERED INCIDENTAL TO CONSTRUCTION.

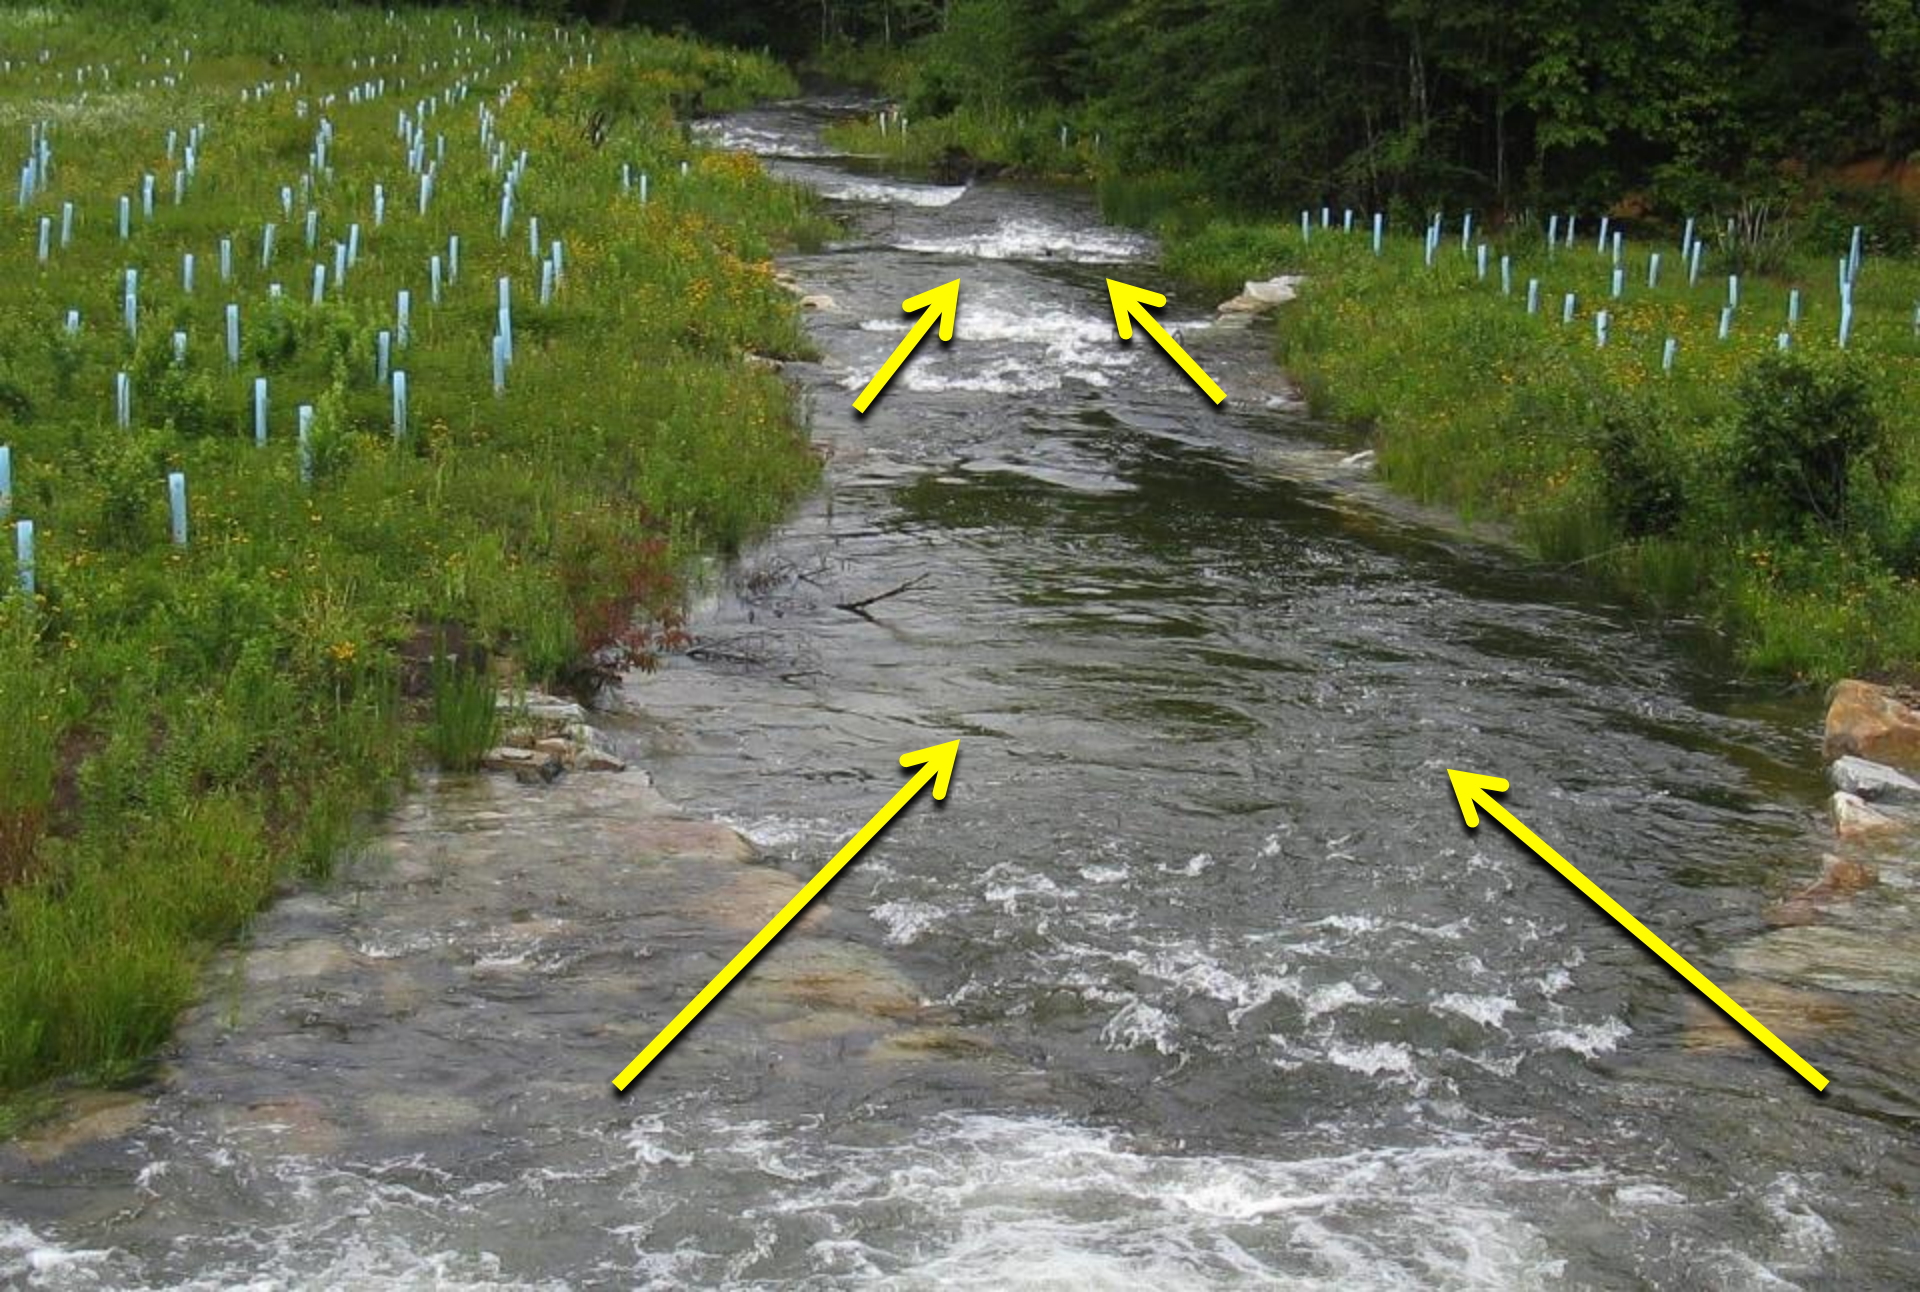
Boulder Cross Vanes: *Grade Control*

Double-Drop Boulder Cross Vane

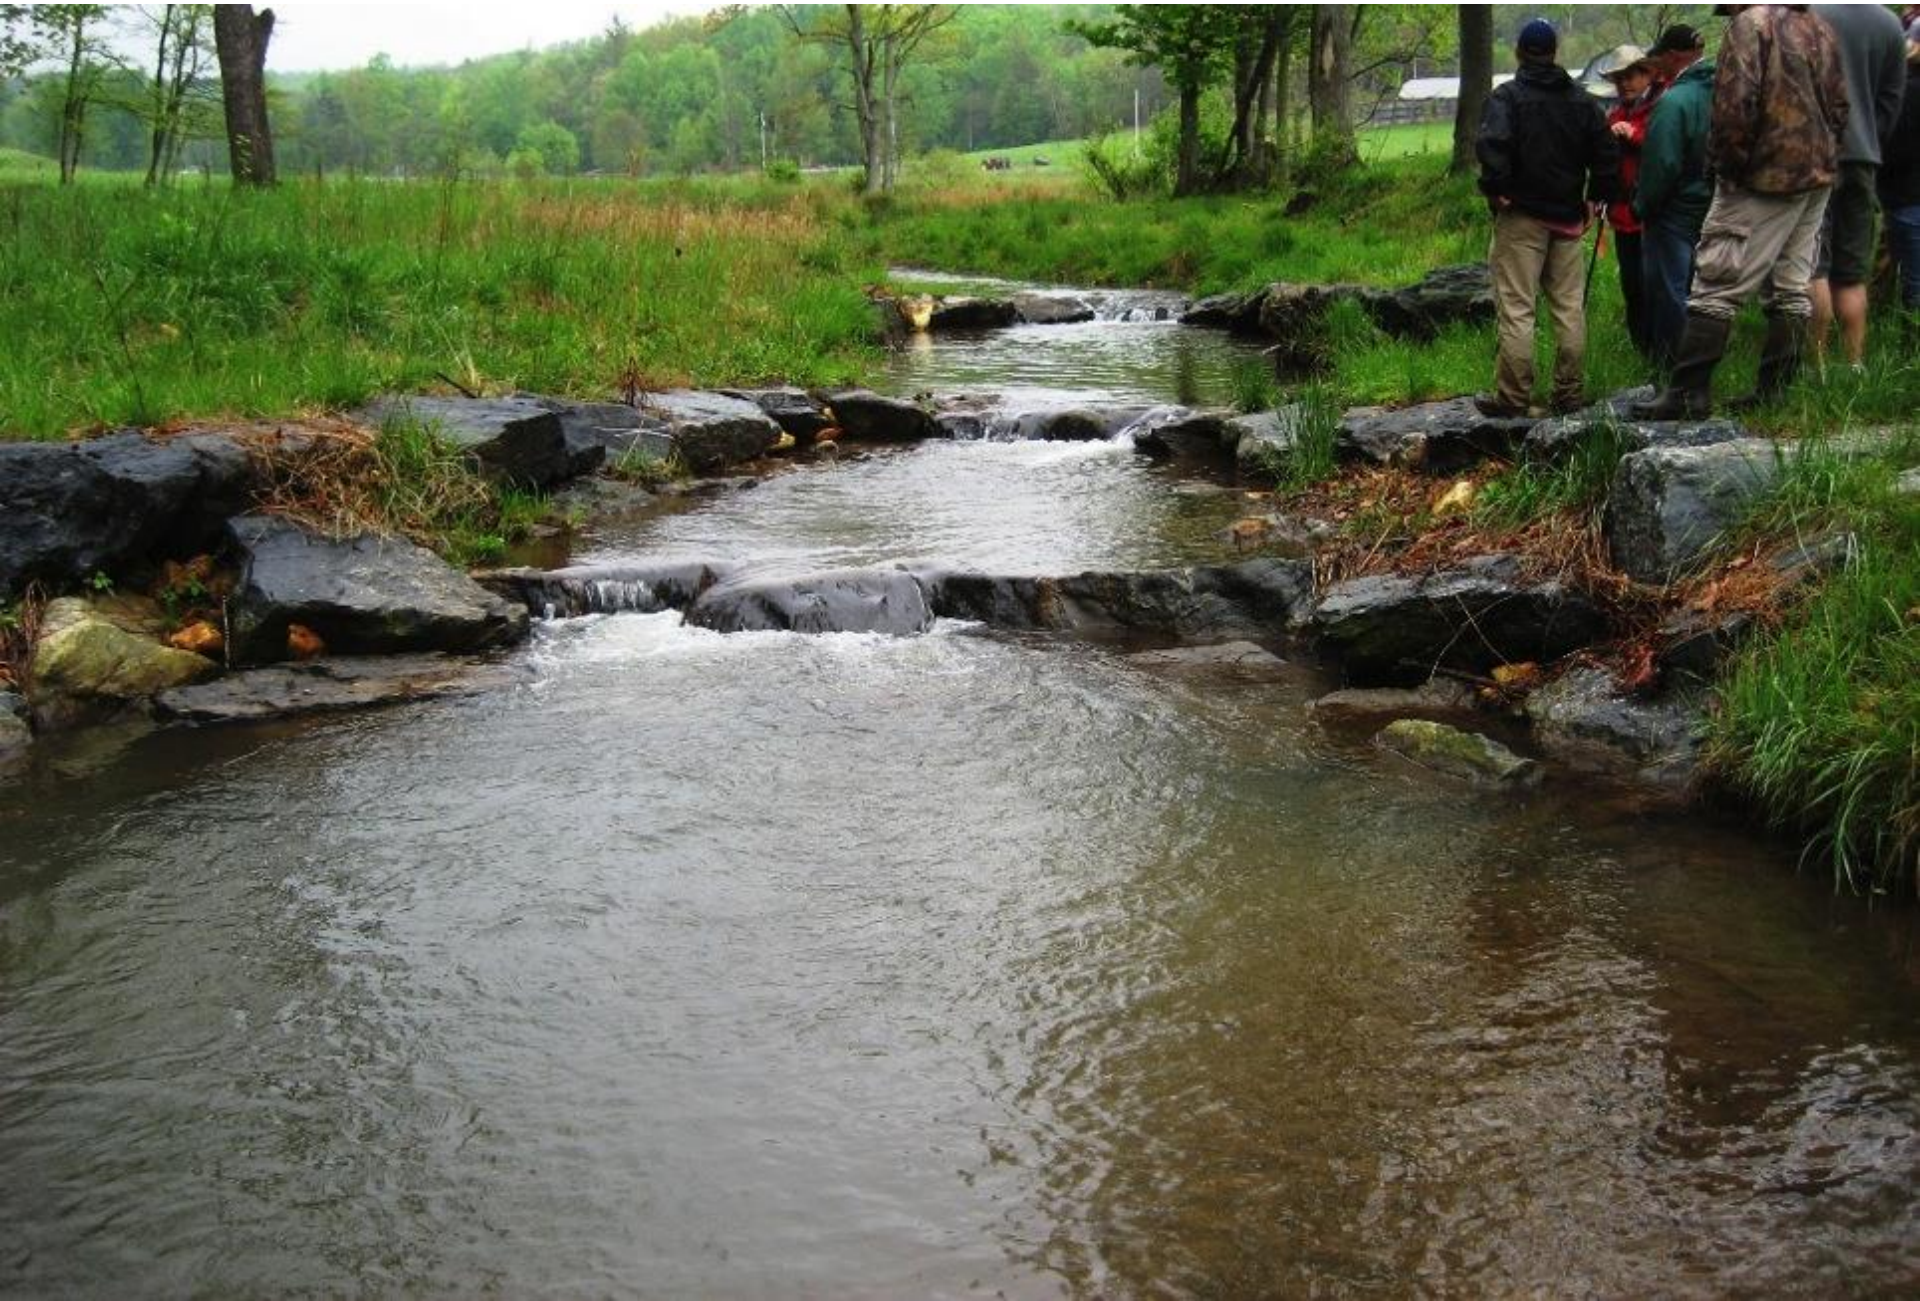
Double-Drop Offset Boulder Cross Vane

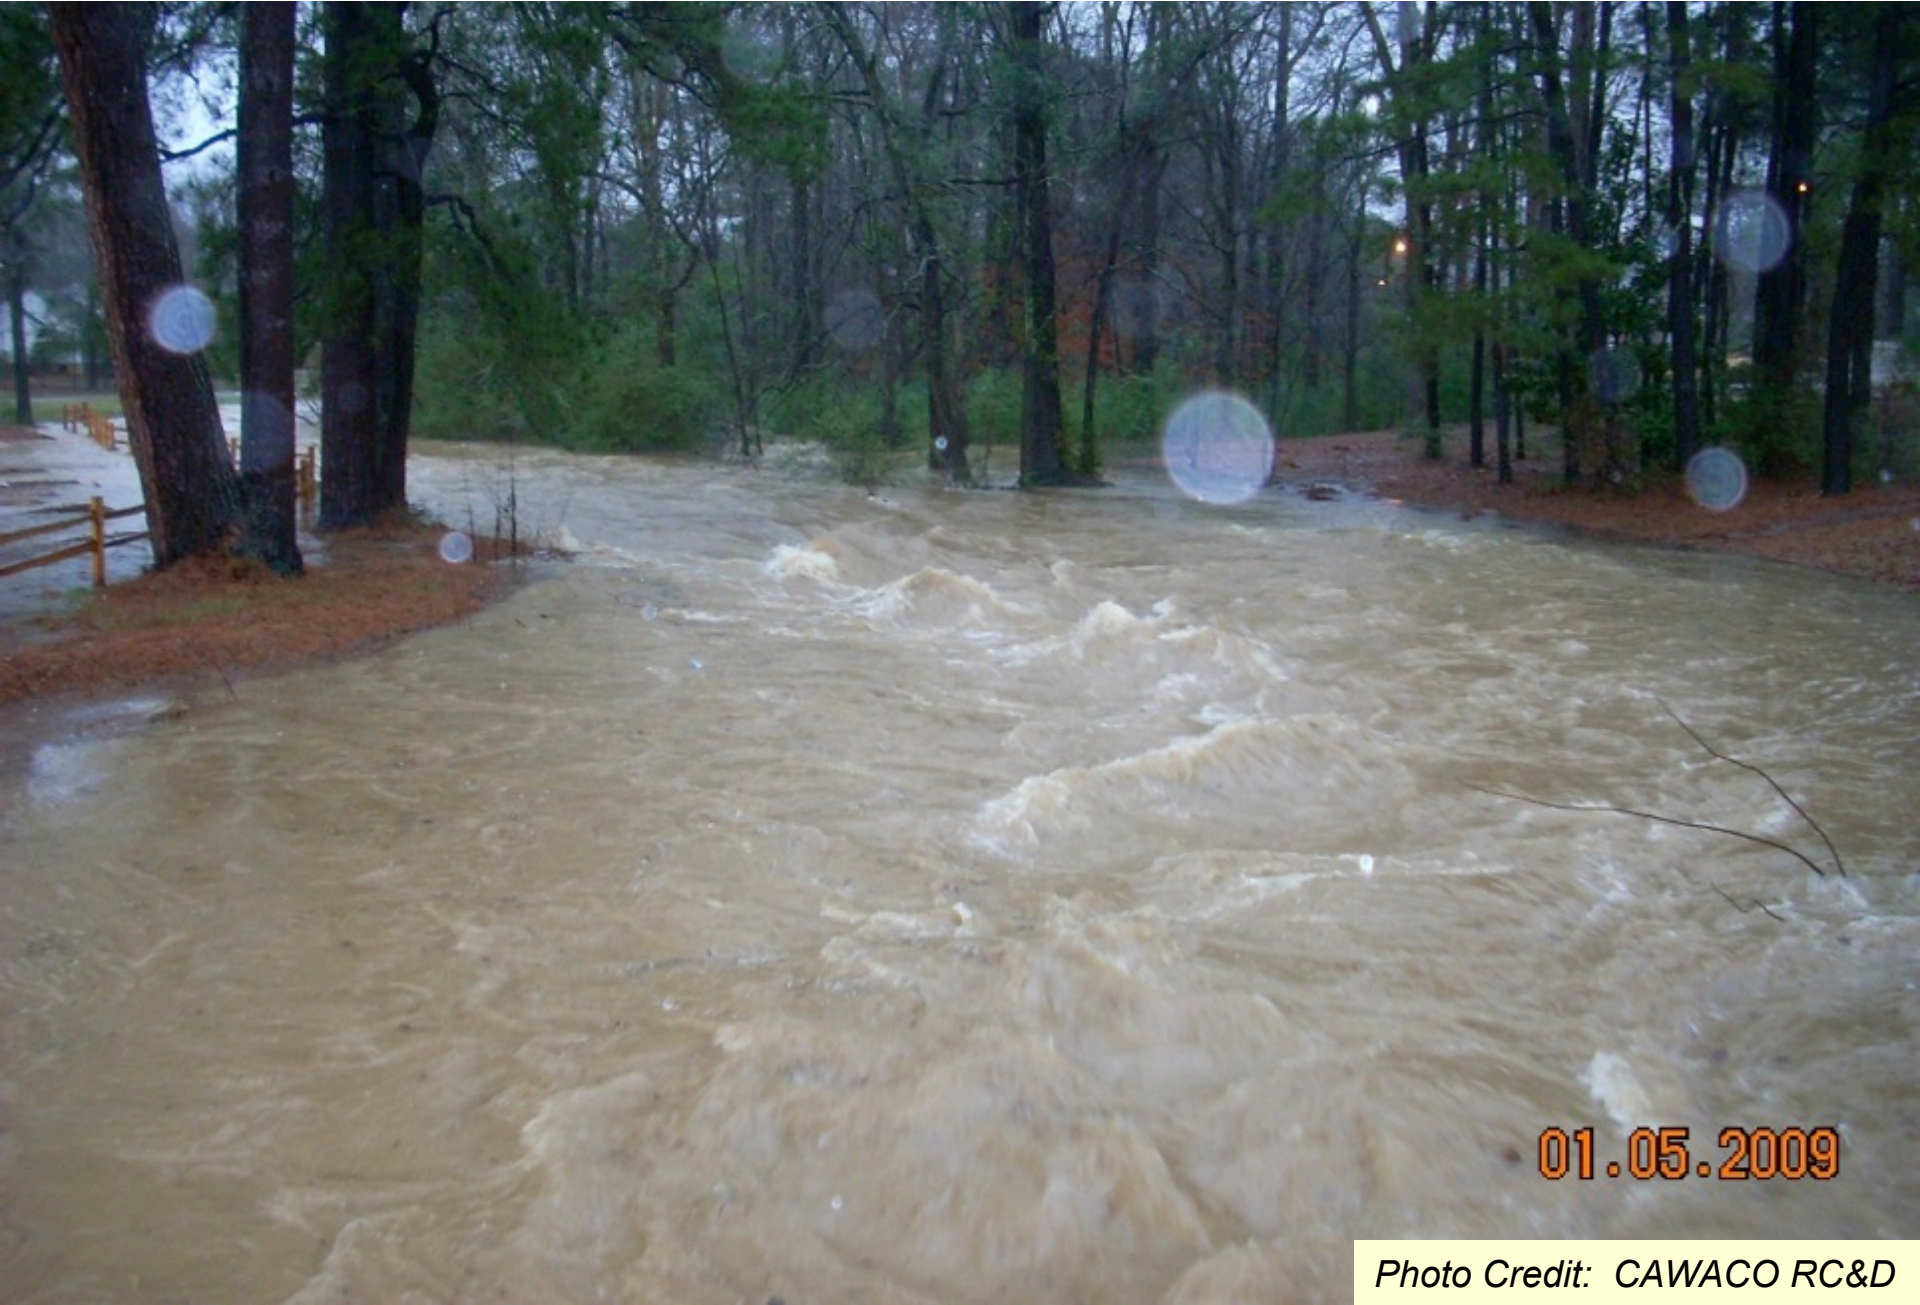
Cross-Vane (Double-Drop): Grade control, flow direction, scour

Arm slope = $2.5 / 50 = 5\%$; Arm angles = 25 degrees

Max drop over each step = 0.5 ft

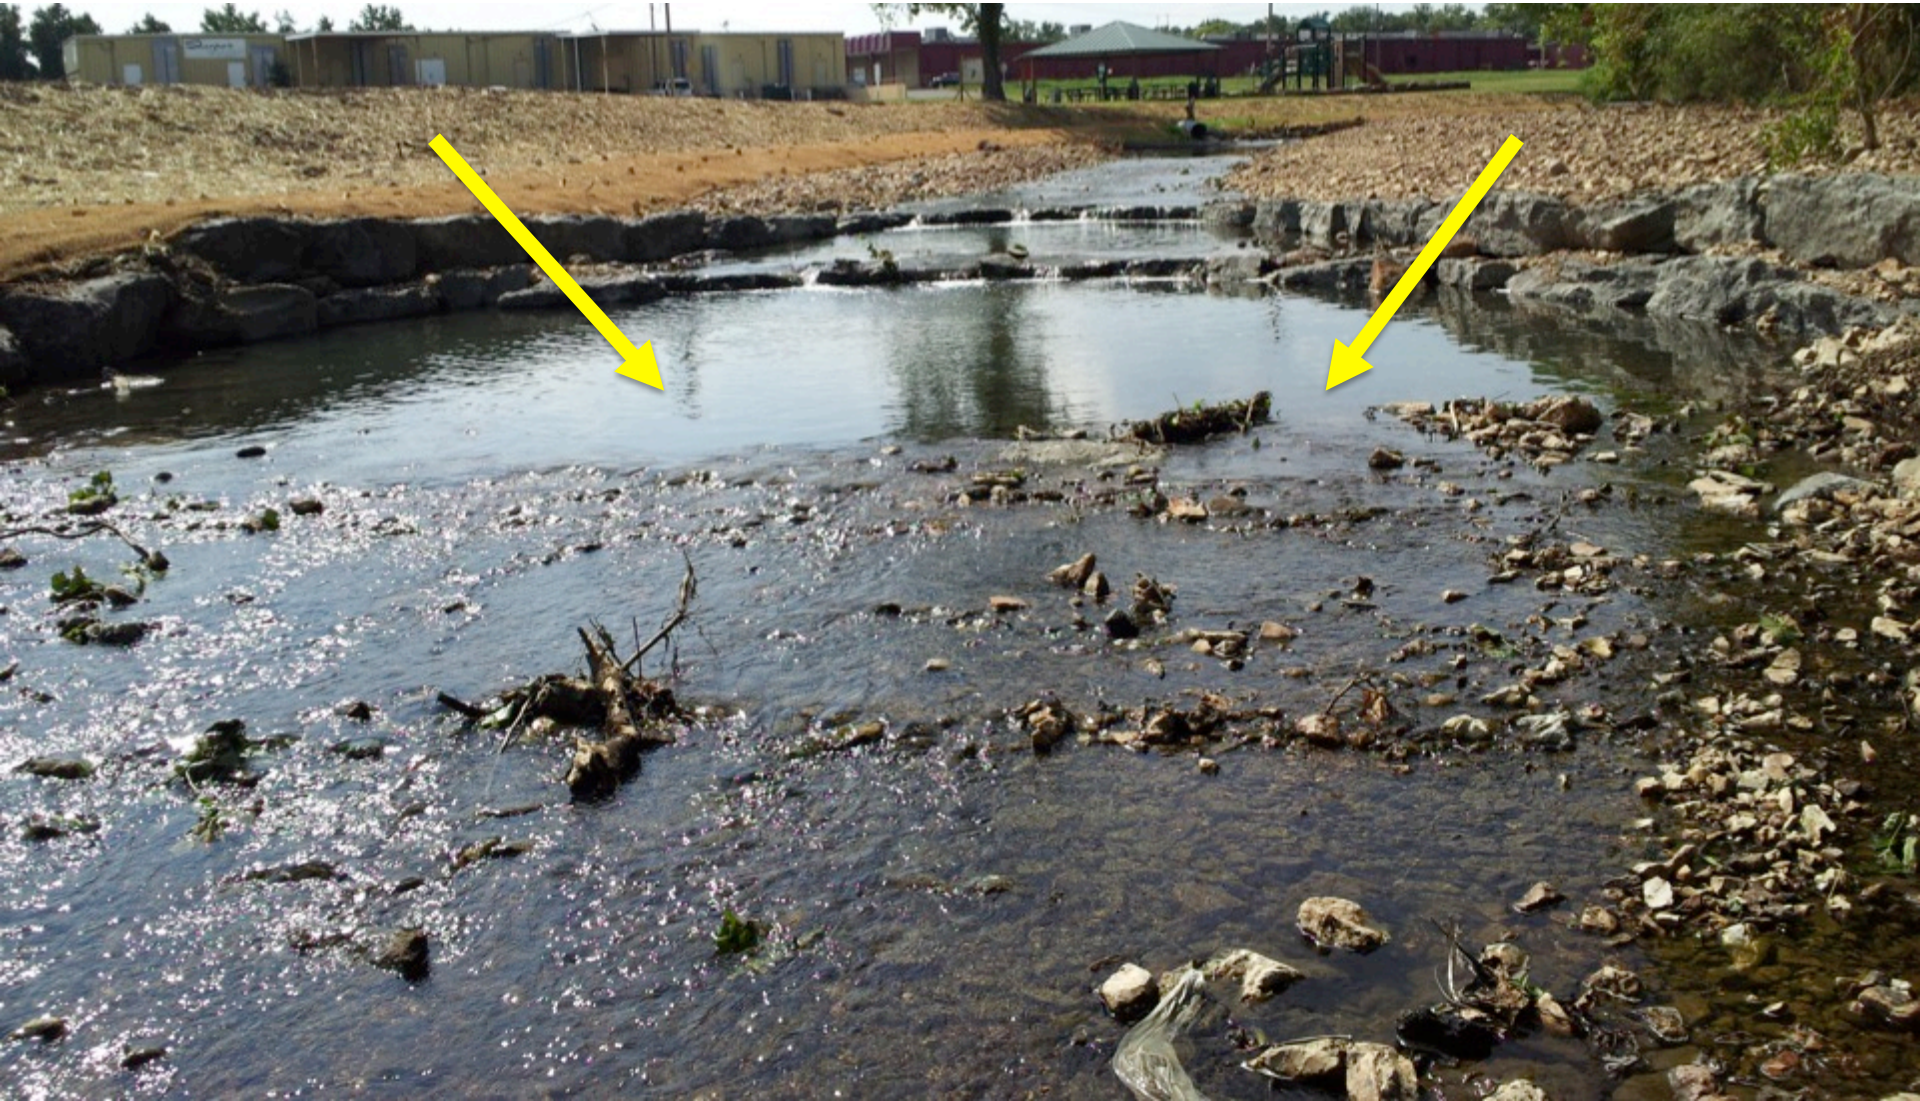
Riffle Morphology: Bankfull Width = 25 ft; Depth = 2.2 ft

Floodprone Width = 55 ft

Entrenchment Ratio, $ER = 55/25 = 2.2$

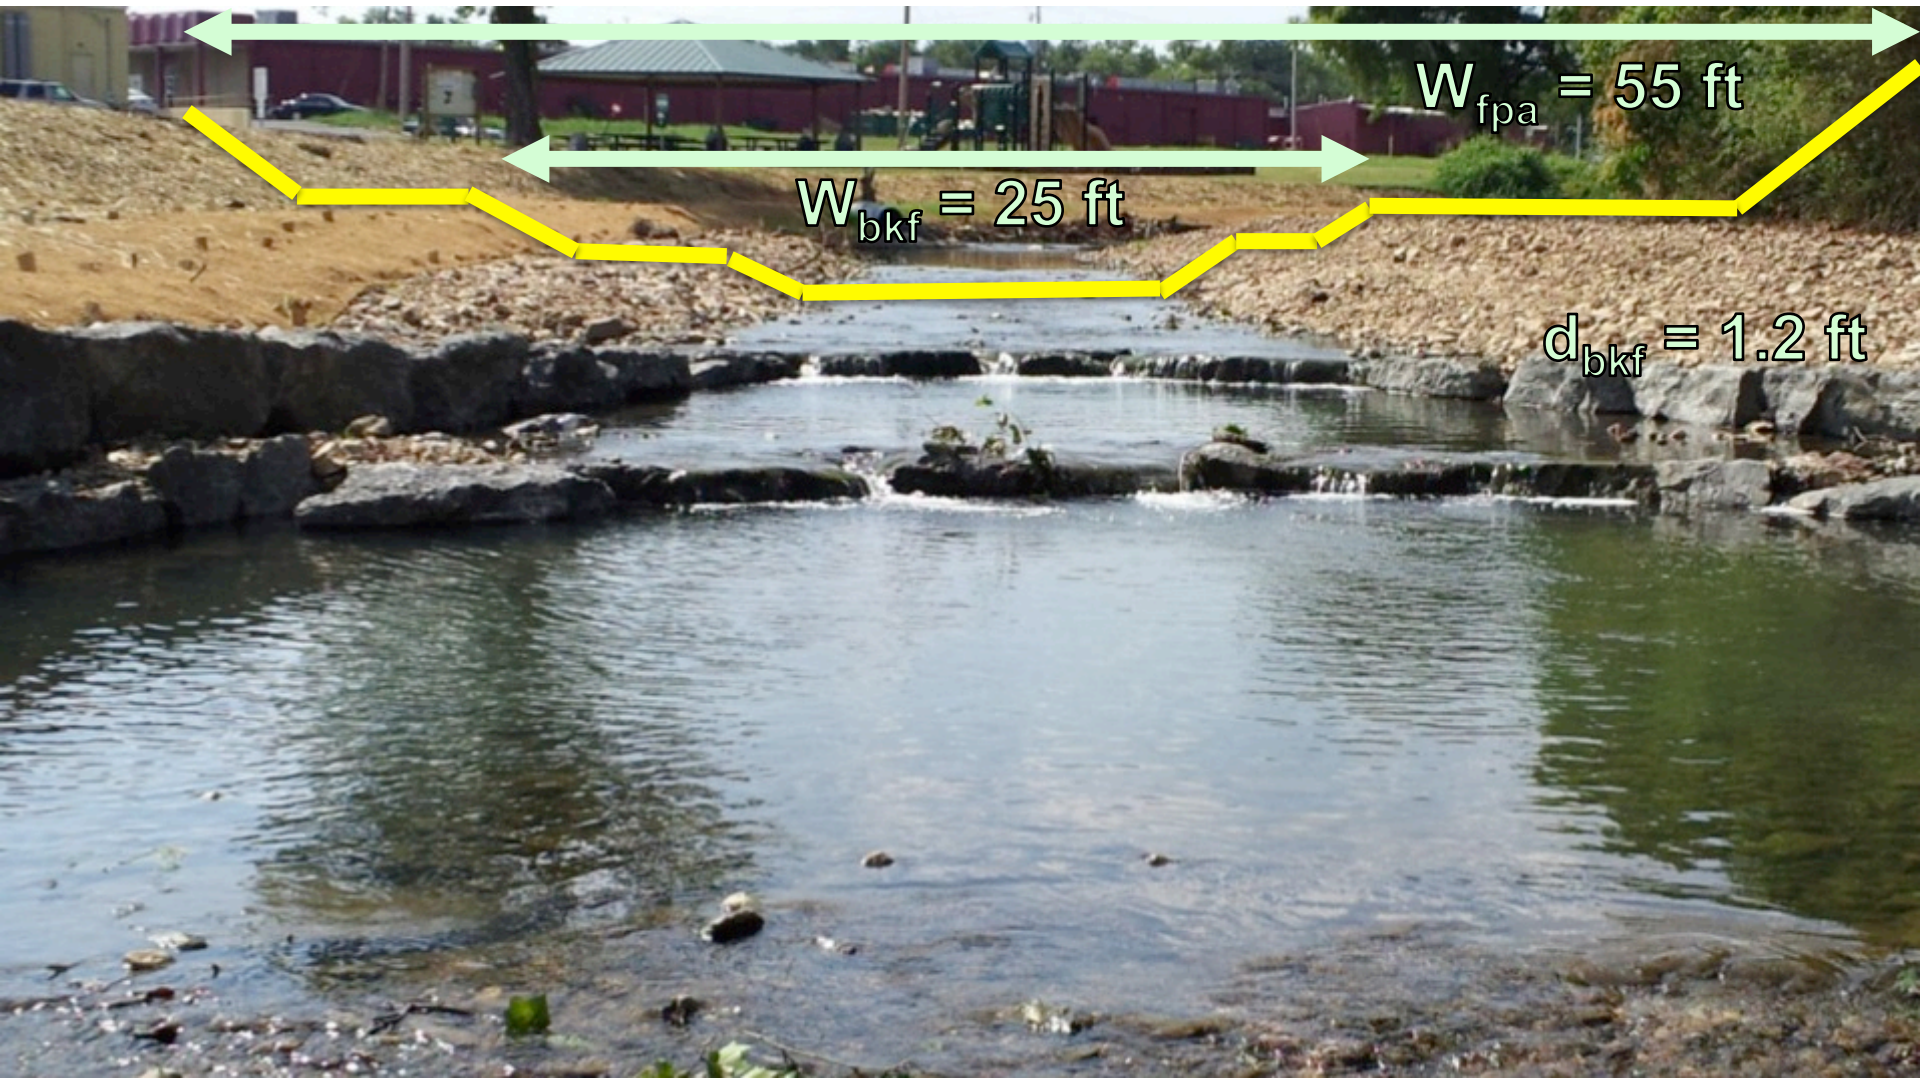
Cross Vane (logs embedded)

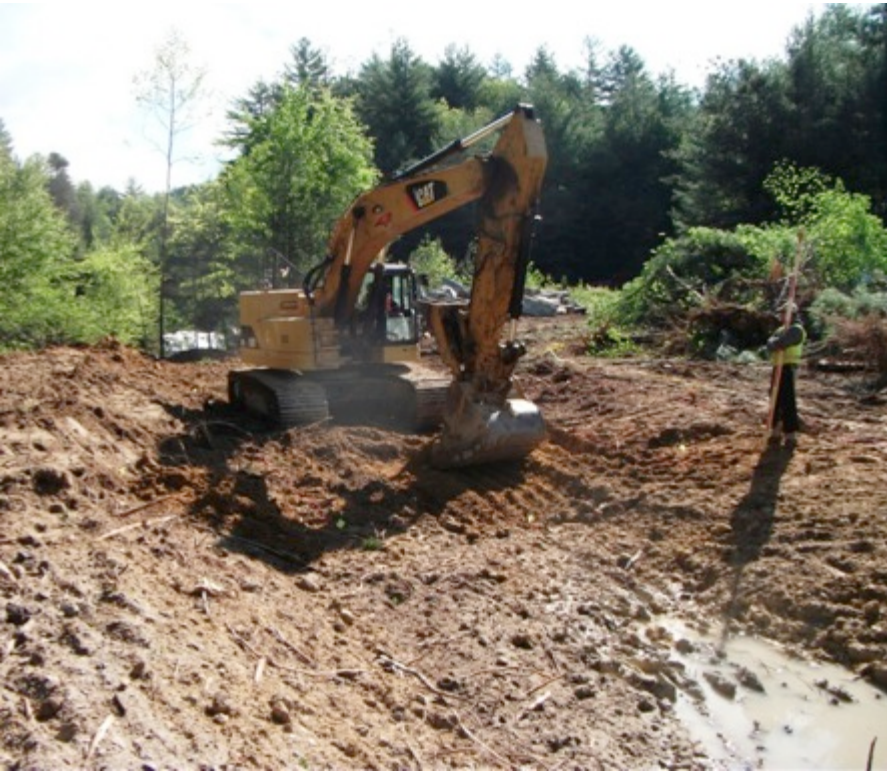
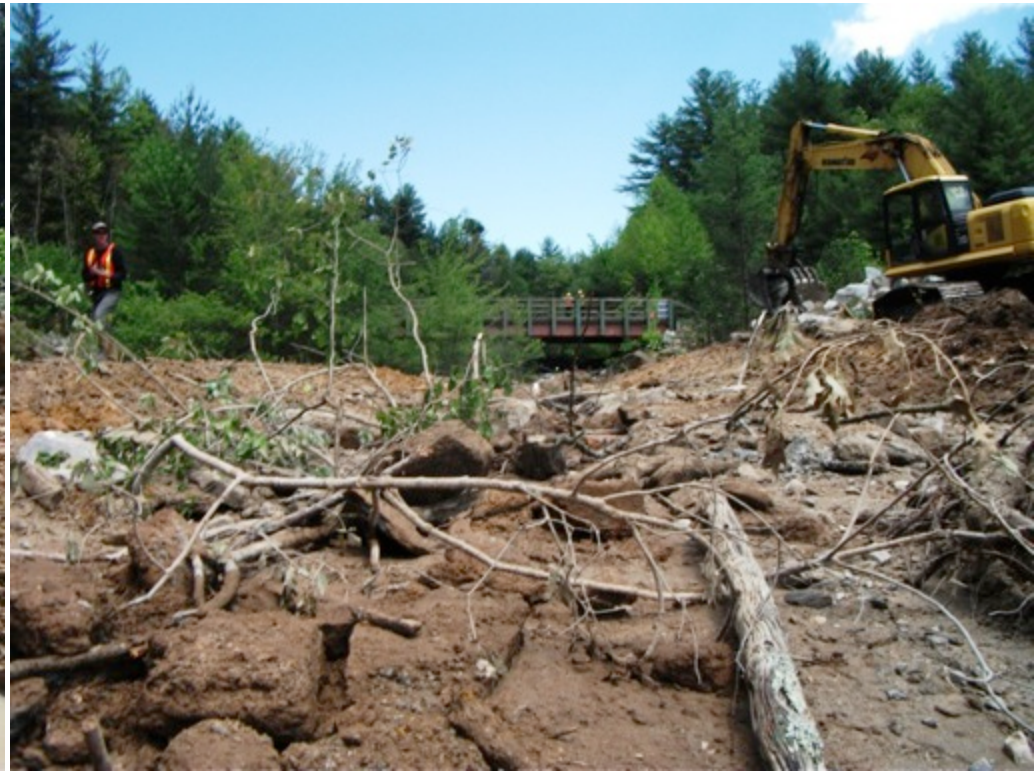
Constructed Riffle with Embedded Wood

- Undercut bed 2 ft and backfill with gravel, cobble, boulders, wood
- Cut thalweg 0.5 ft deep

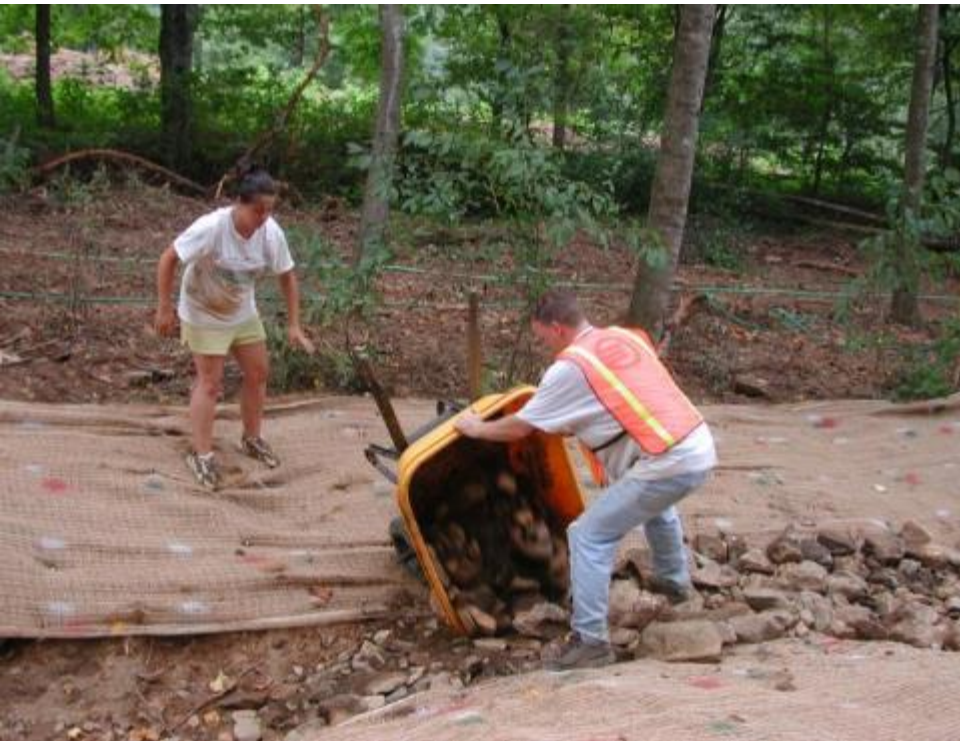
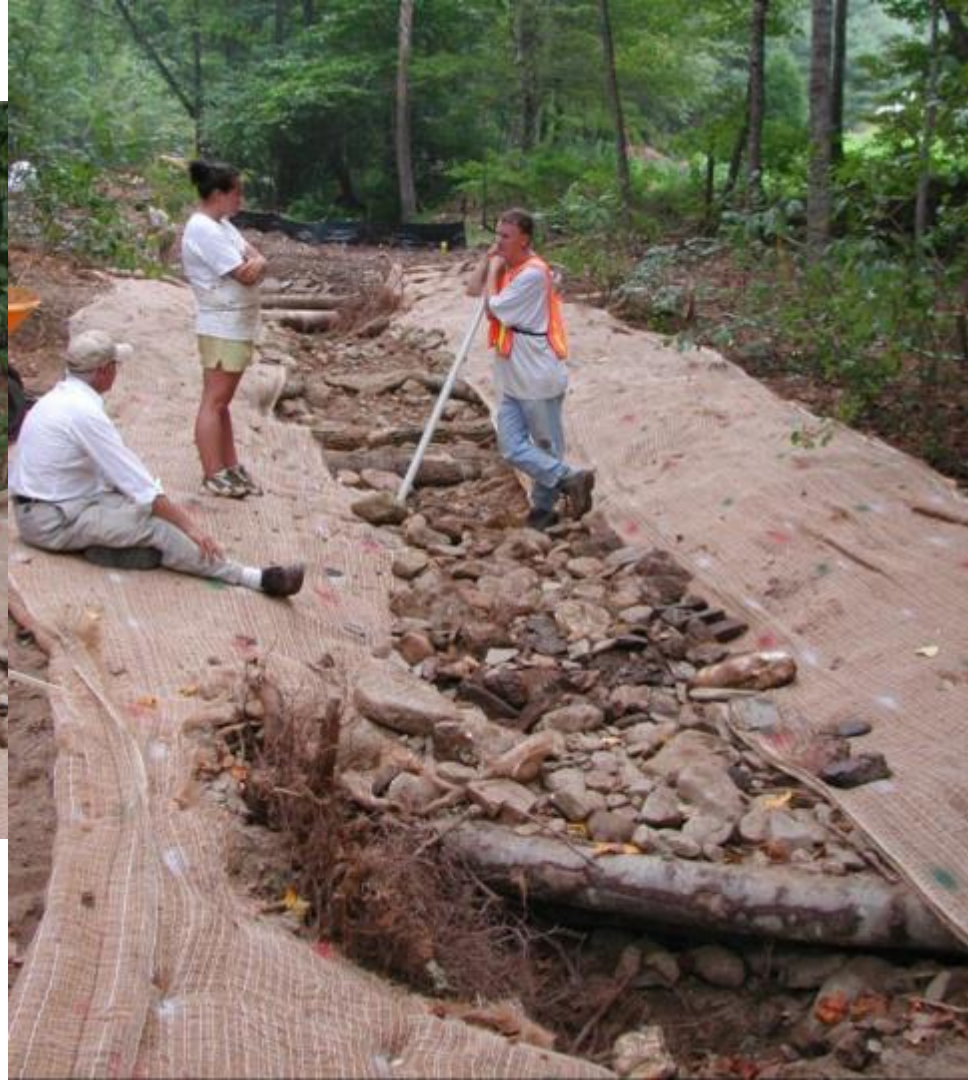
1st Order Streambed Transplant

Substrate transfer from old channel to new channel
