Stream Restoration Implementation

Greg Jennings, PhD, PE
jenningsenv@gmail.com

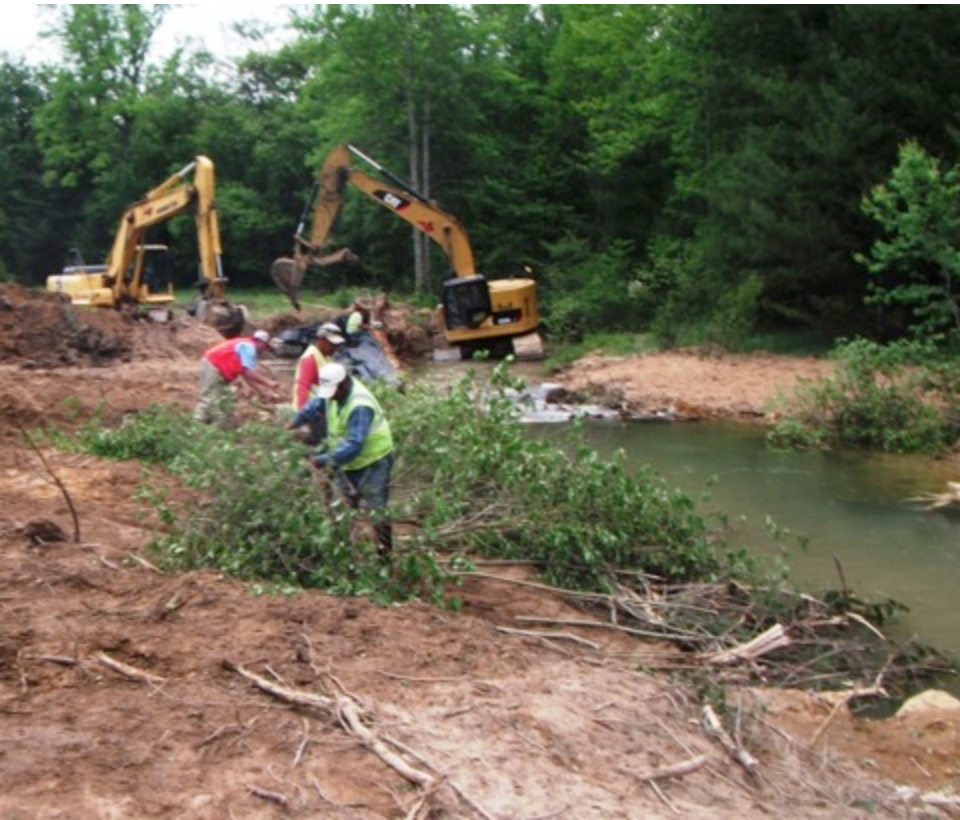
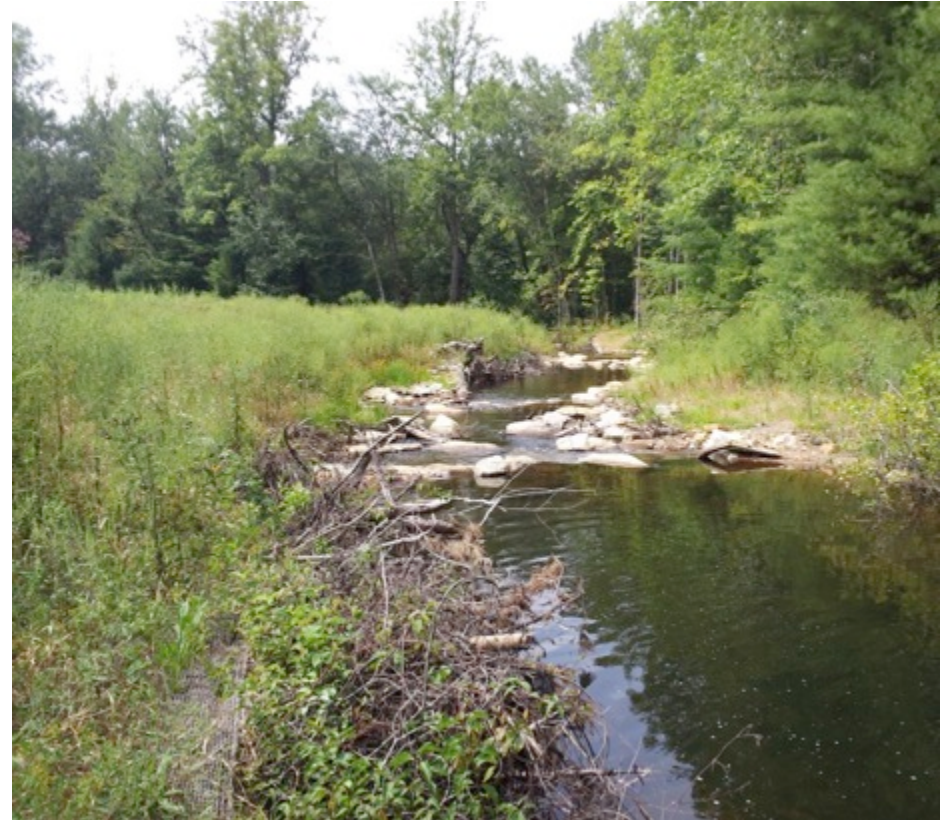
Toe Wood Revetment

- Layers of logs and brush under water in pools
- Live cuttings above water (silky dogwood, elderberry)
- Matting, seed, transplanted alders on top

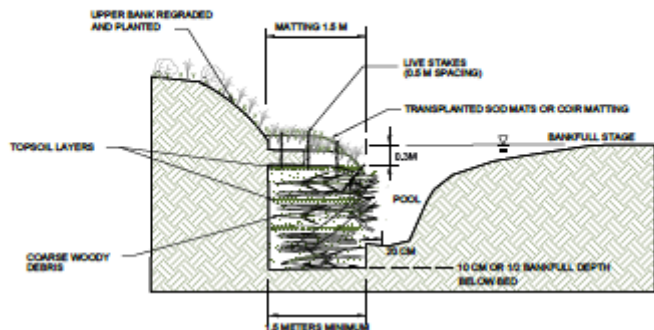
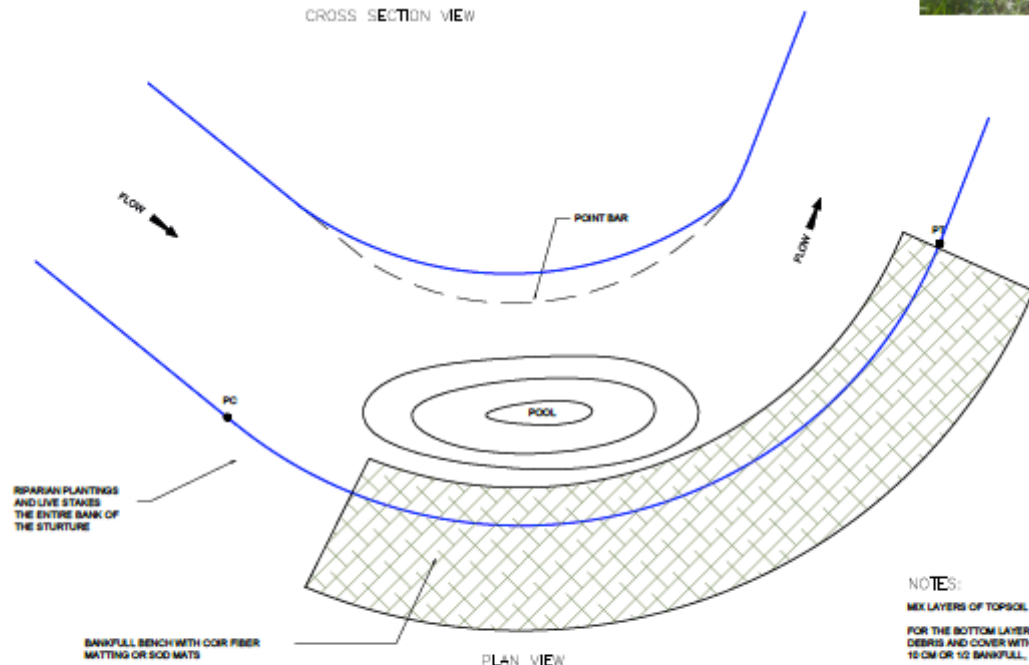
CROSS SECTION VIEW

Toe Wood for bank protection, roughness, habitat

MIX LAYERS OF TOPSOIL ON TOP OF COARSE WOODY DEBRIS.

FOR THE BOTTOM LAYER, INSTALL LIVE STAKES ON TOP OF COARSE WOODY DEBRIS AND COVER WITH A LAYER OF TOPSOIL. THIS SHALL BE AT A DEPTH OF 10 CM OR 10 BANKFULL, BELOW THE BOTTOM OF THE BED.

WOODY DEBRIS SHALL NOT EXTEND INTO THE CHANNEL MORE THAN 30 CM.

Detail - Toe Wood Sod Mats

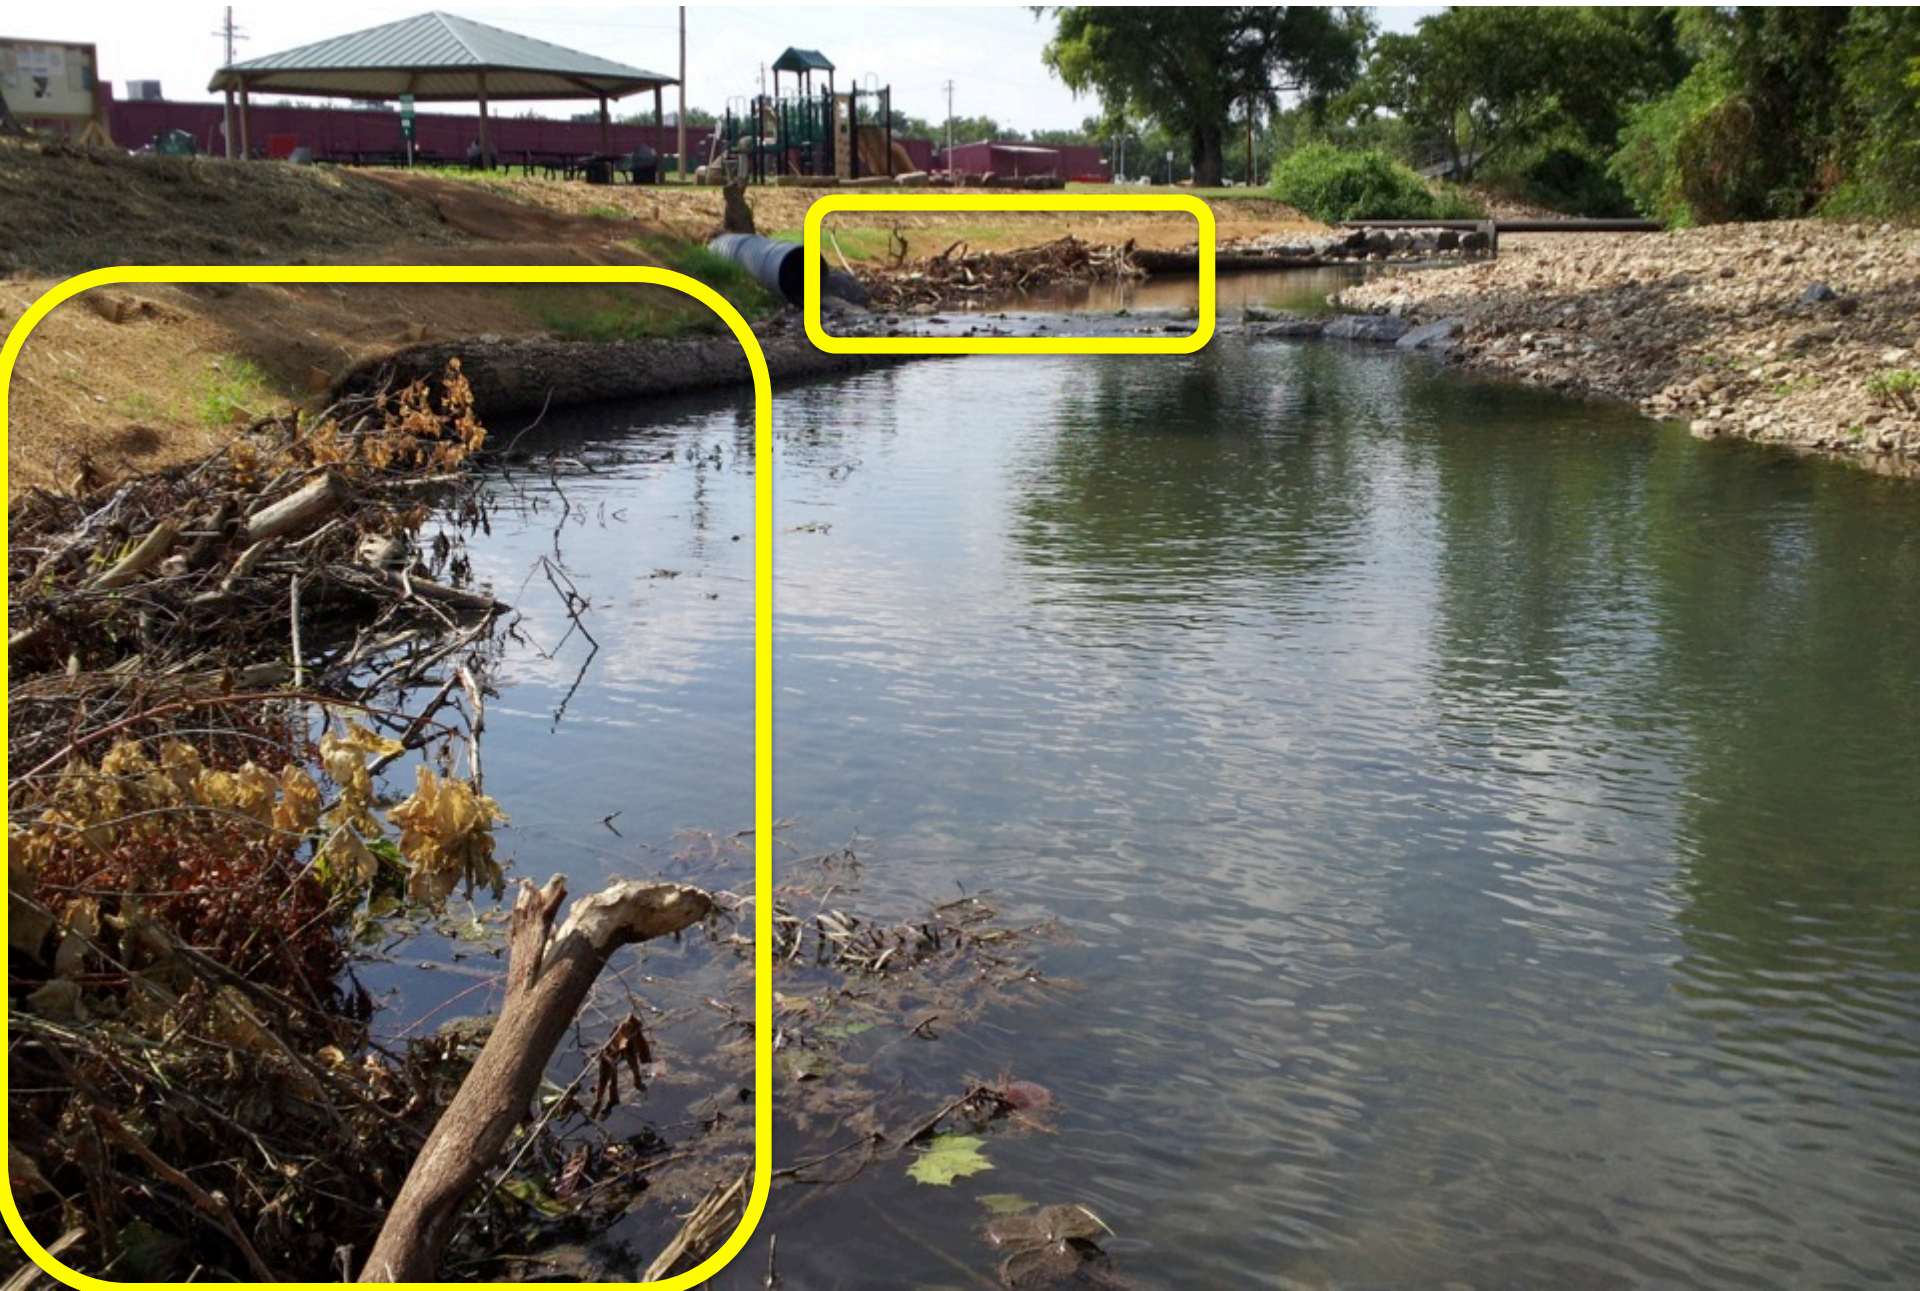
Toe Wood for bank protection, roughness, habitat

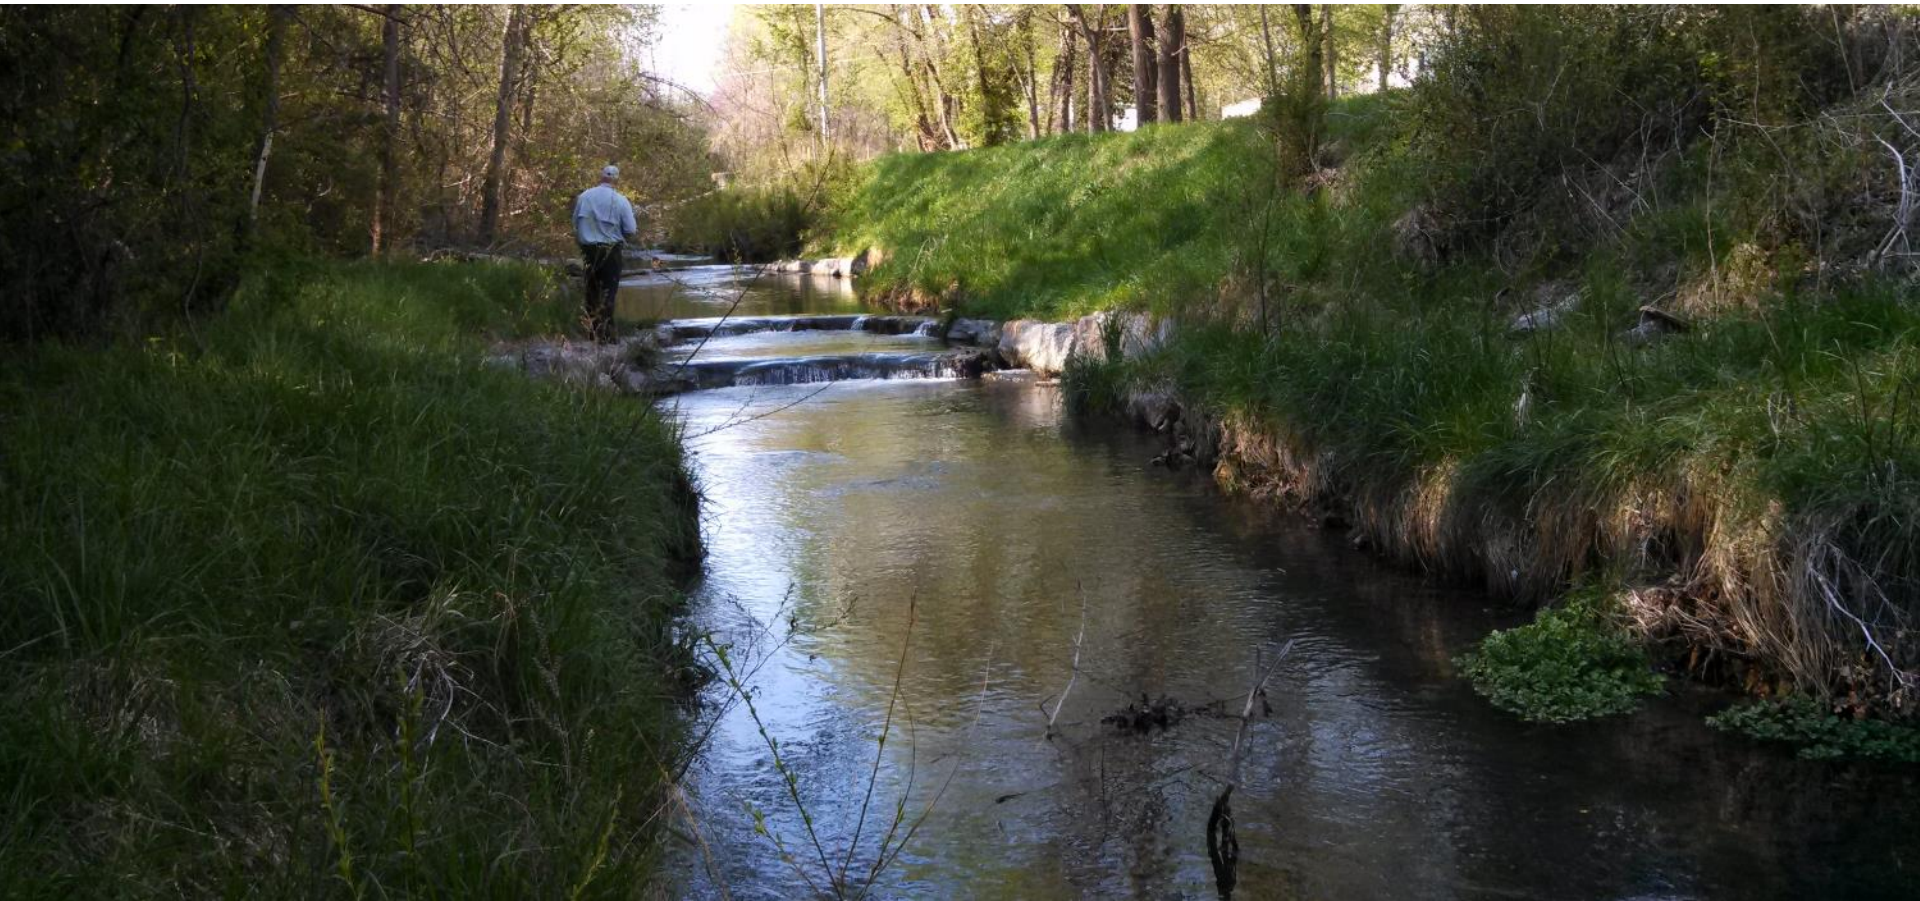
Successful Structures

- Properly designed and located
- Low profile
- Constructed to withstand stress
- Excellent vegetation

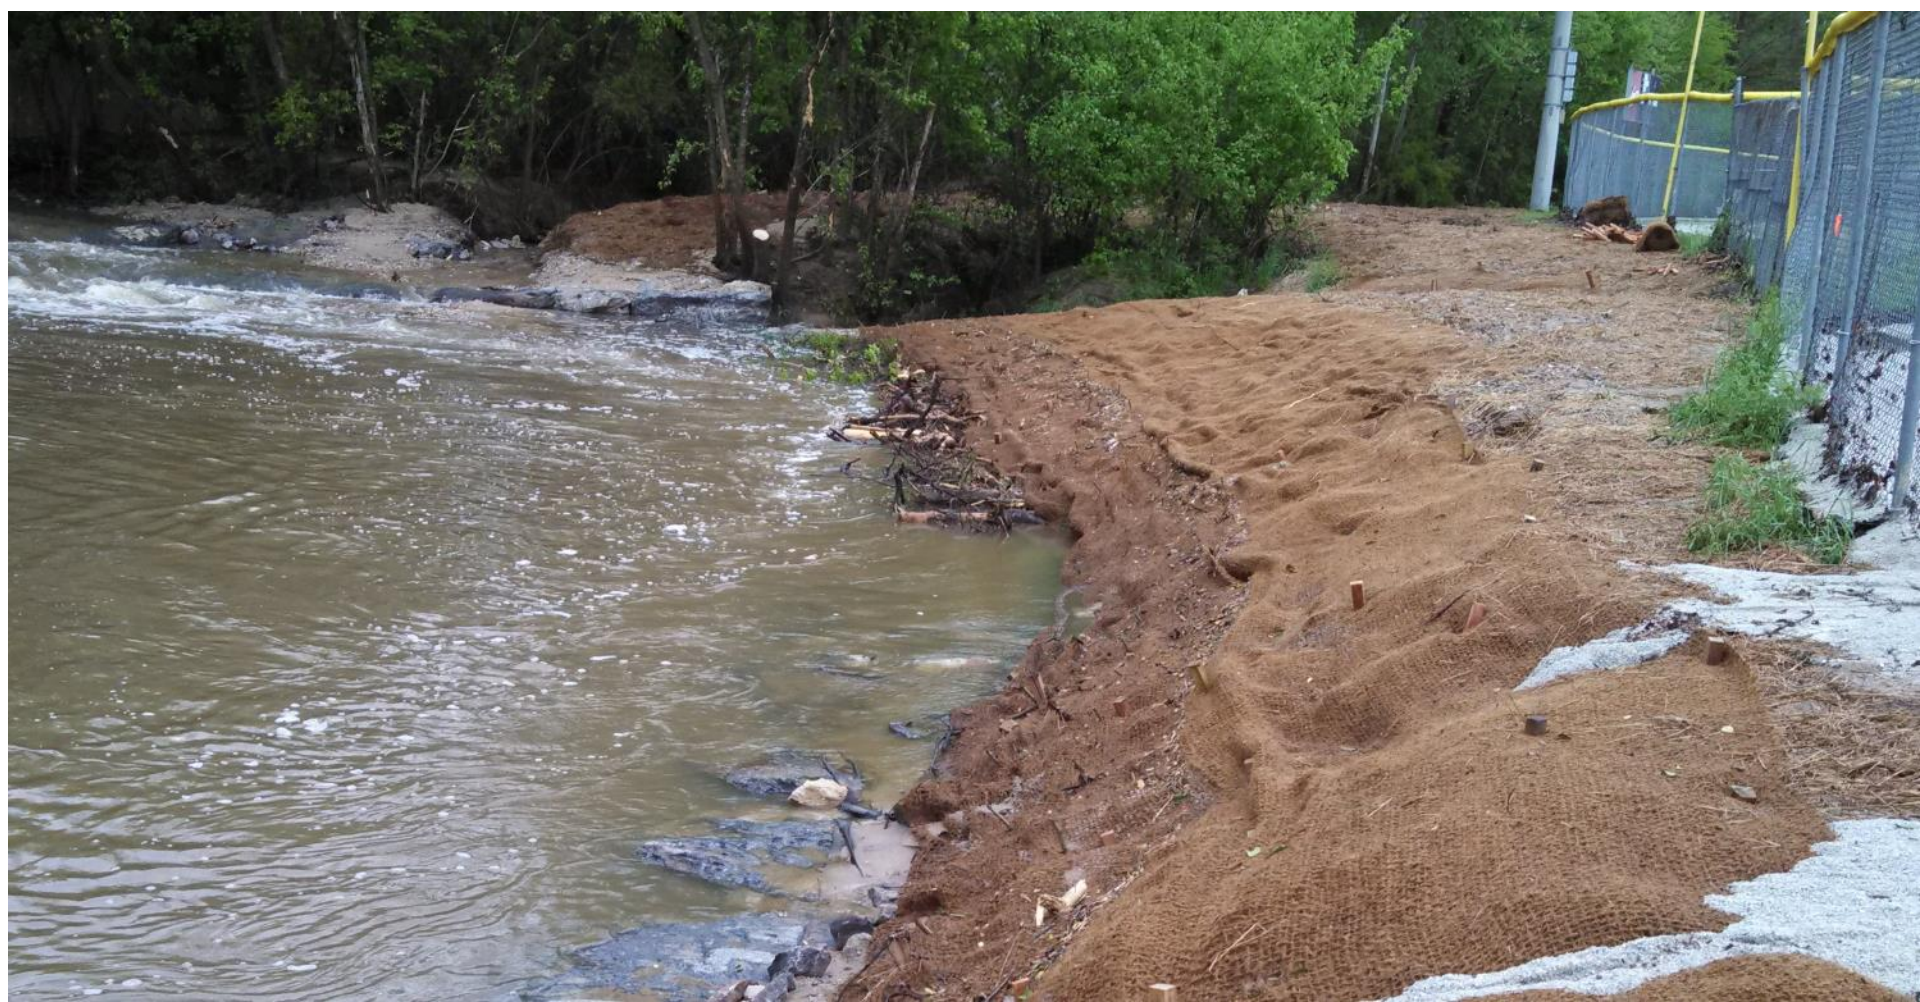
Streambank Stabilization

- Temporary matting
- Bioengineering

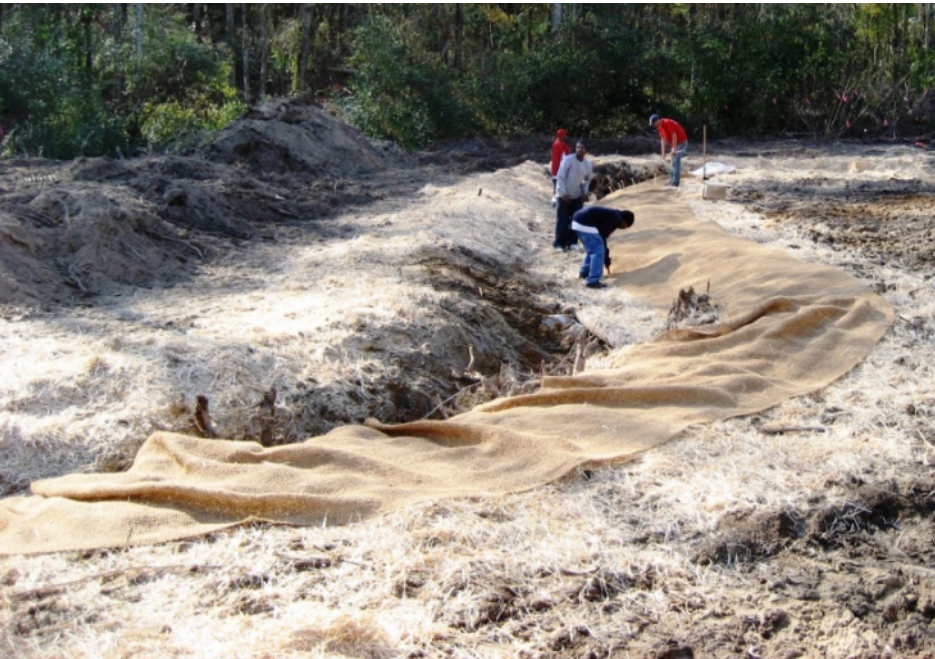
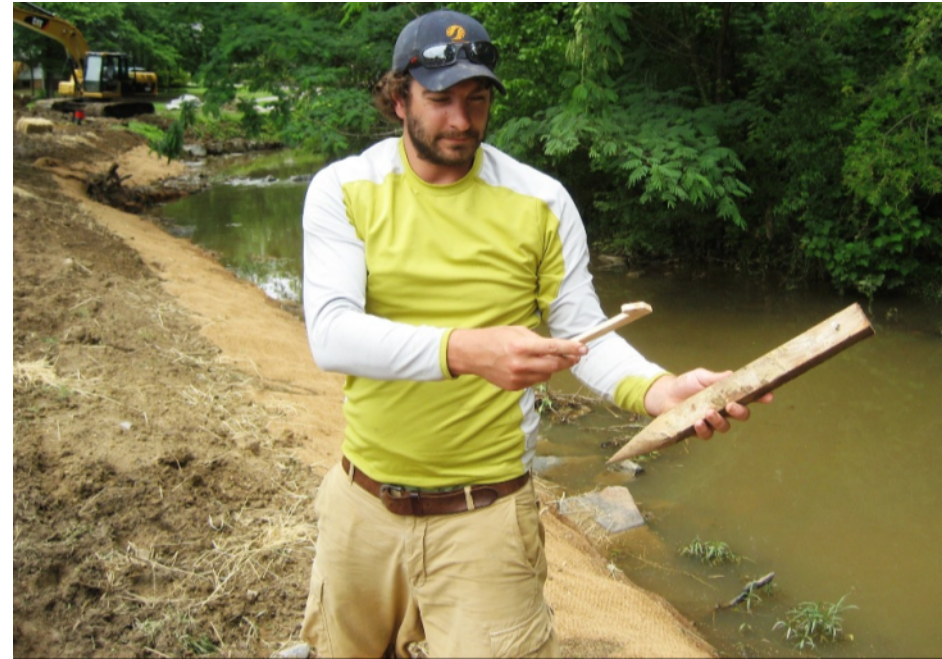
Temporary Matting

- Biodegradable (coir, jute, excelsior)
- Seed and straw UNDER mat
- Keep matting relaxed
- Key in at top
- Stakes: wood or biodegradable plastic

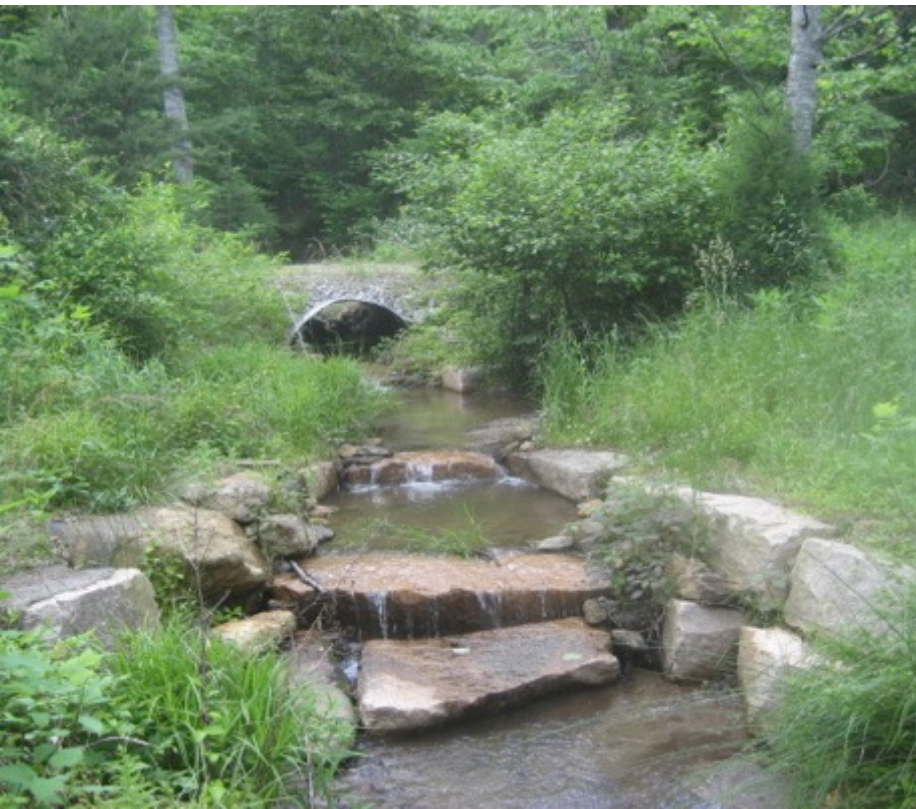
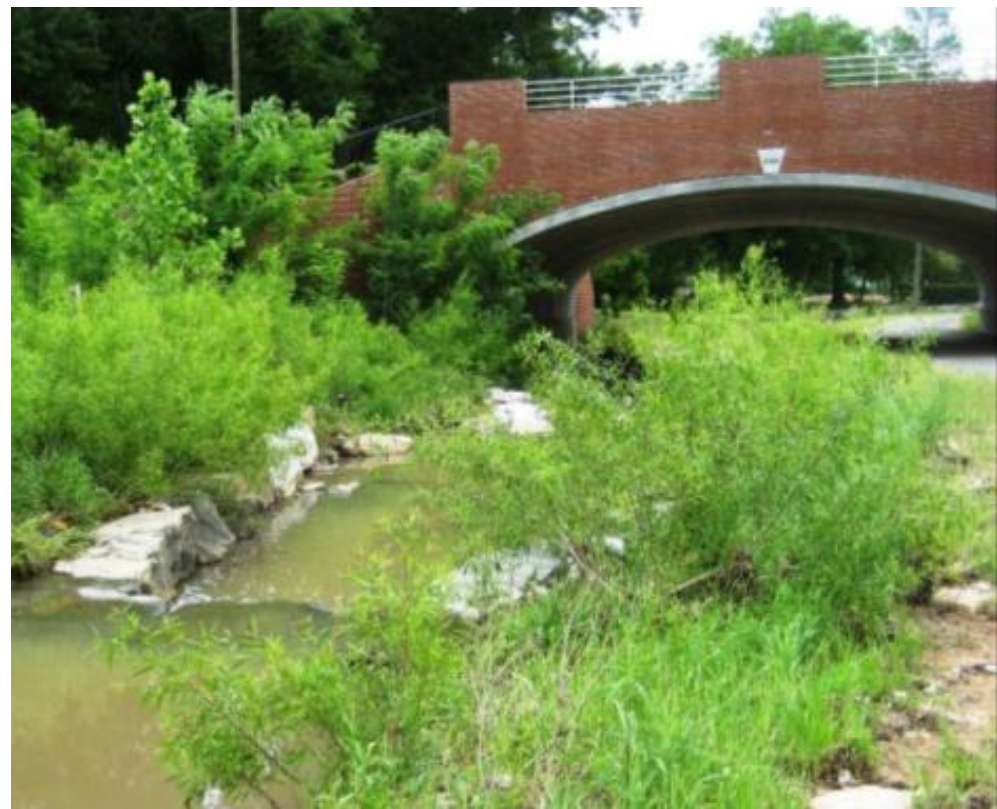
Stream Crossings

- Aquatic organism passage
- Minimize geomorphic impacts
- Pass flood flows

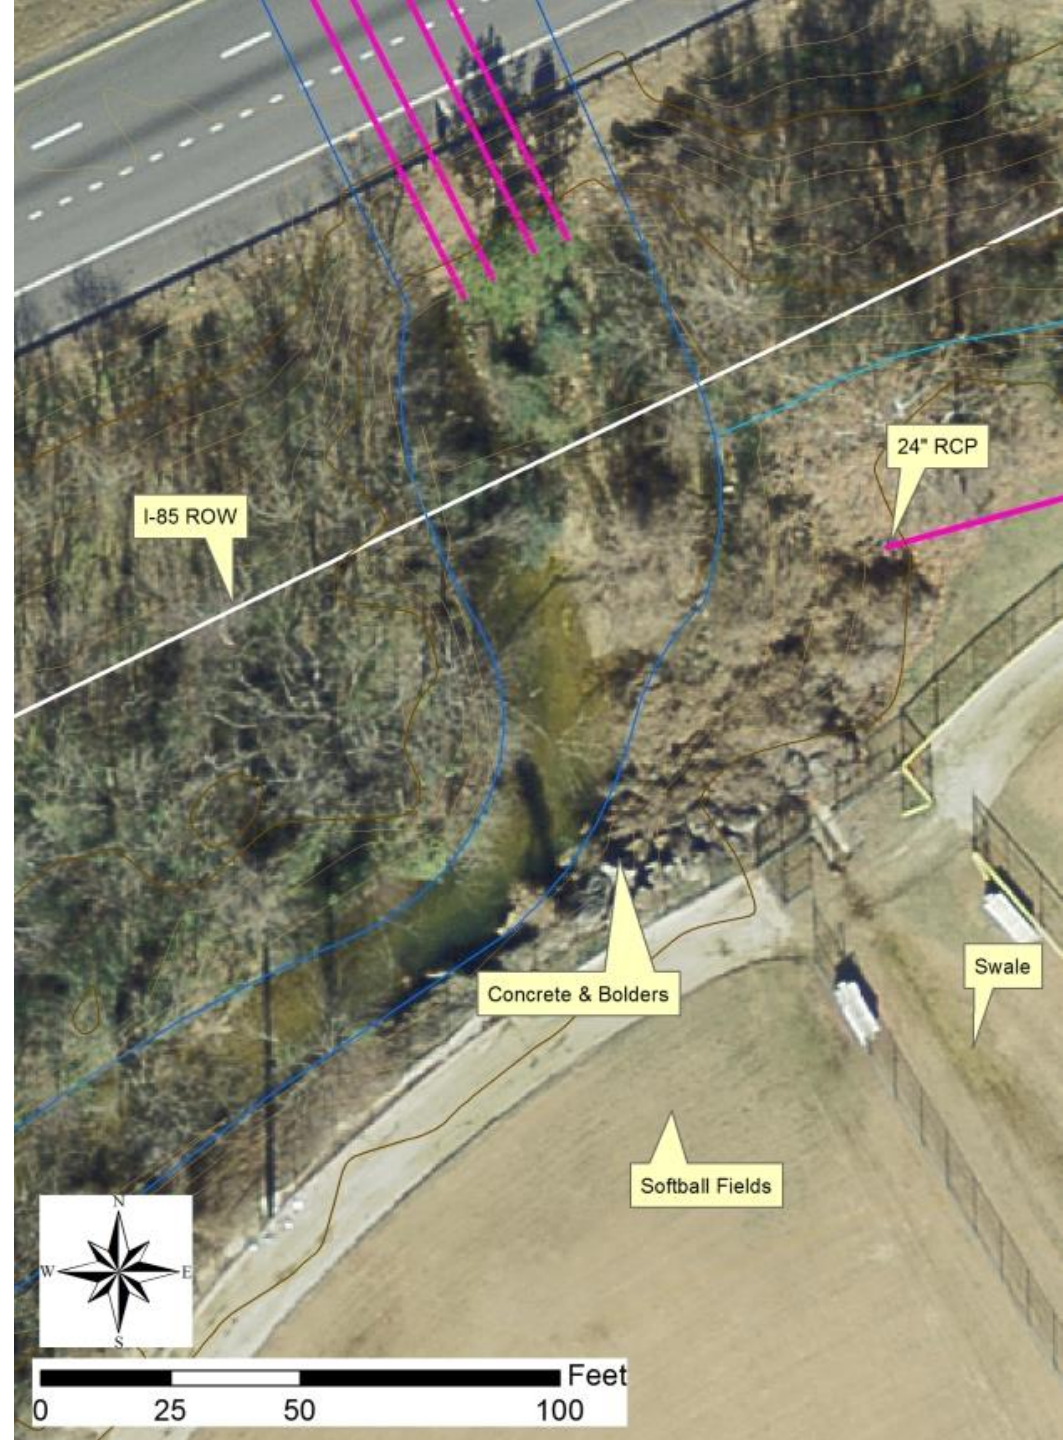
Case Study:

Parkerson Mill Creek, Auburn, AL

Softball Complex
downstream of I-85,
2014

- Channel realignment
- Boulder and log vanes
- Toe wood revetment
- Coir matting
- Native plants

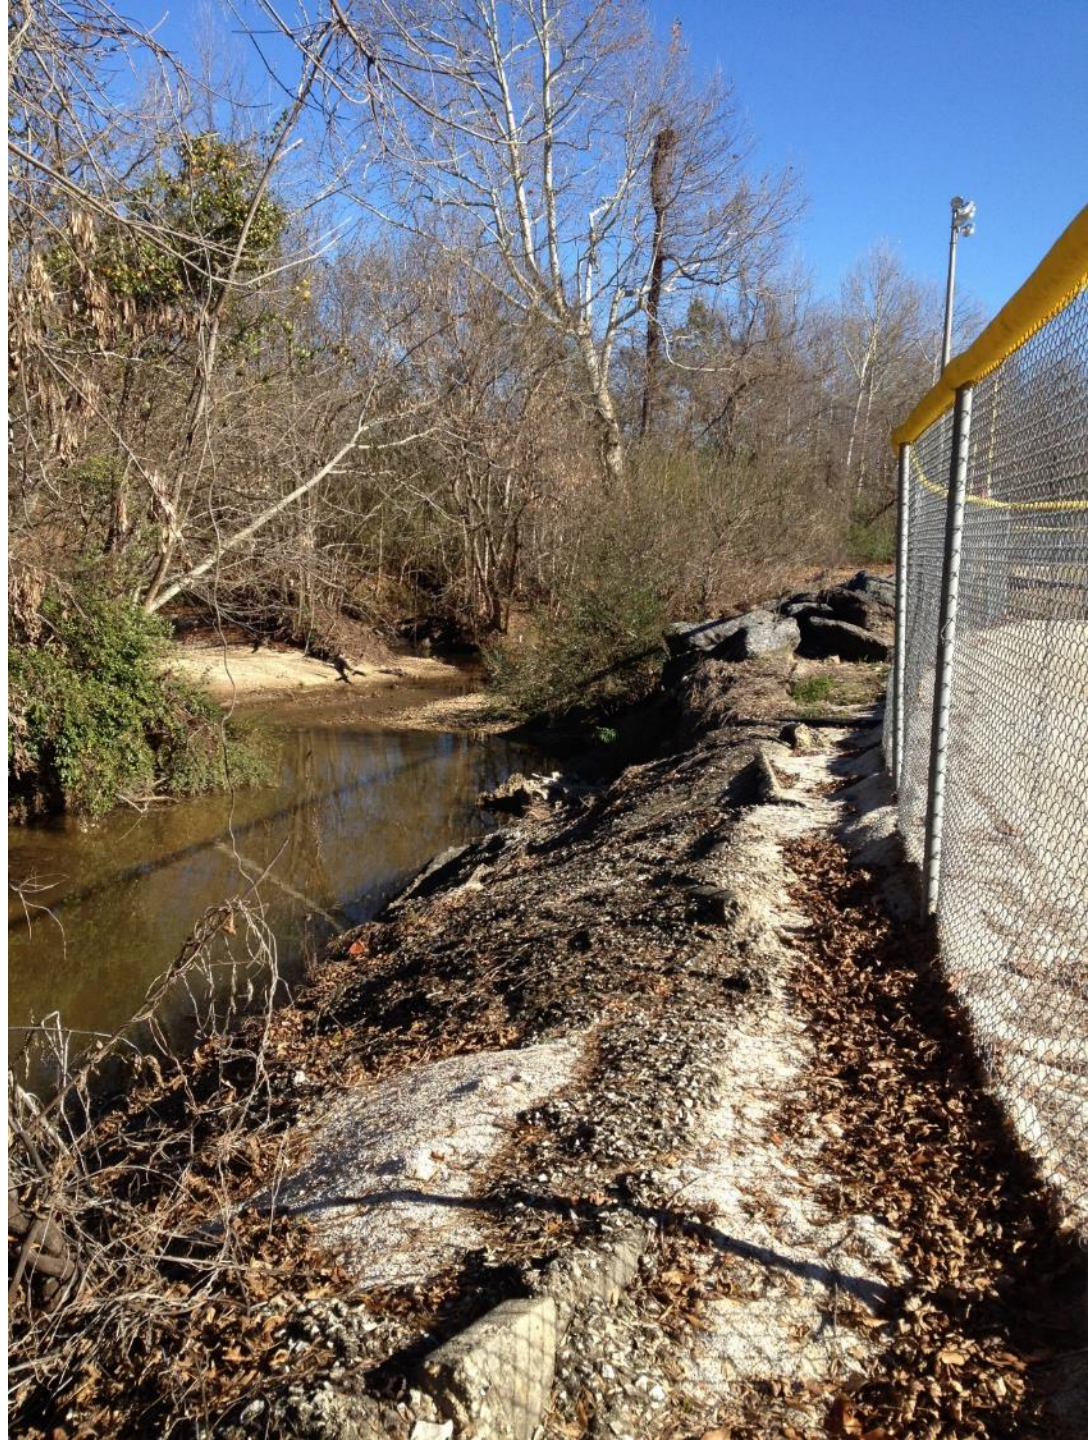
Problems:

- Sharp turn downstream of culvert to accommodate recreation
- Sediment accumulation in channel downstream of culvert forcing flow toward banks
- Failing bank armor
- Lack of native plants
