Backyard Riparian Stabilization & Restoration Projects

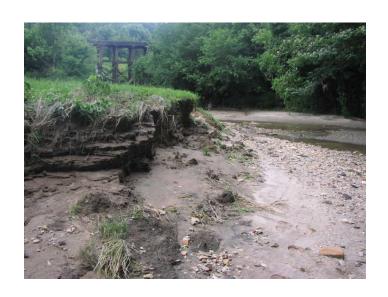
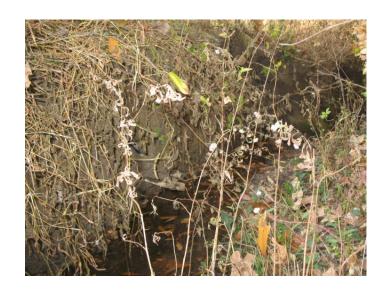
Slumping & sloughing banks

Undercut banks

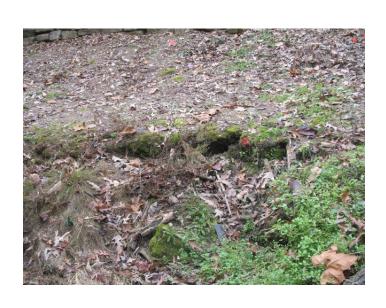
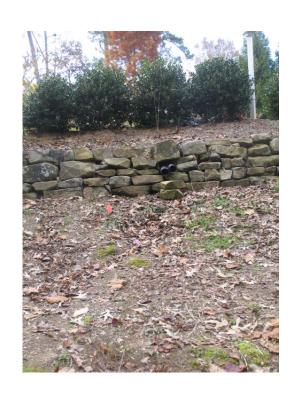
Erosion from above

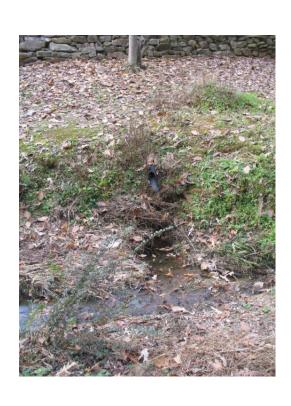
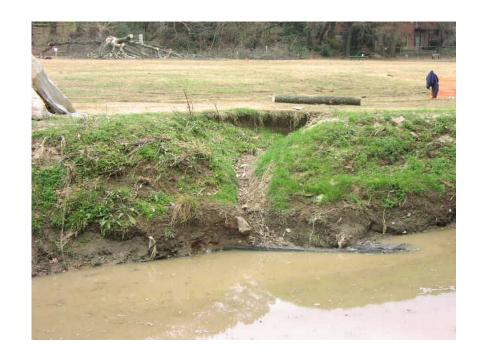
Both below & above

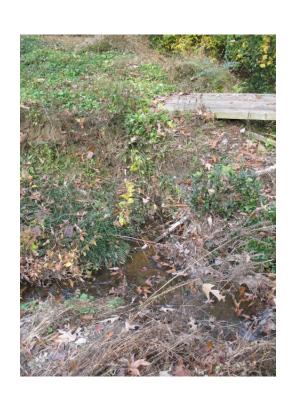
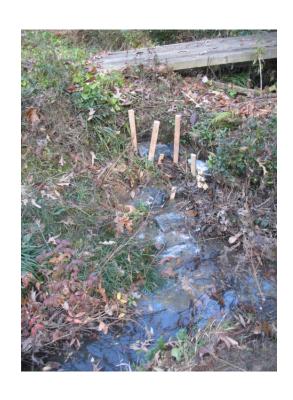
Toe stabilization w. placed rocks, logs, wattles, plants - 1

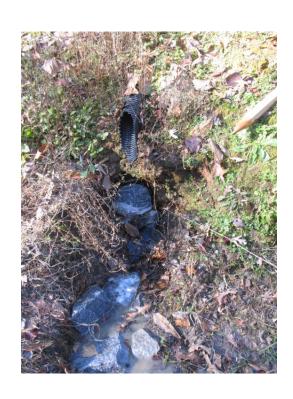
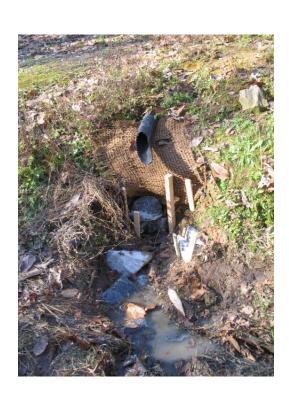
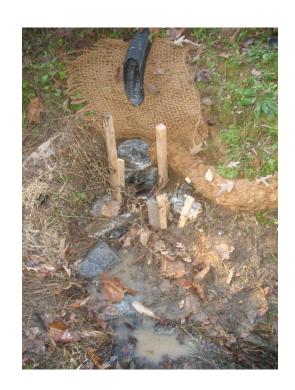
Toe stabilization w. placed rocks, logs, wattles, plants - 2

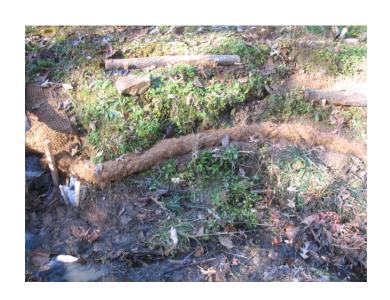
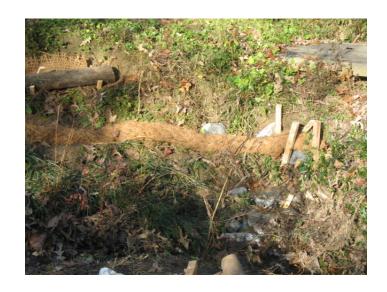
Final stages (so far)

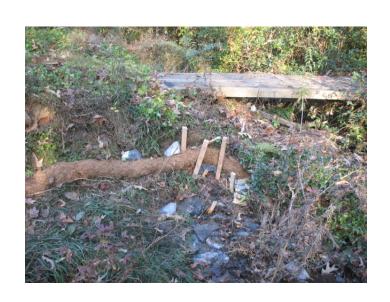
Stable mass into banks

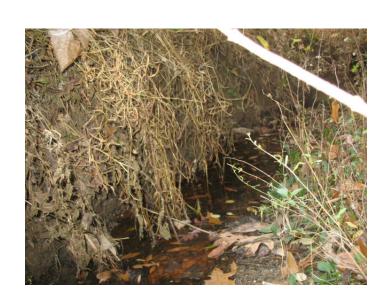
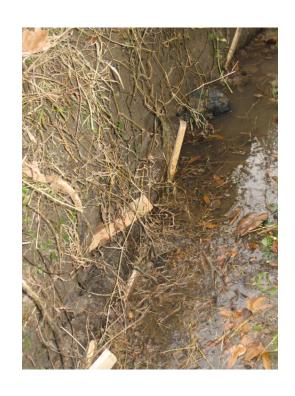
Major element missing

Erosion from below

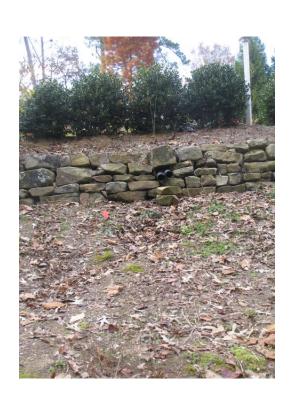
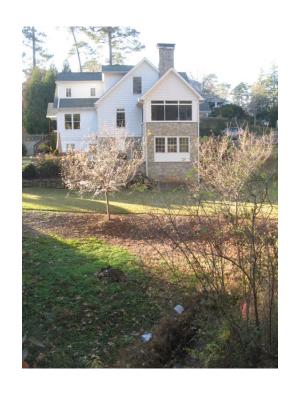
Erosion from above

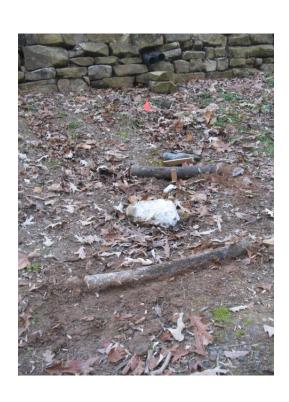
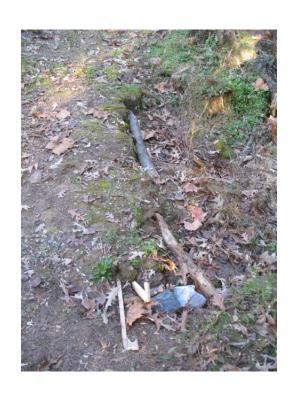
Flows downhill & rills

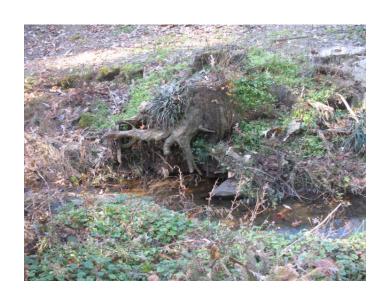
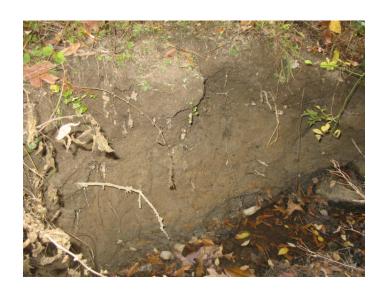
Undercuts - stable & unstable
